ARCHAEOLOGY

MACKAY'S CROSSING

Report to Transit New Zealand on  
Archaeological Investigations arising from  
Authority No. 2003/103  
March 2005

# Report on Archaeological Investigations arising from Authority No. 2003/103, MacKay's Crossing Over-Bridge Construction and Road Realignment.

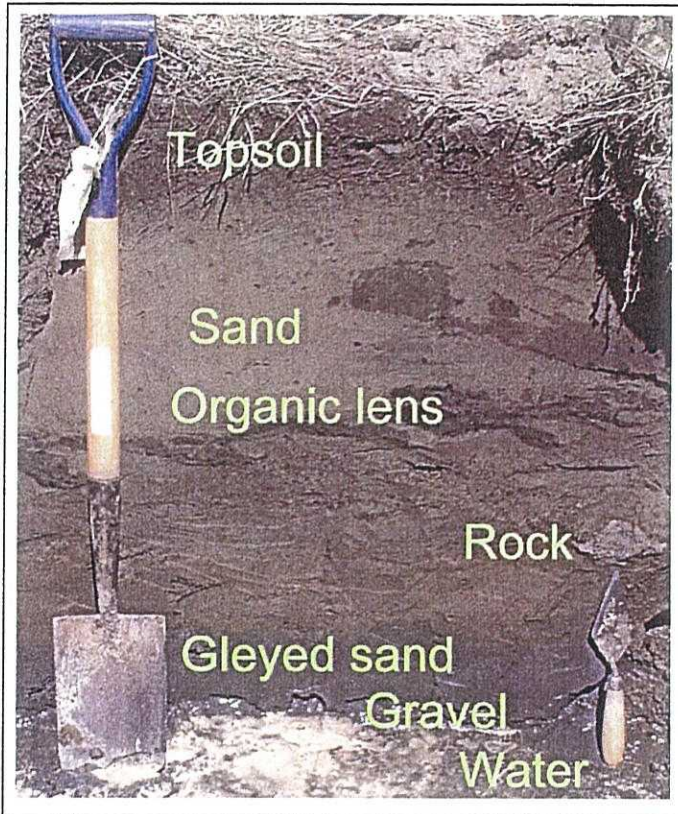
Within the sand are lenses of organic matter usually less than 10 cm thick and 1.5 m long, more or less horizontal but occasionally contorted with tails and bulges (Figure 5) and showing internal layering. The upper and lower external boundaries and the internal layer boundaries are sharp and well-defined. Some lenses are hard to dig, and some appear to lie on tip lines.

The shells, stones, silt lumps and lack of dune bedding indicate the sand is not dune sand. The sharp boundaries, internal layering, contorted appearance, and tip lines indicate that the lenses of organic matter are not a result of soil formation *in situ*, but are material carried in from elsewhere. Their hardness is probably a result of artificial

Figure 5. Section through sand sheet (= A, Figure 1).

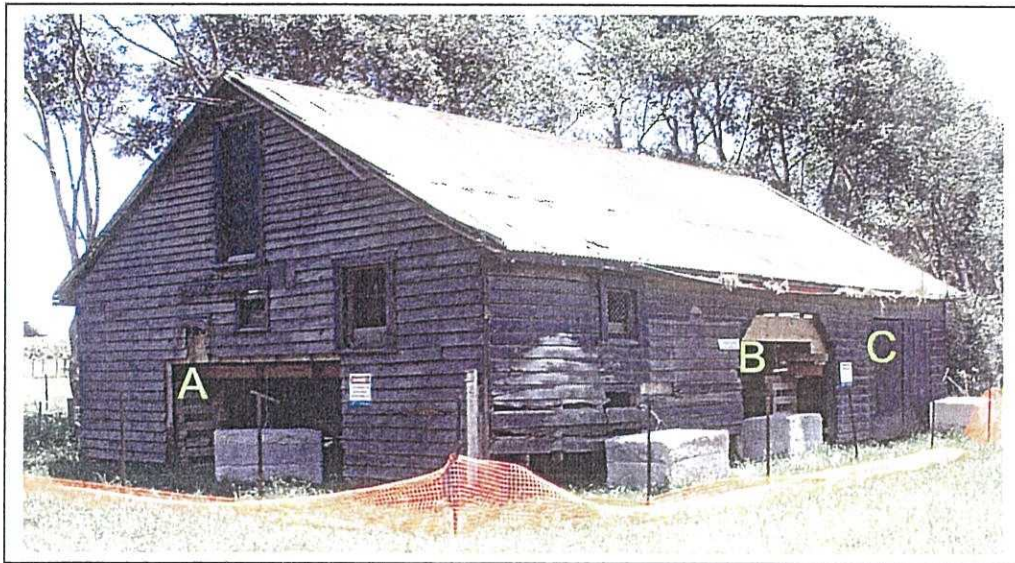
The stable building now rests on temporary supports that raise the wall plates a few cm above the ground. Before shifting the building, the removal crew cut a rectangular hole in its eastern side large enough to back in the trailer of a transporter (Figure 6 exterior), and they cut off the front 1.78 m of the wooden floor, just in front of the middle bearer, to transport separately. The lower part of the front wall is missing, having disintegrated due to rot, and there are two large openings in the front wall. Considering the age of the building, and the loss of so much of its structural integrity, even though the contractor added bracing to mitigate distortion, I would expect the building suffered some structural distortion because of moving. I do not know how

Figure 6. View of barn from north east corner. A = opening cut for removal trailer. B = barn doorway. C = barn doorway with door.

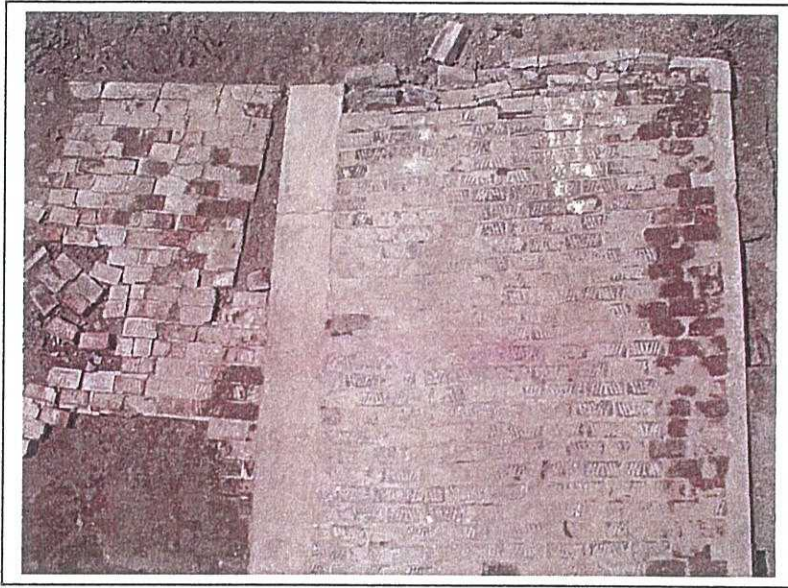
**Figure 10.** Detail of brick paving at southeast end. Note dislodged rim and bricks skewed out of position-

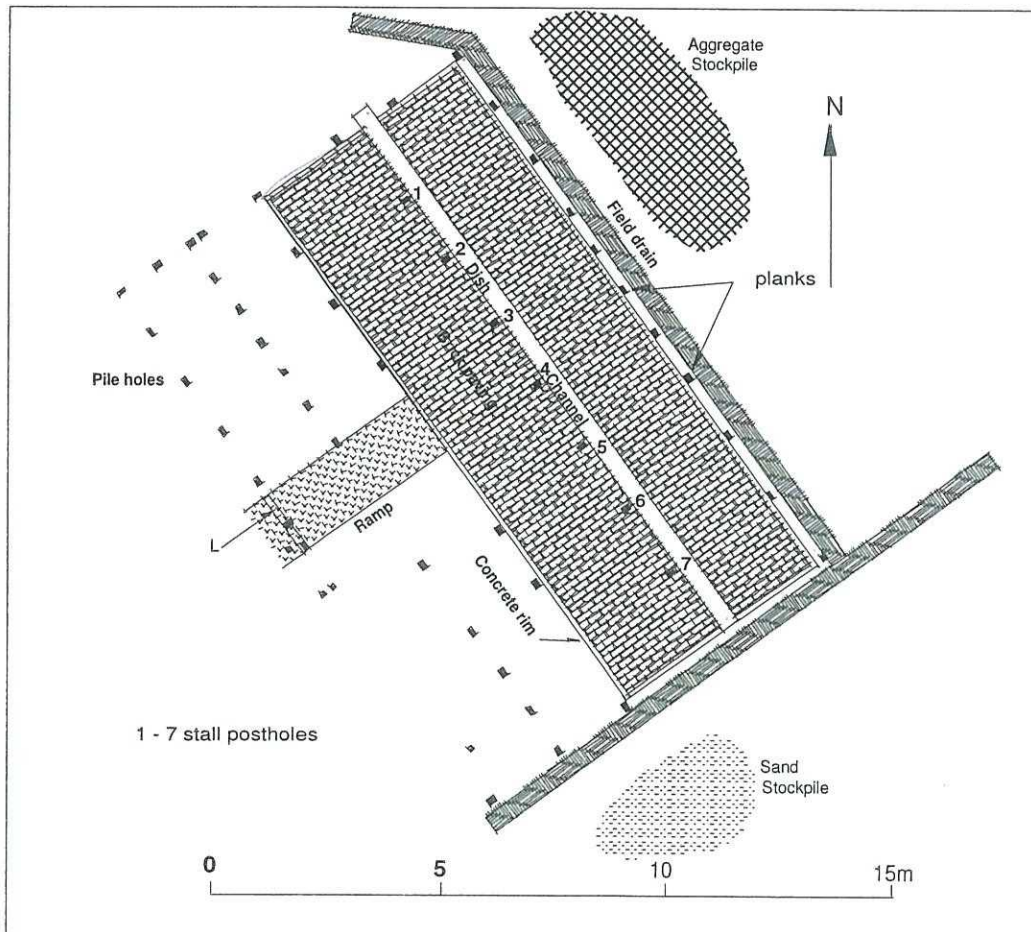
The investigation did not locate all pile positions (Figure 11); there were gaps along the southwestern side of the floor between the ramp and the field drain, and along the southwestern side of the paved area near the ramp and south corner. I made a careful search for pile holes where the ramp abuts the brick pavement, but found none. The ground was firm, dry at this point, and would preserve pile holes well, although I acknowledge that a pile hole filled with local fan material would effectively disappear. Between the ramp and south corner, the ground was soft and damp, and any holes would probably have filled in when trench digging machinery moved over the ground. There were pile holes at the south and west corners of the brick pavement, but none at the southeastern end. The dislodgement of the rim at the southeast end of the pavement may have obscured or removed the holes.

**Figure 11.** Plan of archaeological features uncovered beneath the barn site. Black rectangles are locations of piles, except those numbered 1 to 7, which are postholes. Arrows labelled “planks” point to opposite ends of two planks laid alongside the concrete rim (Figure 13). For explanation, see text. L = linear depression left by the barn wall in the ramp. Aggregate stockpile inferred from the presence of gravel similar to that in channel concrete. Sand stockpile inferred from the presence of sand similar to that used to bed bricks in the pavement.

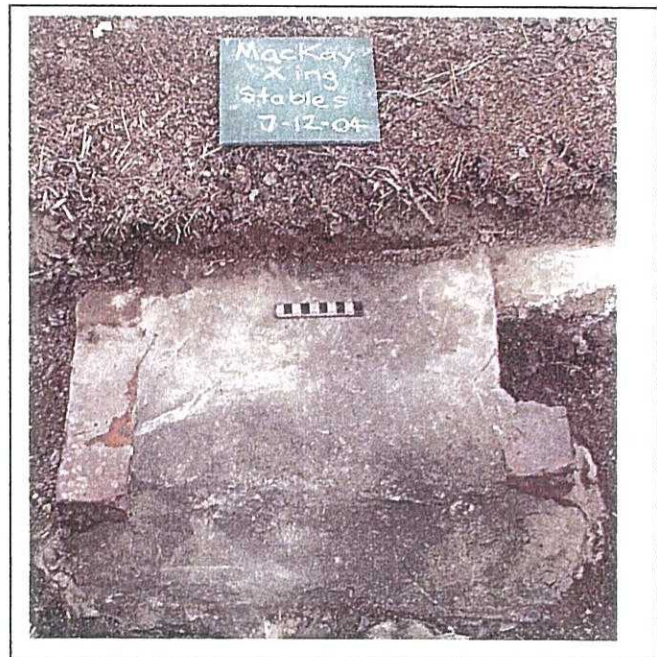
Figure 17. Channel discharge at northwest end of stable floor. Scale = 10 cm.

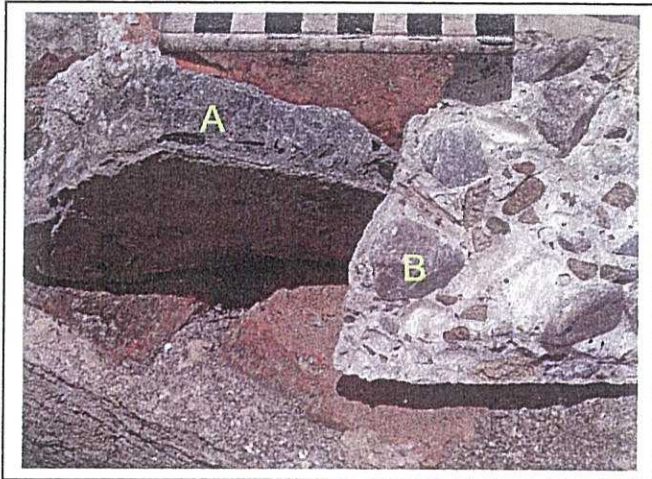
**Figure 22.** Comparison of the concrete forming the channel (=A) and that forming the rim around the brick paving (=B). Scale = 10 cm.

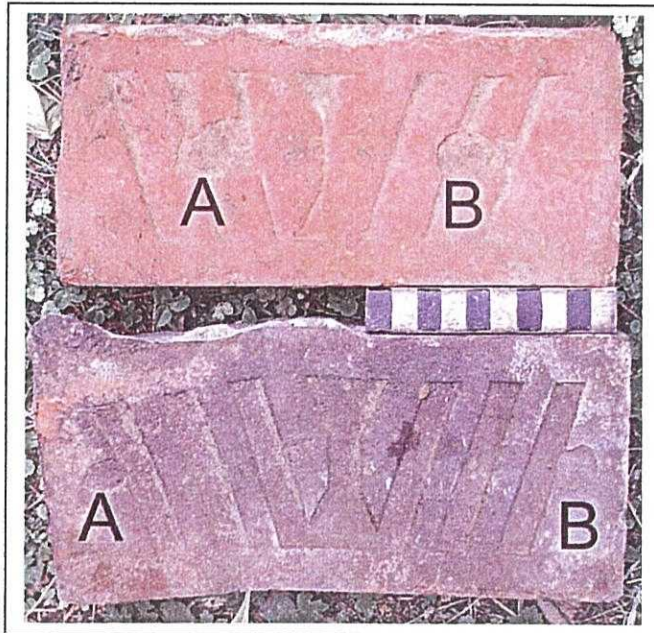
**Figure 23.** Bricks from pavement showing WW pattern and marks of bolts holding the pattern inside the steel mold (=A,B). Note deformation of lower brick from excess kiln heat. Scale = 10 cm.

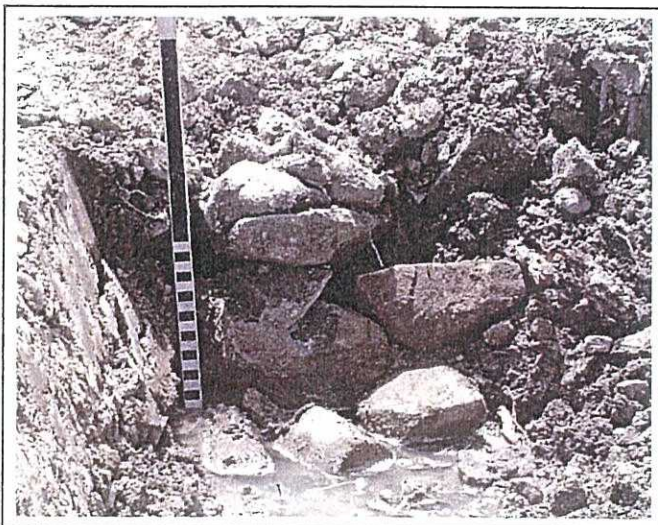
The field drain was an excavated trench, trapezoidal in cross-section (Figure 18) with its greatest width at the top and filled with stones (Figures 24 & 12). The stones were all water worn and probably collected from a nearby stream or river. The drain was c.0.2 m outside the concrete rim along the southeast end of the pavement, and 0.2 – 0.3 m outside the rim along the northeast side. The remains of piles around the northeastern and southeastern perimeter of the pavement were between the drain and the concrete rim, and the edge of the pile at the south corner of the floor was visible in the side of the drain.

**Figure 24.** Cross section of stable field drain. Scale = 40 cm.

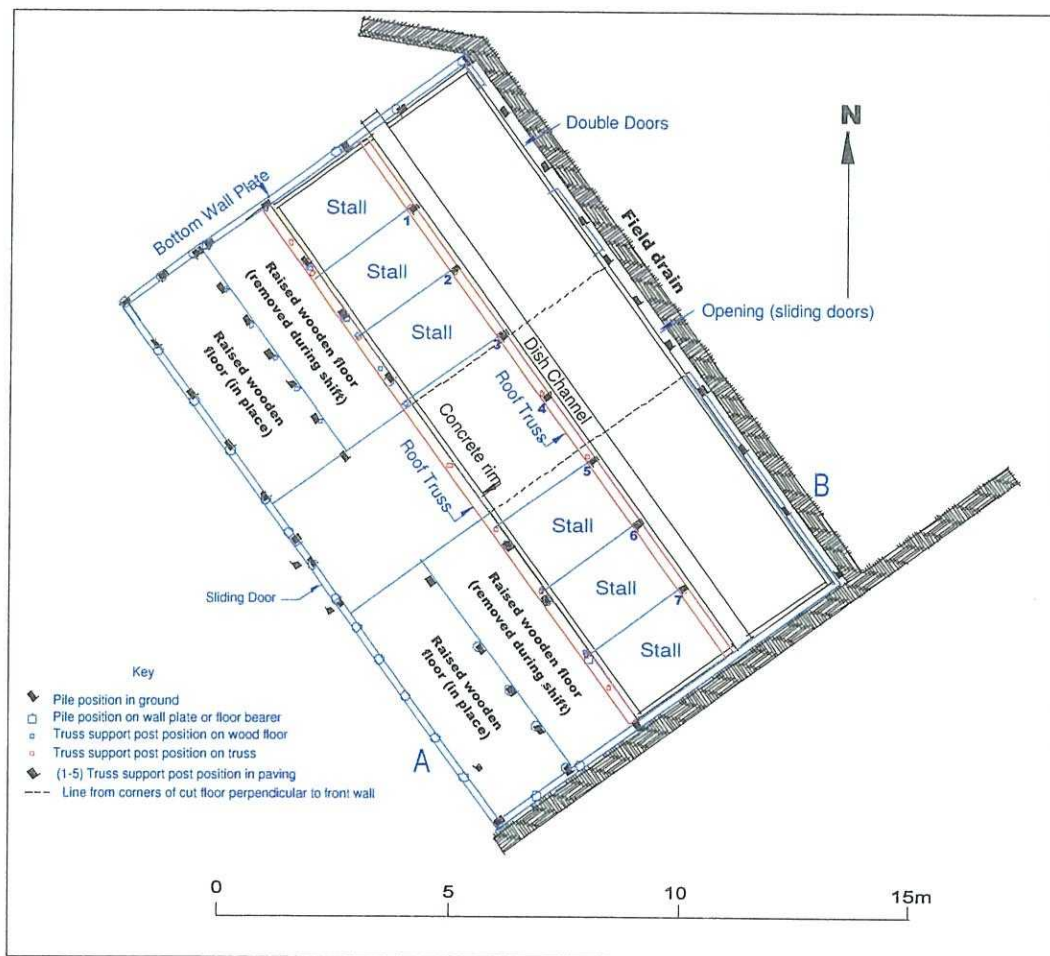
The floor did not extend right across the rear of the building, there is about 3 m missing from the centre, immediately in front of the sliding door (Figure 29). The missing part of the floor lines up with the 3.3 m wide opening in the front wall.

If lines are drawn from the front corners of where the floor is cut, perpendicular to the front wall, they intersect the wall very close to the sides of the opening in the front wall, and the butt of post 4 lies almost midway between them (Figure 11). Also between the lines, the pile alongside the concrete rim was missing, despite a search for one, yet the spacing of the piles alongside the rim strongly suggests that one should be present. Nor was there a pile in the next row back, where again spacing suggests that one should be present. On the other hand, there was a pile in about the right position along the rear wall.

**Figure 29.** Plan of stable building superposed on plan of excavated pile holes. Note area of missing wooden floor along southwest wall. Dashed lines from edges of missing floor drawn perpendicular to front wall – note close correspondence with sides of front opening. A-B = cross section of stable building (Figure 31).

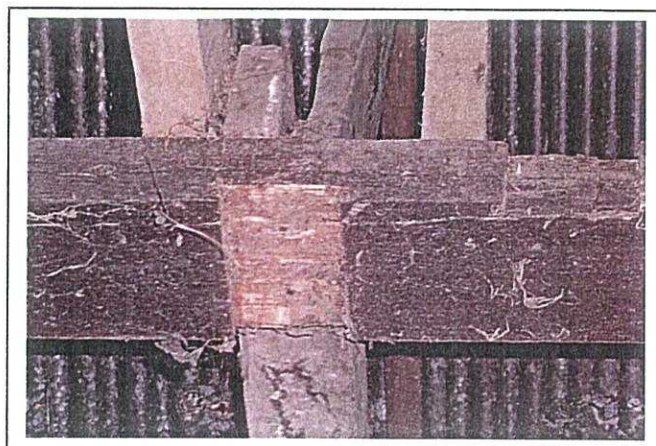
Figure 29 shows the rebates in the front roof truss, directly above the postholes alongside the dish channel. The rebates are probably from the posts that Peter Sannazzaro (*pers com*) observed supporting the roof trusses just before he removed the stable building. Nails and discoloured patches in the rear roof truss are directly above the nail holes in the front floor bearer and small sections of floor cut out to allow the posts to sit on the bearer, and these too will be from roof support posts. The two sets of posts line up and define the stable stalls that Mrs. Robinson described.

**Figure 30.** Bottom face of roof truss showing rebate for top of stall post. Note the earlier rebate in the side of the truss from an earlier use.

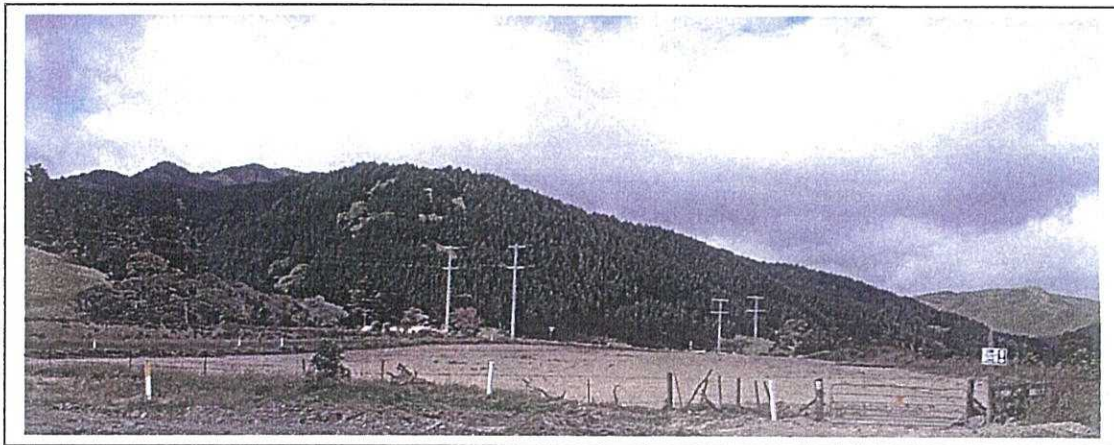
Grey coloured topsoil 20cm to 30 cm thick overlies light brown to yellow brown subsoil formed in the old stream fan deposits. Trench diggers with 1 m wide, smooth-edged buckets stripped the topsoil (Figure 34), exposing archaeological features in the underlying subsoil. The features showed as patches of grey to black soil or, in the case of some burnt areas, as reddish brown patches of soil, at the interface between the topsoil and subsoil. Each feature was marked with a pin and bright coloured tape and numbered, and its location later recorded with survey quality GPS. Unfortunately, an archaeologist was not always present during the taking of GPS measurements, and loss of labels due to wet weather and disturbance of markers by cows, meant the loss of details for several points.

**Figure 34.** Photograph looking south showing area of topsoil stripping (= A, Figure 33).

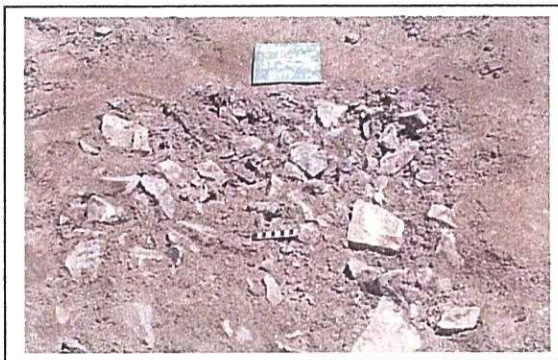
**Figure 46.** Feature 1, Camp Russell. For details see Table 2.

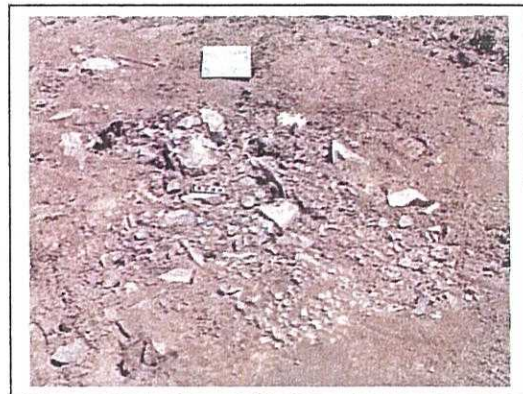
**Figure 47.** Feature 2, Camp Russell. For details see Table 2.

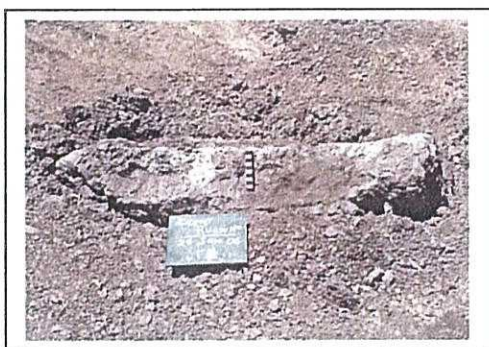
**Figure 48.** Feature 3 (concrete), Camp Russell. Scale = 10 cm. For details see Table 2.

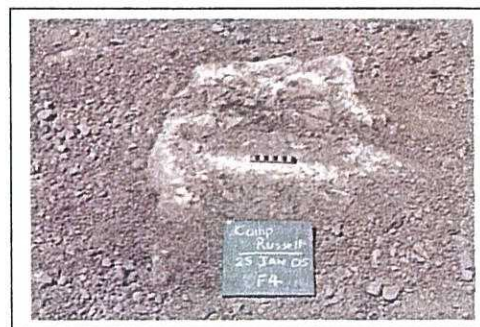
4	2676608.7	6024499.8	Piece of broken concrete roughly rectangular 48 cm x 59 cm. Aggregate = subround gravel up to 3 cm, plus weathered angular gravel up to 6 cm.	Fig. 49
5	2676591.3	6024483.9	Irregular patch of rubbish; edge is reddened and blackened, indicating burning <i>in situ</i> . Probably a pit. Contents include broken ceramic (see text), rusty nails, burnt wood, and 2 large boulders (up to 40 cm on long axis) and several smaller stones of angular unweathered blue-grey greywacke. 0.75 m x 0.80 m. Crockery collected.	Fig. 50
6	2676548.6	6024456.6	Oval patch of concrete, 0.9 m x 0.6 m, with two postholes 11 cm square. Aggregate = sub-round gravel up to 3.5 cm, but most less than 1 cm.	Fig. 51
7	2676600.1	6024530.3	Discoloured burnt silt (from <i>in situ</i> fire) 2 m x 1 m.	
8	2676594.8	6024525.3	Yellow rubble patch 1.5 m x 0.8 m.

**Figure 49.** Feature 4, Camp Russell. Scale = 10 cm. For details see Table 2.
