Peer Review of Greater Wellington Flood Protection Assets

By Horizons Regional Council 19 & 20 June 2008

Report prepared by Paul Joseph and John Eyles, September 2008

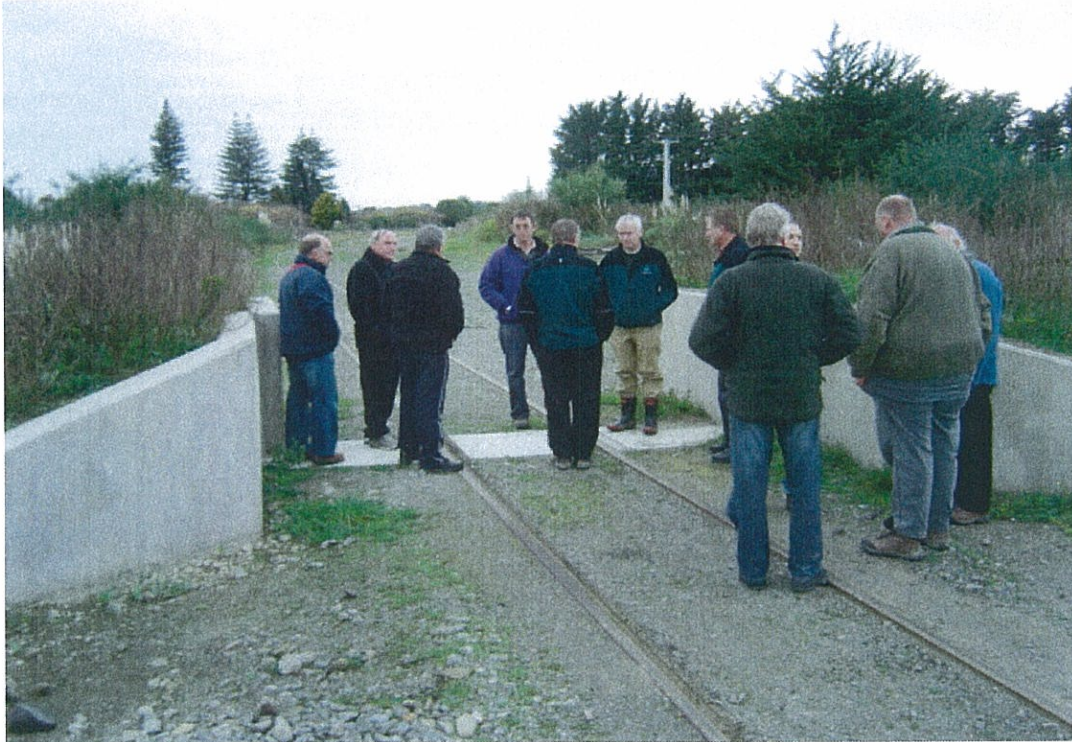
2.1.1 Chrystalls Extended Stopbank

HRC staff were very interested in the design and operation of the removable aluminium Blobel floodgates on the main trunk railway line, and are considering adopting this solution for similar situations in their region.

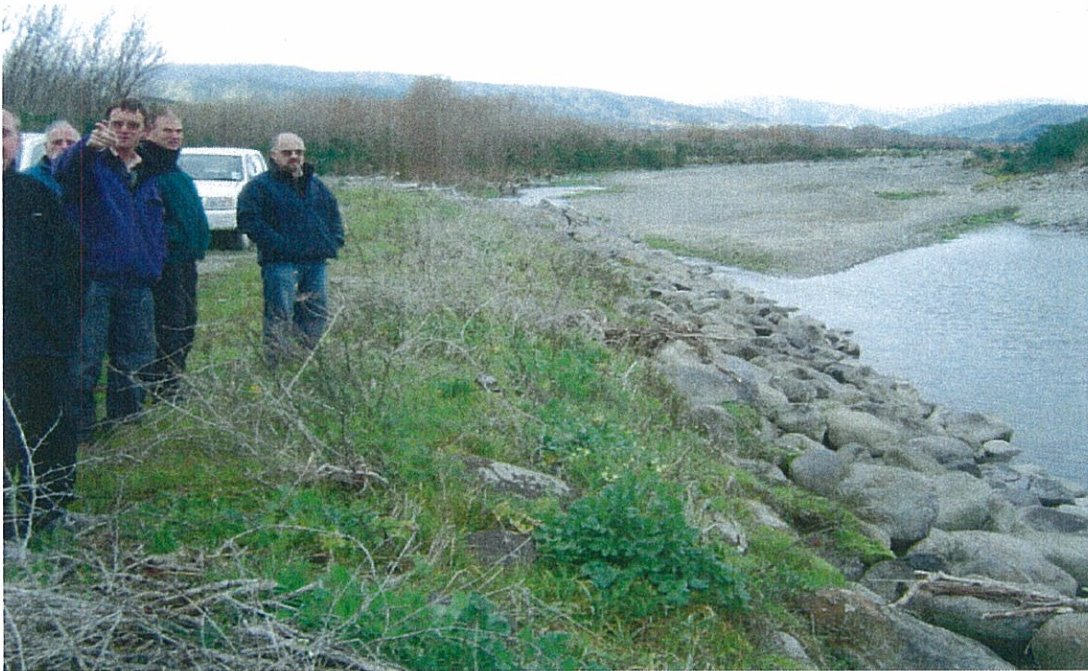
2.1.2 Chrystalls rockline

This rockline was constructed with 30,000 tonnes of rock from Tangiwai. Staff from GW and HRC both agreed that skilled machine operators are critical for placement of large rock. HRC practice is to specify and place angular rock for rocklines. GW preference is for more rounded shaped rock, although it was agreed that the shape of the rock is not critical compared to operator competence. River bank discussions included the embedment of rock into the bed of the river with regard to scour depths, durability of the works and the risk that the job could be outflanked.

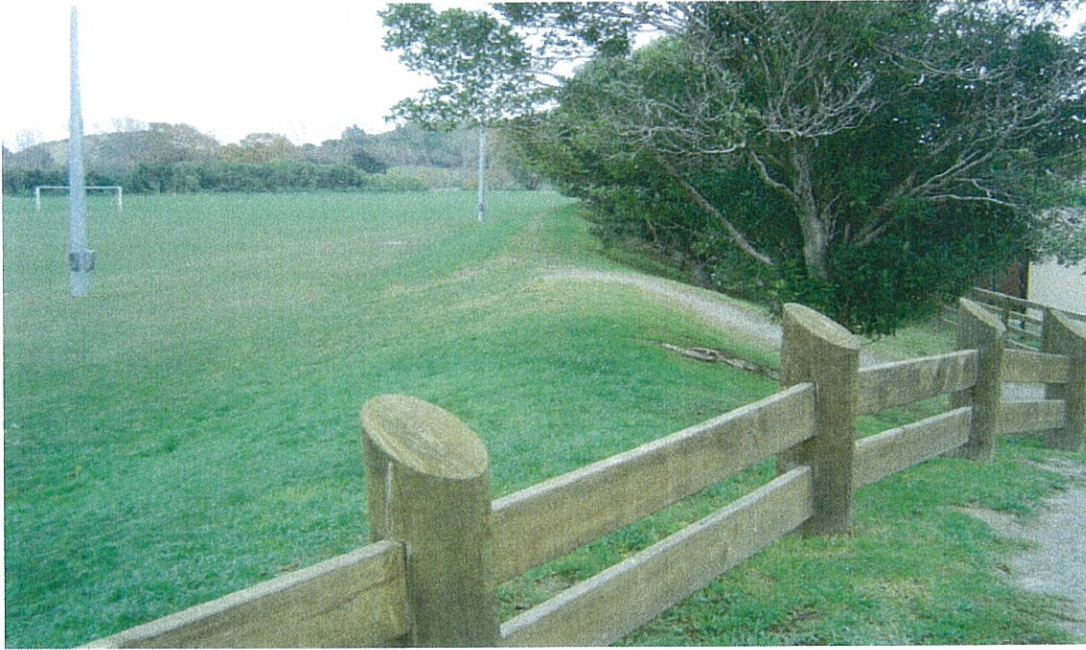
2.2.1 Jim Cooke Park

The old stopbank is rated poorly because of steep batter slope, trees growing in stopbank, steps cut in and private gardens, insufficient height and width. HRC are currently reviewing their condition ratings, and found the debate extremely useful. The revised asset condition ratings, customer and technical levels of service that will be included in the latest edition of HRC asset management plans will be forwarded to GW when finalised. Presently, HRC would rate this old stopbank a higher condition than GW (condition 4- due for capital upgrade).

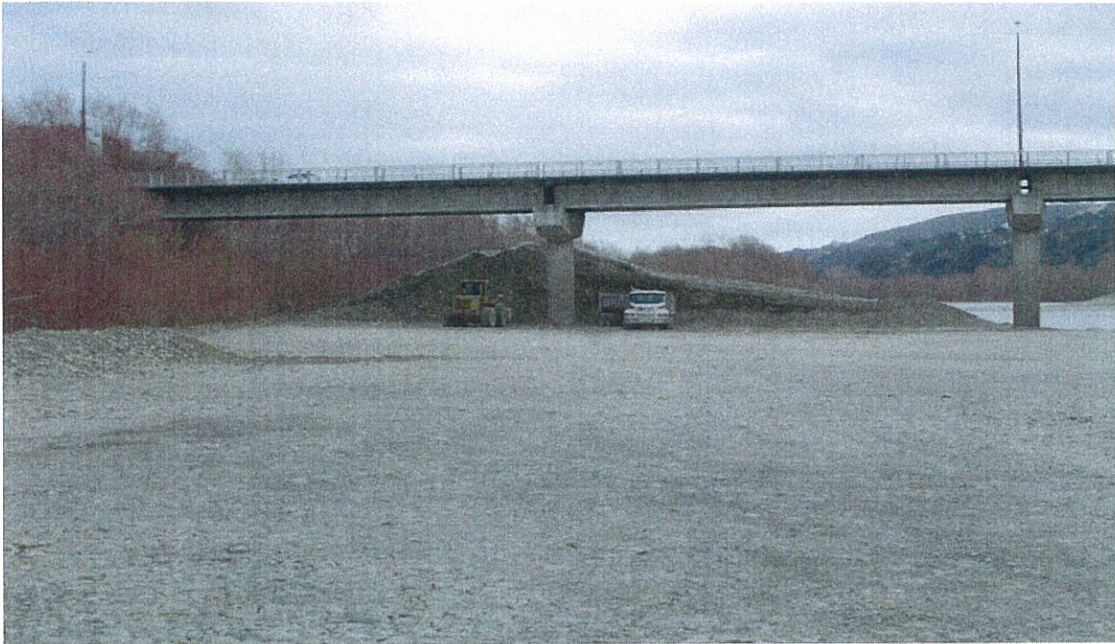
Gravel extraction at Kennedy Good Bridge. GW’s global consent allows for gravel extraction on dry beaches, but this is not enough to return bed levels to 1998 levels. A wet extraction consent has been granted, but conditions require a natural channel shape with a meander pattern to be put back (requirement of Fish and Game). Wet extraction gives an income of \$2 per m³ for gravel but increased dozer costs of \$3 per m³ for pushing up and channel-shaping costs means a loser activity for GW. Wet extraction in this reach was completed last Christmas. HRC identified that the size of the gravel pile stockpile under the bridge could increase flood risk. This was acknowledged by GW staff who consider the risk to be low.

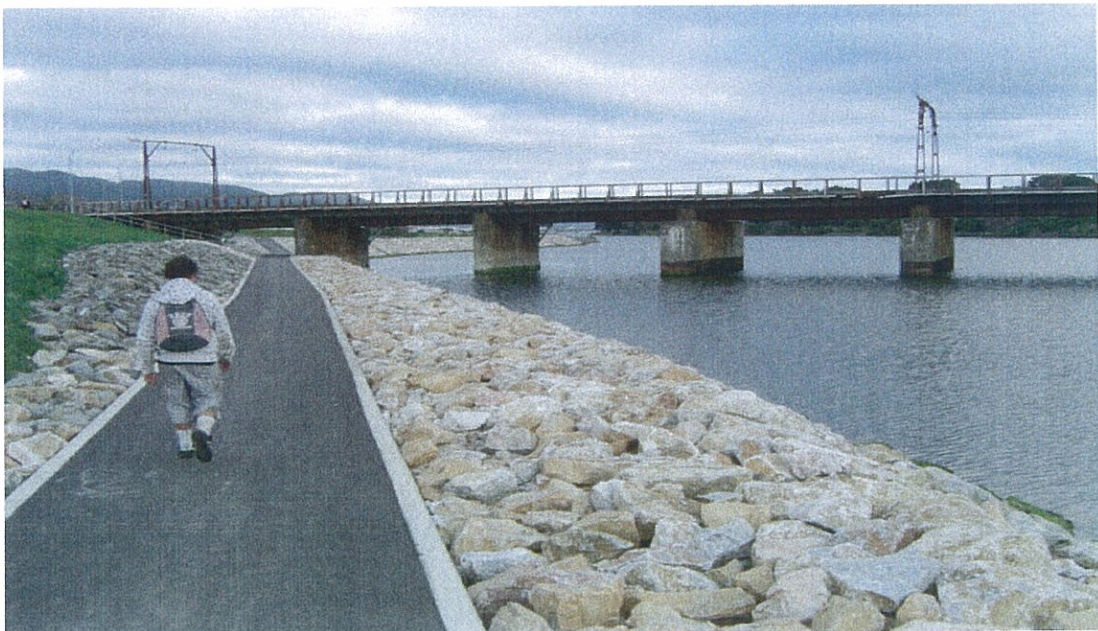
2.3.1 Ava to Rail bridge Capital works

This \$5M capital project has recently been completed. HRC were very impressed by the standard of the works at this site. The walkways and rock complemented each other aesthetically and provided a sound engineering solution to bank erosion in this reach. Interesting to note that rock was barged in from the South island, and how smoothly this operation went, showing good project management skills by GW.

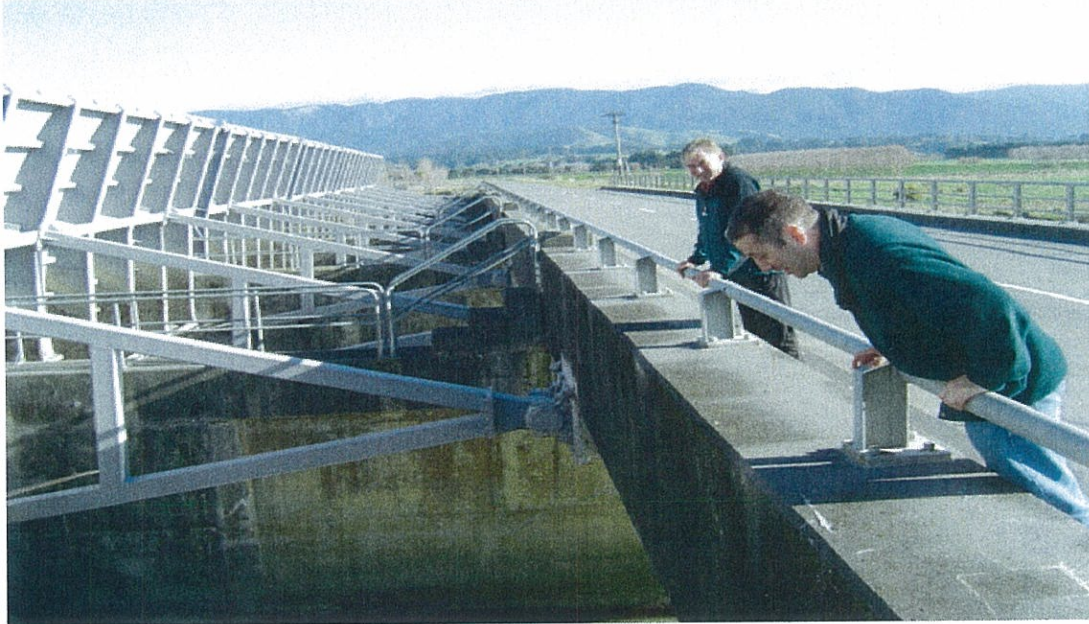
2.4.1 Barrage Gates

HRS considered that the scale and operation is very similar to their floodgates at Moronui. Depreciation is allowed for but no funds are physically set aside. The mouth at the exit from Lake Onoke needs frequent cutting (11 times already in last 6 months)

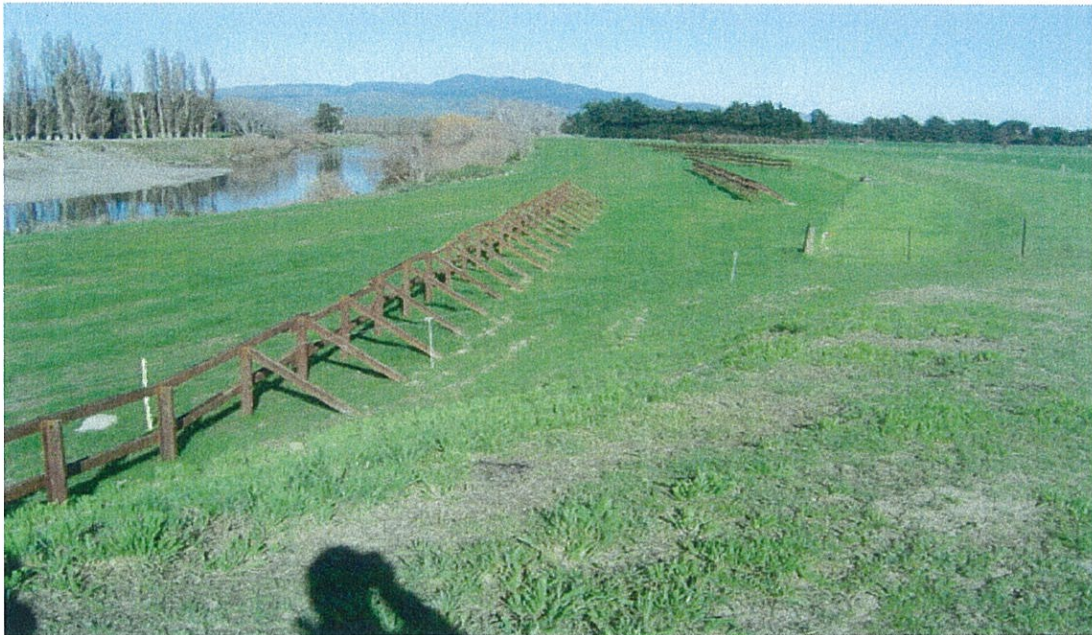
2.4.2 Hikinui Sill

The Hikinui sill operates as an overflow path in the lower valley in high flows and operates about once every 2 years. Previous problems with fast flows caused a hydraulic “jump” together with steep batters causing scour. The solution was to smooth out batters and reinforce grass cover over the sill to prevent scour. Rail irons have also been installed for debris protection. There is a boulder lining on the outside approach curve to the sill which is loose but effective.

HRC were particularly interested in this innovative solution to the problem of hydraulic jump bank erosion. The holistic view taken of this reach of the river, and the combination of a variety of works to solve this problem was a good example of sound river engineering practices.

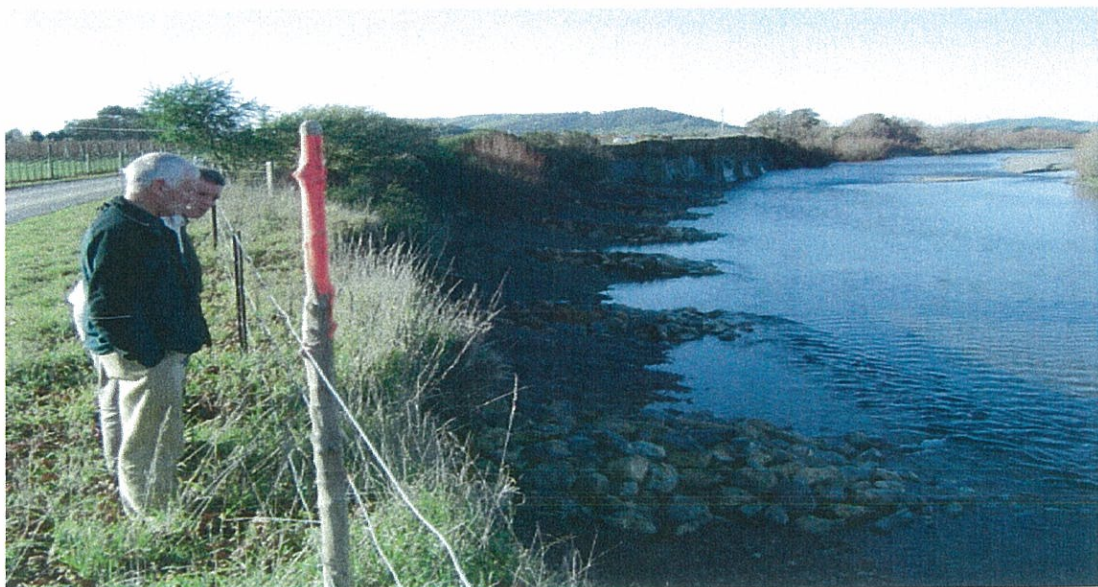
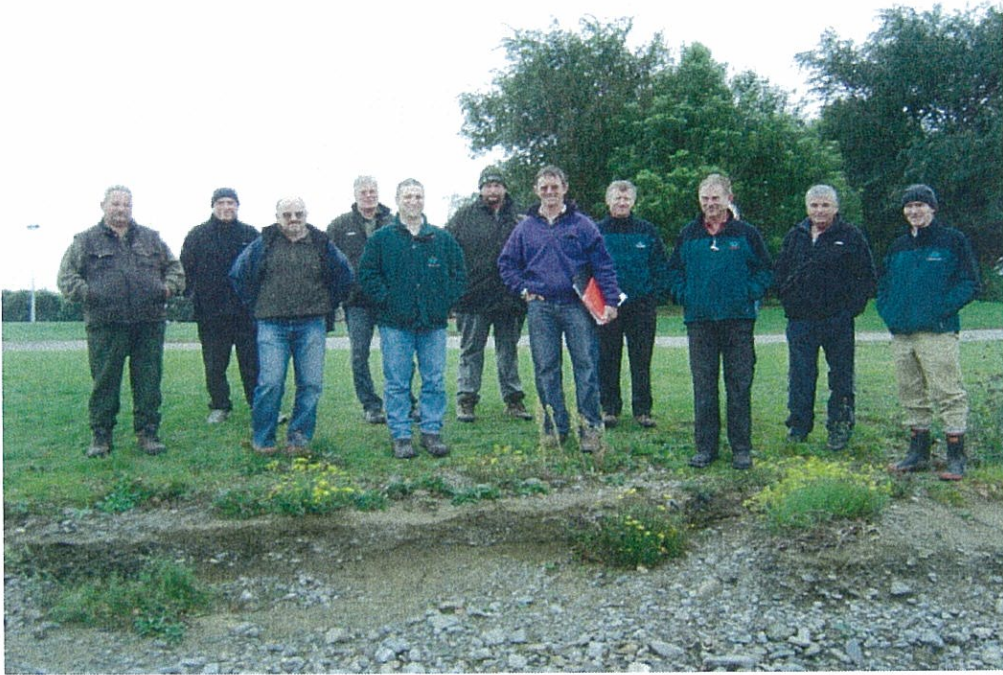
2.4.3 Dakins Road Rock Groynes

These are in the Gladstone scheme of the Ruamahanga river and are designed to protect a road, vineyard and camping ground. The groynes were installed in 2007 and jointly funded by Carterton DC, Transit and GW. HRC were keen to implement this style of protection for a similar job, where the \$4M estimate is not affordable. HRC understood that this site was particularly difficult, both with access and river conditions, and considered the solution employed by GW to be the best both in cost effectiveness and philosophy for this particular site.
