Review of Navigation Safety in Wellington Harbour Entrance Channel and Approaches

By South Maritime Solutions for Greater Wellington Regional Council and CentrePort Limited

Final Report - Review of Navigation safety Wellington Harbour Entrance

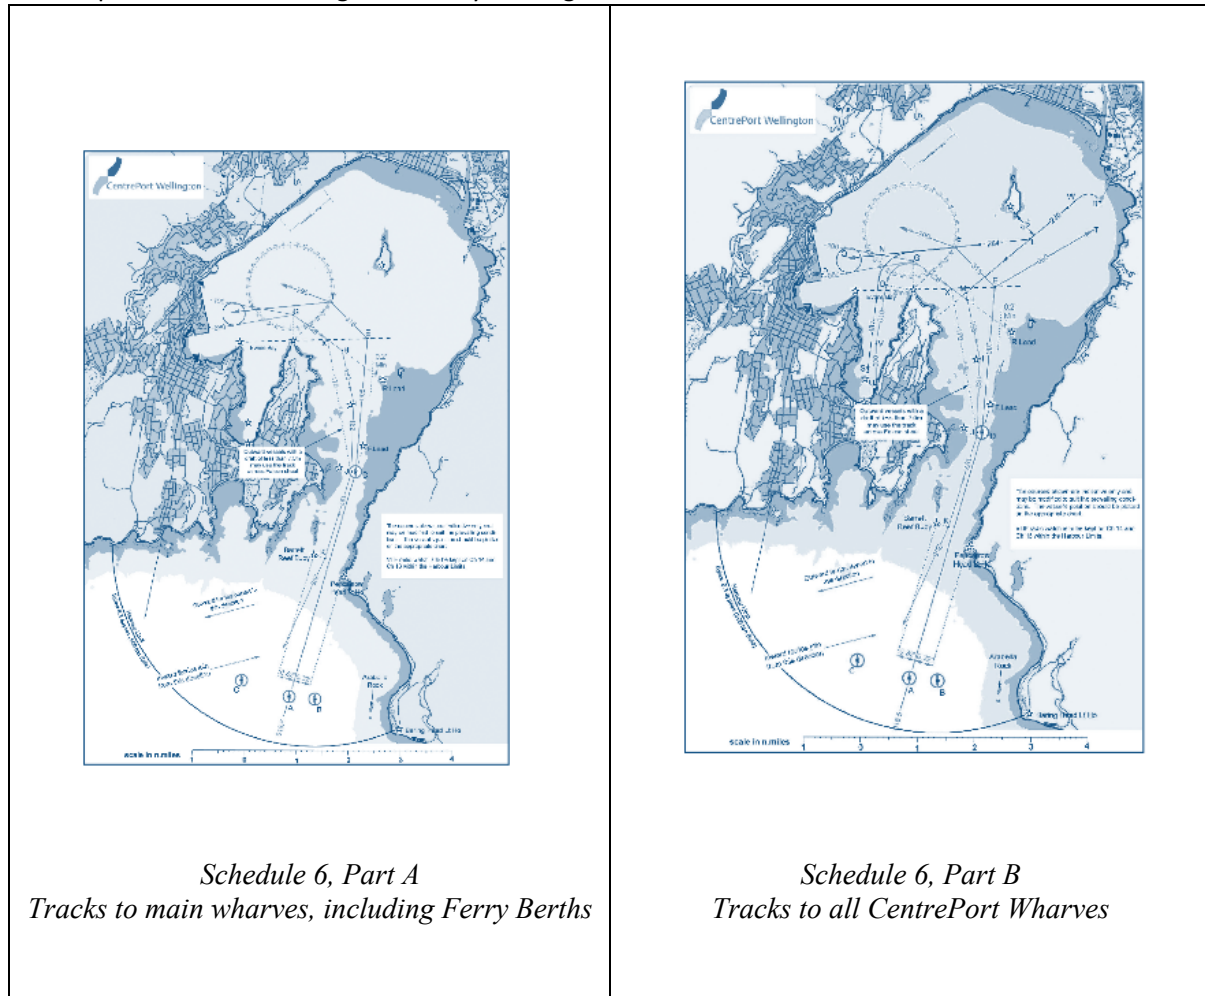
Schedule 6 of the current Navigation Bylaws is titled 'Recommended Tracks' and is split into Part A and Part B. Part A is a diagram showing recommended tracks through the Entrance Channel and then on to '*Tracks to Main Wharves, including Ferry Berths*'. Part B is a diagram showing the same recommended tracks through the Entrance Channel and then on to '*Tracks to all CentrePort Wharves*' (see Figure 3). Schedule 6 also contains a list of all 'Wellington Pilotage Waypoints', which correspond to the recommended tracks described within the Navigation Bylaws.

The notation on the chart does not delineate between those recommended tracks contained in Part A or Part B of Schedule 6; it simply refers to 'recommended tracks' in Schedule 6.

Figure 3
Diagrams from Schedule 6 to Navigation Bylaws

For these reasons, and those discussed in the following sections, we are recommending that the recommended tracks be removed from the Navigation Bylaws. If they are to remain then these anomalies will need to be rectified and the intent of the recommended tracks fully and clearly explained for the benefit of all harbour users.

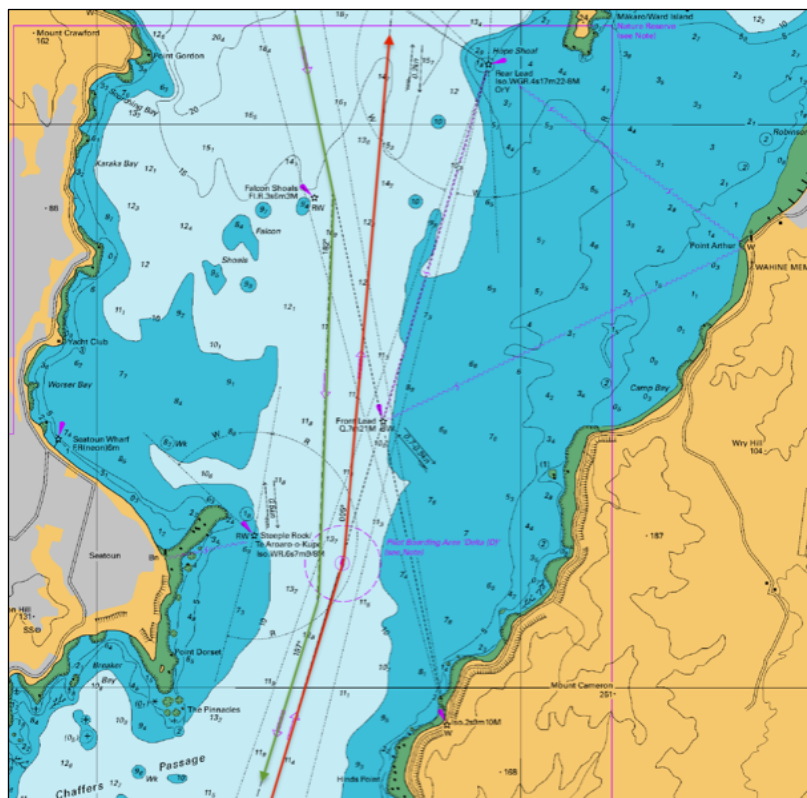
Extract from Chart NZ4633 showing inward tracks highlighted in red and outward tracks in green

Figure 4 shows the recommended tracks for the Entrance Channel published on Chart NZ4633. The inbound bound tracks have been highlighted in red and the outbound tracks in green. The tracks converge to a minimum distance between them of 75 metres just south of Steeple Rock, and then open slightly to 120 metres off Barrett Reef Buoy to the south and to 280 metres off Falcon Shoal to the north.

Ships with an excess of 25 metres beam frequently transit the Entrance Channel with a combined closing speed of up to 40 knots. Two ships at a 25-metre beam passing off Steeple Rock, and on the recommended tracks, would pass with a 50-metre closest point of approach (CPA), which leaves little margin for human error or mechanical failure. The credible consequences of a ship collision or grounding in this area would be high.

- 4 That the recommended tracks be reviewed and amended as appropriate to correspond with any other actions arising from this report.
- 5 That regardless of what other actions are adopted, the recommended tracks be reviewed to alleviate or remove unnecessary doglegs and facilitate the controlled turn method instead of an abrupt waypoint-to-waypoint method.

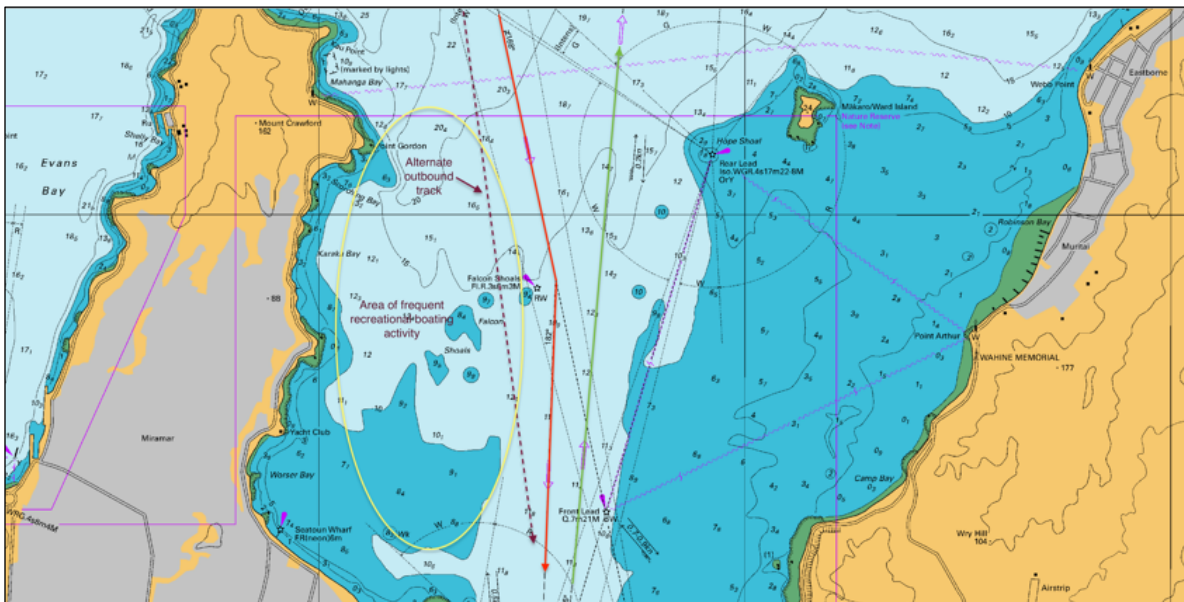
Stakeholders report several near misses between recreational craft and ships transiting west of Falcon Shoal.

Also, in our opinion, ships that routinely transit west of Falcon Shoal may not be complying with Paragraph 6.2.6 of the Navigation Bylaws, which states they may only deviate from the recommended tracks 'for reasons of navigation safety or pressure of weather'. As mentioned, the route is published in the Navigation Bylaws, but not on the chart. The issue is not free from doubt. We recommend considering the option of prohibiting ships from transiting west of Falcon Shoal Beacon unless it is in exceptional circumstances.

Figure 5
Extract of Chart NZ 4633 showing Falcon Shoal area

As mentioned, however, there is limited room for ships to pass within the navigable channel west of Falcon Shoal Beacon. In fact, this is the narrowest part of the Entrance Channel and involves outbound ships potentially encountering an inbound ship while altering course adjacent to the beacon. If it were feasible to move Falcon Shoal Beacon further west and dredge the edge of the shoal to widen the navigable channel, this would reduce the risk of ships colliding in the area and reduce the need for them to transit west of the beacon. We recommend that this option is explored and the cost versus benefits evaluated with those of an alternate option, which is to include the area off Falcon Shoal in any controlled navigation zone. A combination of both options should also be reviewed.

- 7 That one or more of the following options be taken:
 - 7.1 Prohibit ships of over 500 gross registered tonnage (GRT) from transiting west of Falcon Shoal, with a goal of separating large shipping from frequent recreational boating and fishing activity in this area, or
 - 7.2 If outbound ships will be permitted to pass west of Falcon Shoal to achieve greater separation from inbound vessels, then this should be socialised with other harbour users and the recommended track west of Falcon Shoal should be published on the chart, or
 - 7.3 Investigate the feasibility of moving Falcon Shoal Beacon westward and dredging the eastern edge of the shoal to increase the width of the navigable channel in this area. If this option is adopted, then Option 7.1 could be adopted instead of Option 7.2.

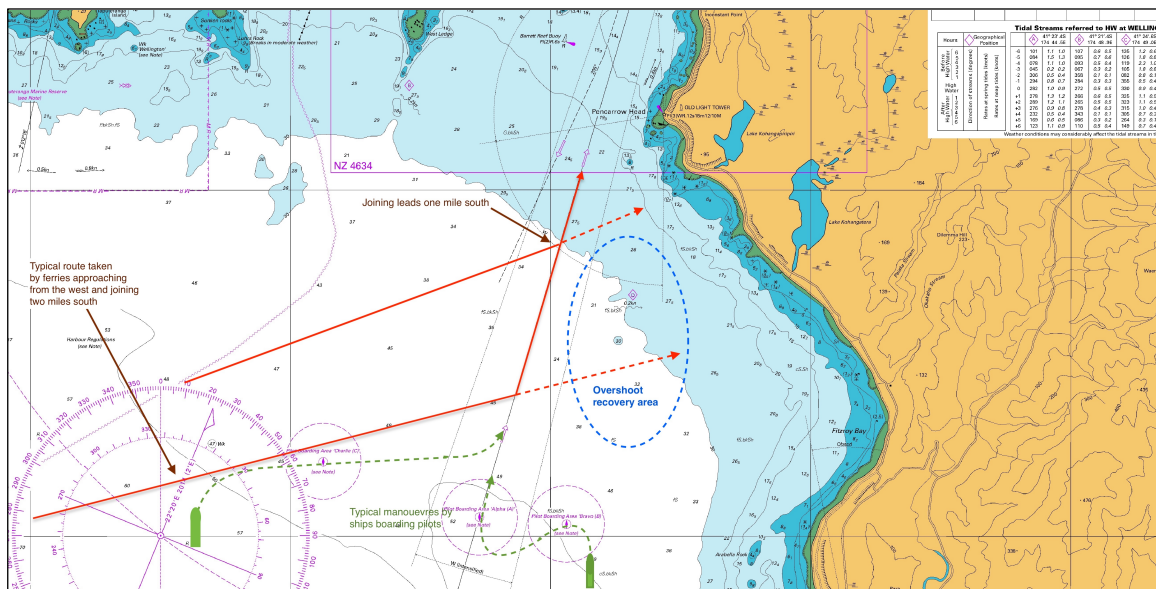
Figure 6

Alpha, Bravo and Charlie pilot boarding areas are used variously by the pilots, depending on vessel traffic and weather conditions. In the main Bravo, to the east of the line of leading lights, is used in easterly or fresh southerly wind conditions, or when required to separate outbound traffic or inbound traffic approaching from the west. Alpha, on the line of the leading lights, is used in light wind conditions. Charlie, west of the line of the leading lights, is used in northerly and southerly wind conditions but is the most used pilot station for northerly conditions, which is the prevailing wind (see Figure 6).

Extract from Chart NZ4633 showing potential conflict between vessels near the pilot boarding grounds

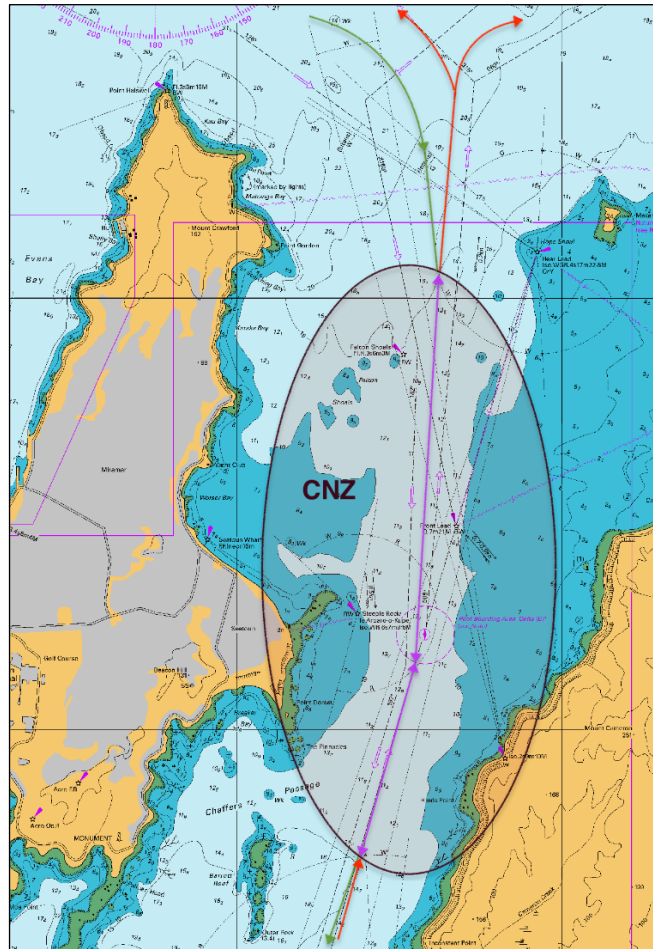
Figure 8

Annotated extract from Chart NZ4633 showing a broad concept of how a controlled navigation zone and associated recommended tracks in the Wellington Harbour Entrance Channel could look

Should this option be implemented, the recommended tracks within the zone could be adjusted to form a single bi-directional track that aligns with the AtoNs and the deepest water. The recommended tracks leading into and out of a controlled navigation zone could be optimised to give a marginal offset to starboard, while providing maximum opportunity to recover from an adverse event.
