# **ASSESSMENT OF LIQUEFACTION AND GROUND FAILURE HAZARDS IN THE GREATER WELLINGTON REGION, 1992-1993**

## **STAGE 1**

**IGNS CONTRACT REPORT No 1992/84**

*The Wellington Regional Council*

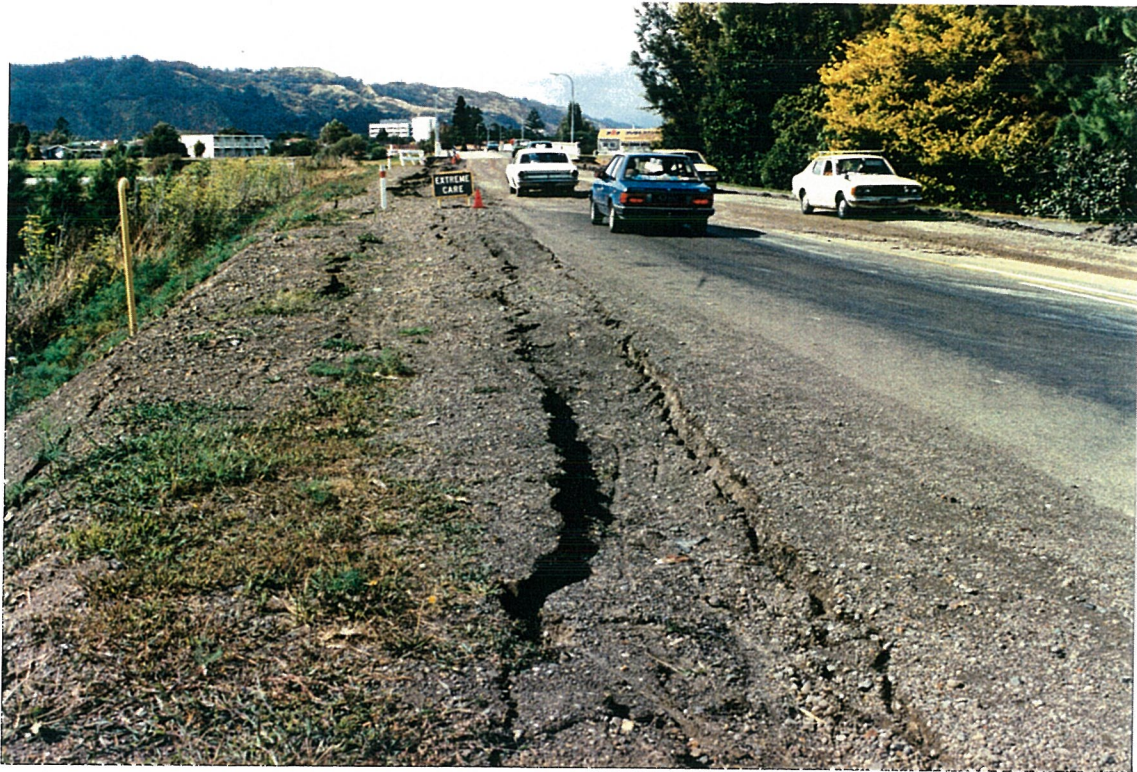
The main ground damage that resulted from the liquefaction processes was that caused by lateral spreading. Such damage included open tension cracks, sand ejections, and settlements of bridge approach fills and flood-control and roading embankments close to the main rivers (Photos 1-4). There was also widespread minor slumping of stop banks.

**Photo 1.** Settlement and spreading of the bridge abutment fill at Whakatane Bridge. With a duration of strong shaking of 8–9 seconds, the ground damage due to liquefaction effects was relatively slight. For a larger magnitude earthquake the duration of strong shaking would be longer (20–30 s for M 7.5, about 50 s for M 8) and the ground damage far more severe.

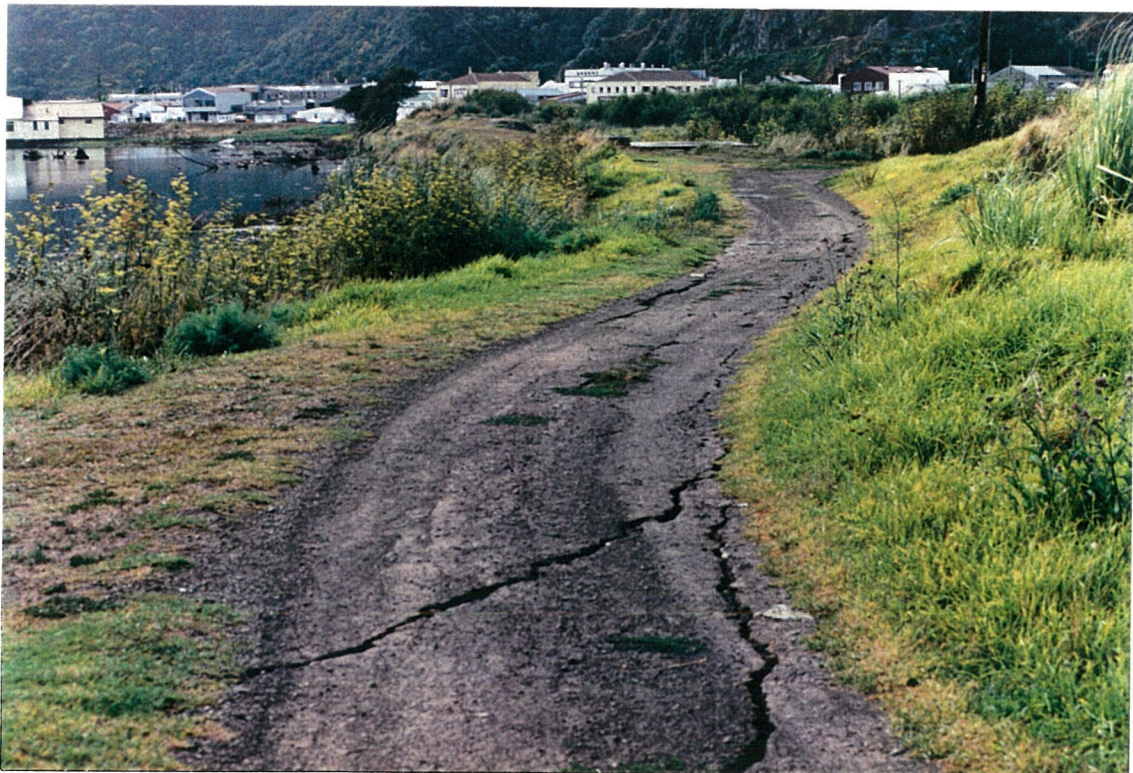
**Photo 2.** Fissures associated with lateral spreading in the river bank at Whakatane.

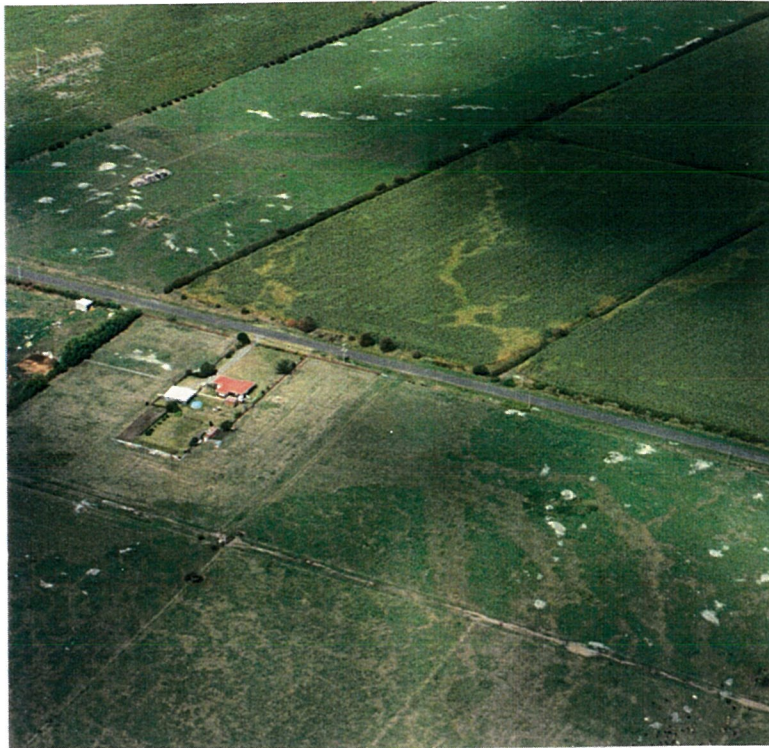
**Photo 3.** Aerial view of sand boils near Powell Rd.

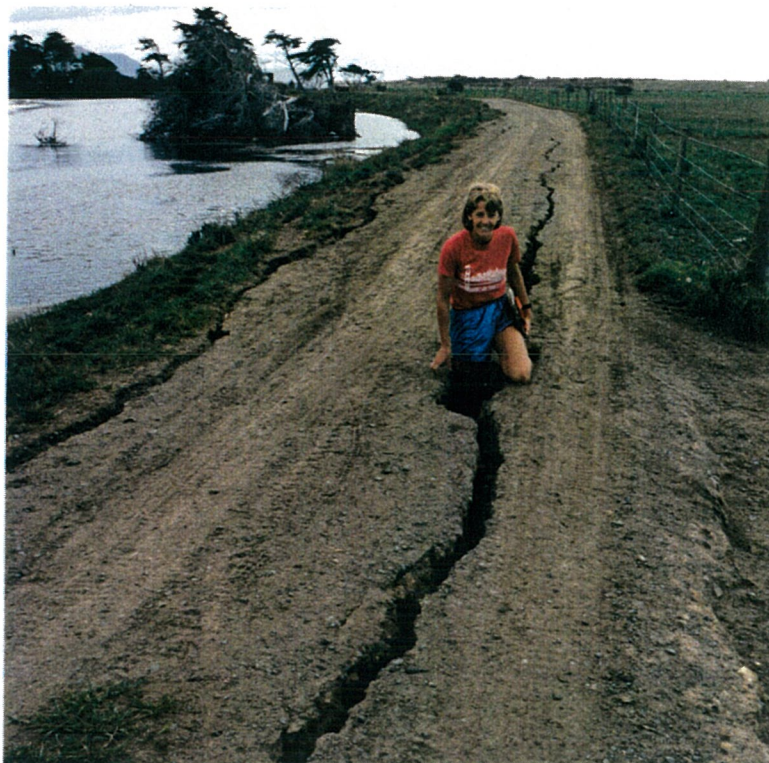
**Photo 4.** Lateral spreading and linear cracks on stop bank close to SH 2 at Greig Road.

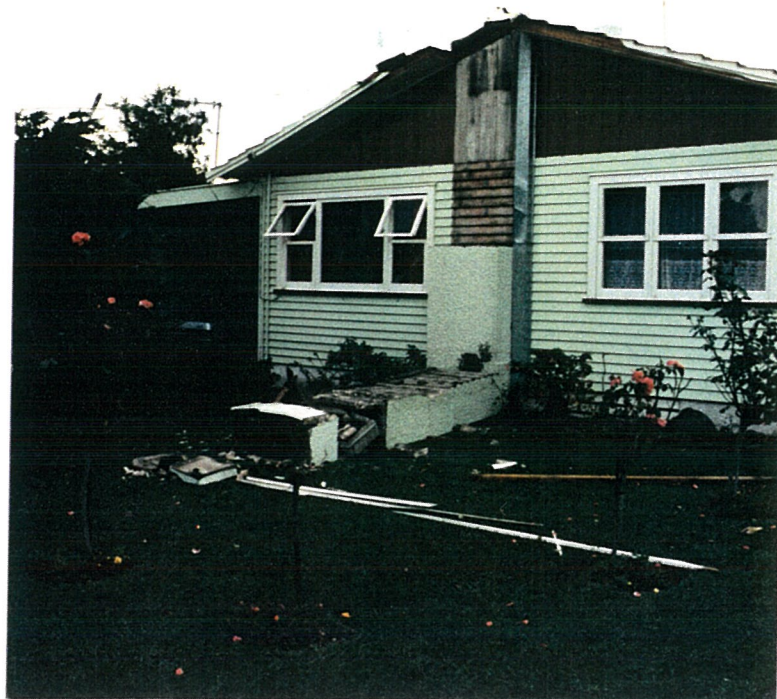
**Photo 5.** Chimney collapse, Kowhai Avenue, Edgecumbe.

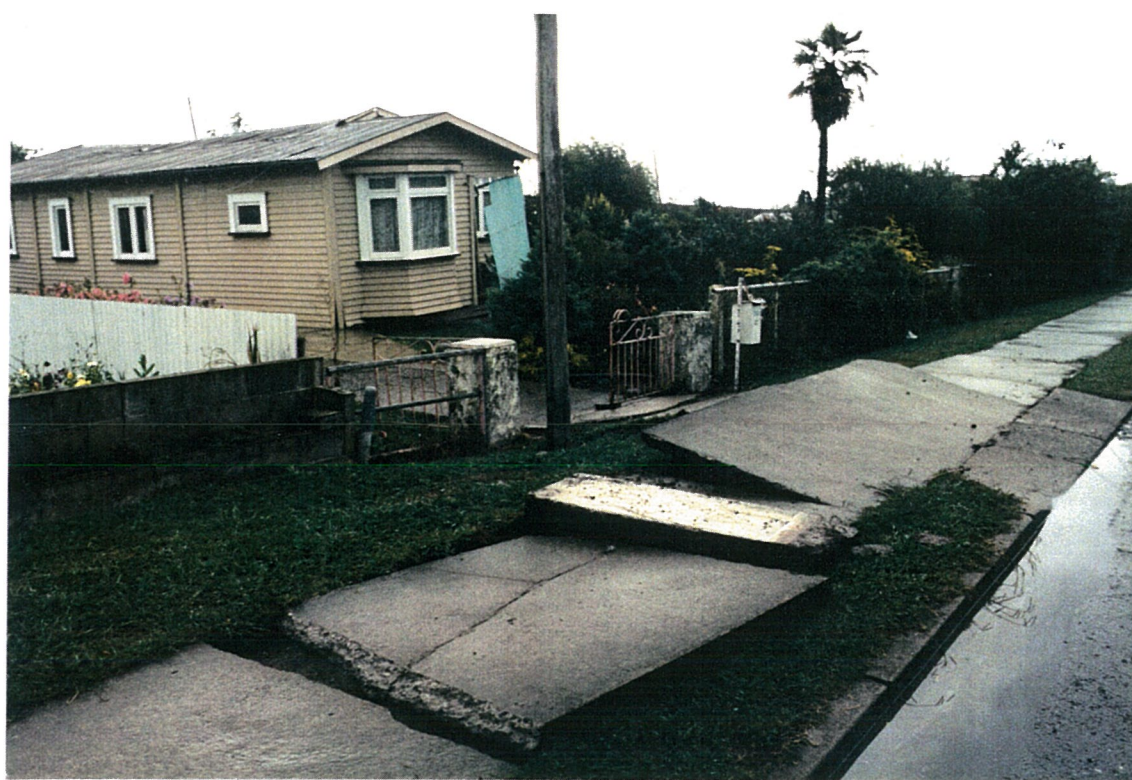
**Photo 6.** House thrown off its piles, south side of High Street Edgecumbe, note compression features in path.

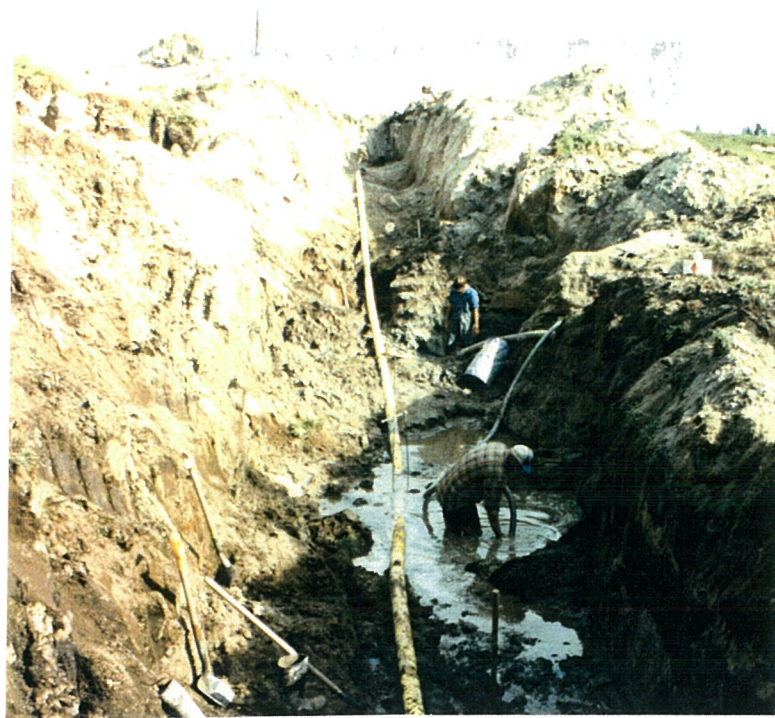
**Photo 7.** Excavation of high pressure gas pipeline through Edgecumbe fault, note sagging and distortion of pipe.

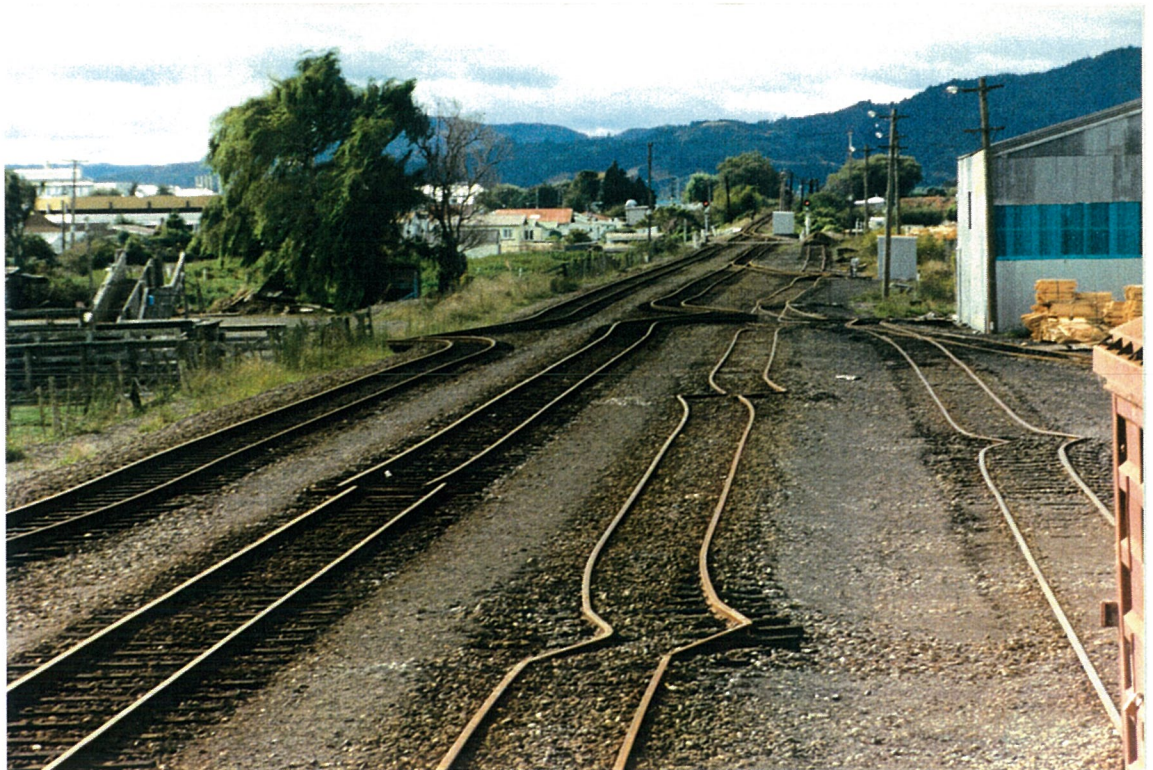
**Photo 8.** Railway lines damage at Edgecumbe station.

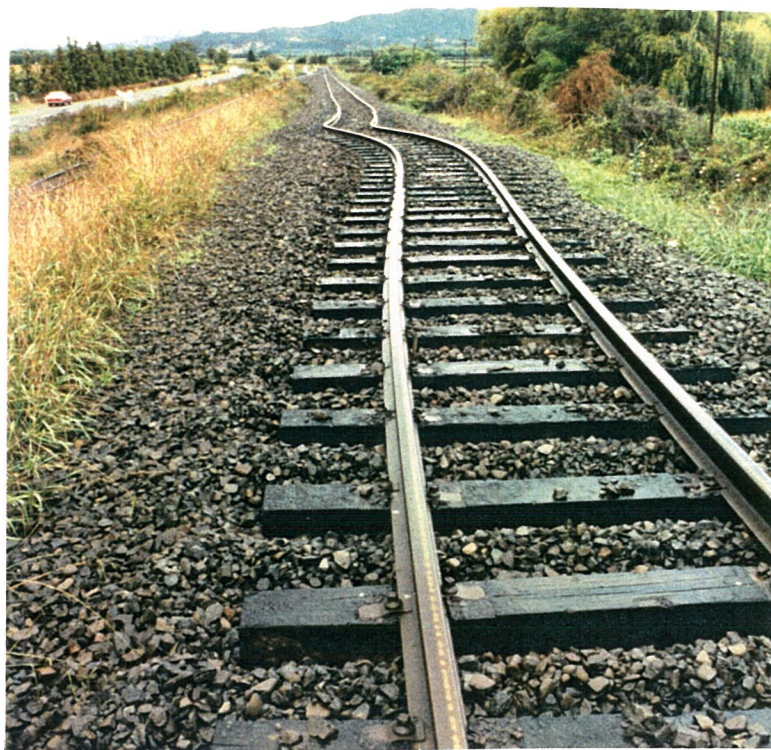
**Photo 9.** Railway sleepers 'vibrated' out of stone ballast on embankment opposite Bay Milk Company, Edgumbe.

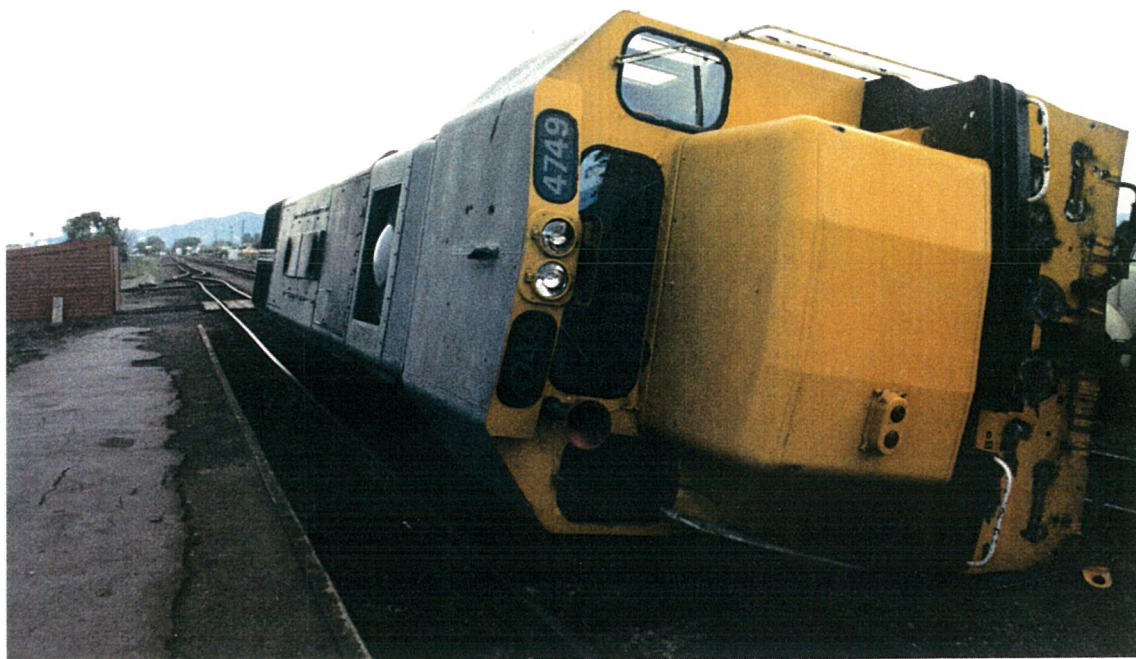
**Photo 10.** 67 ton diesel locomotive toppled in Edgumbe.

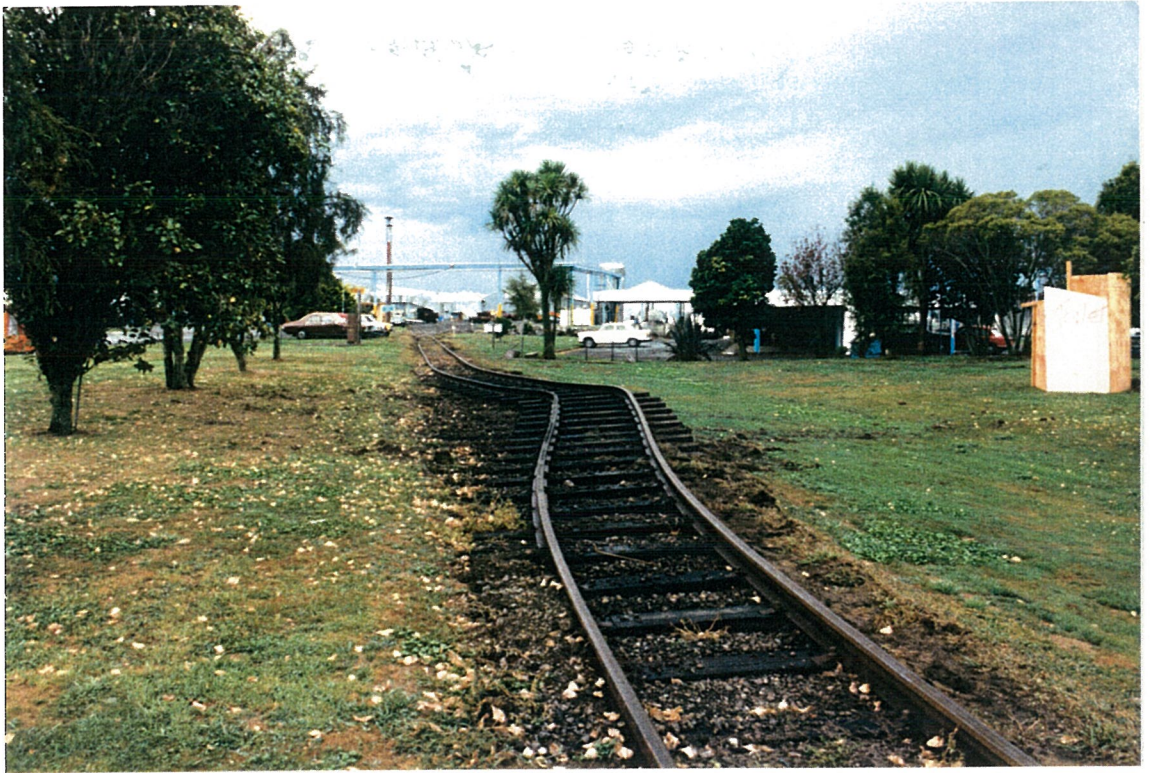
**Photo 11.** Branch railway line into Bay Milk Company premises, Edgecumbe.

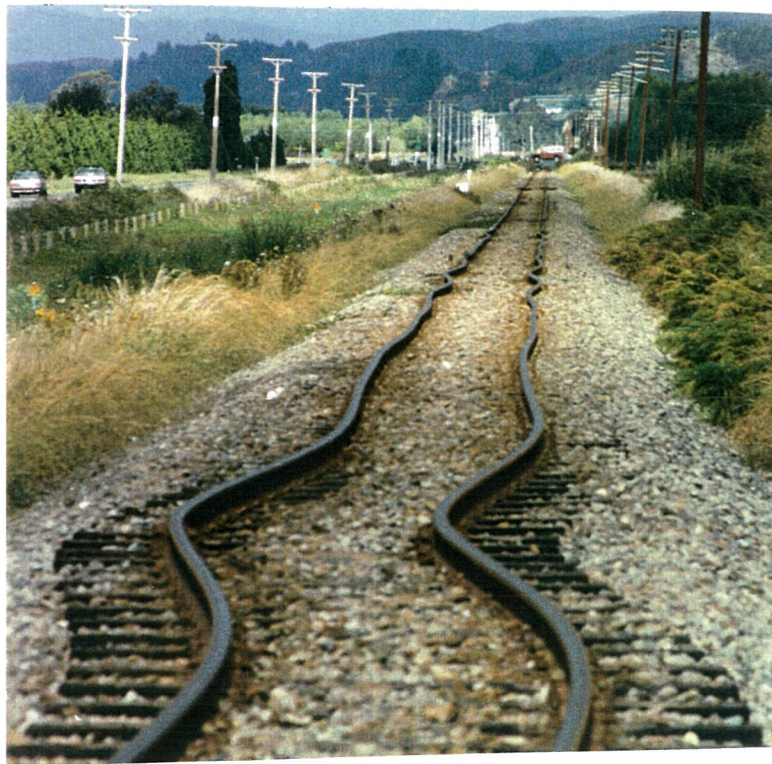
**Photo 12.** Compressional features in rail lines east of Edgecumbe.

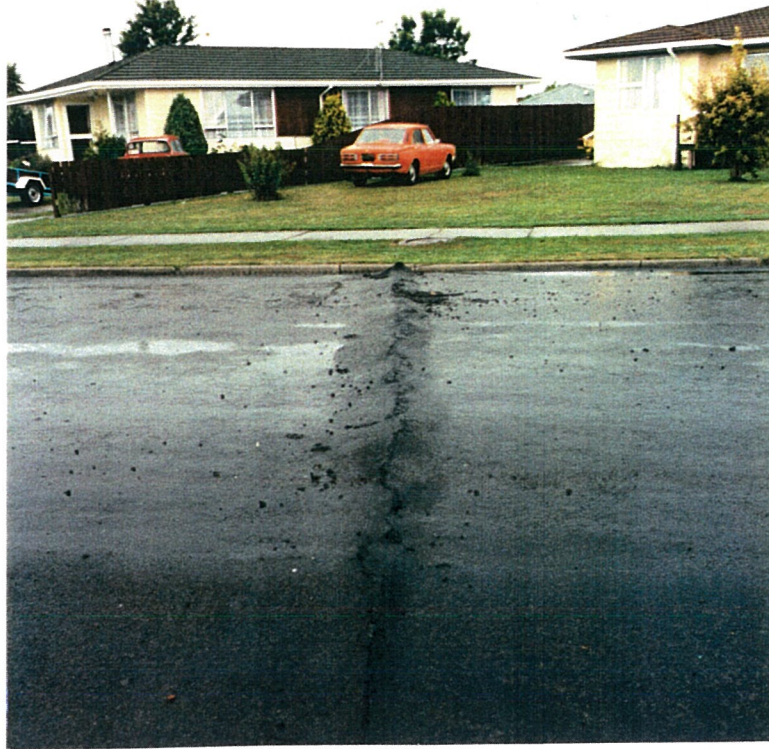
**Photo 13.** Compression ripple in asphalt surface of Rata Avenue, Edgecumbe.

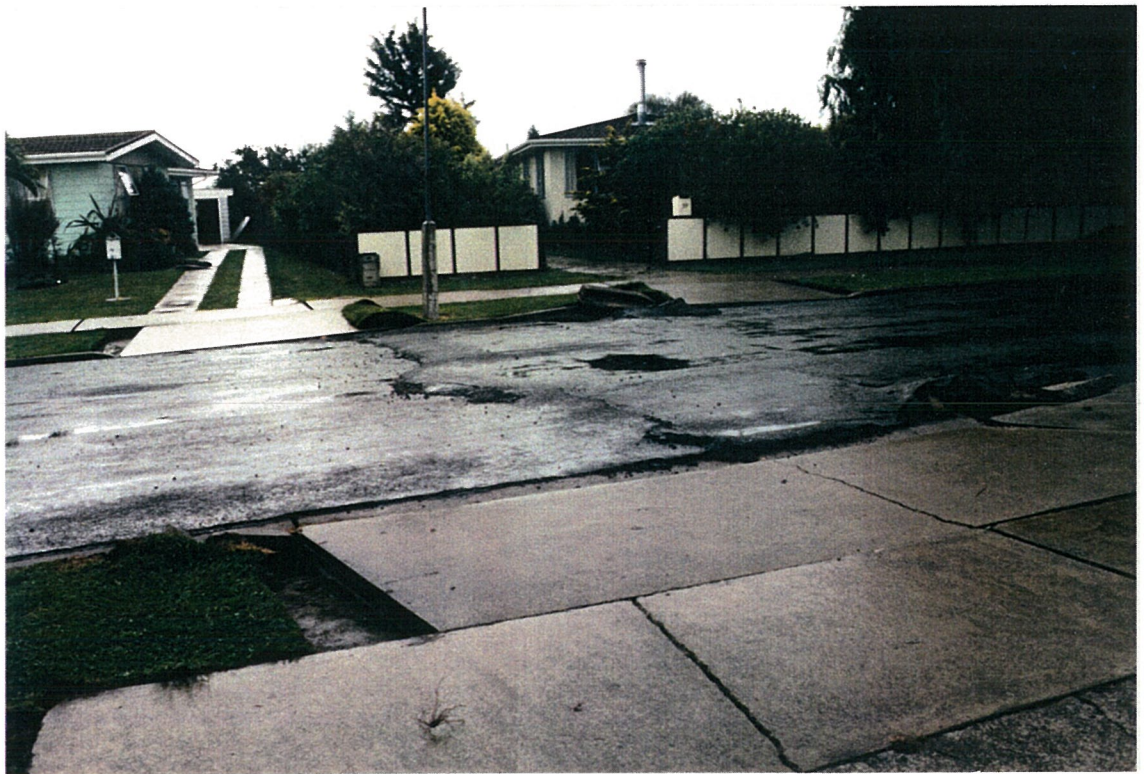
**Photo 14.** Compression flow in asphalt in Rata Avenue, Edgecumbe looking west, note north trending movement of pathway concrete blocks.

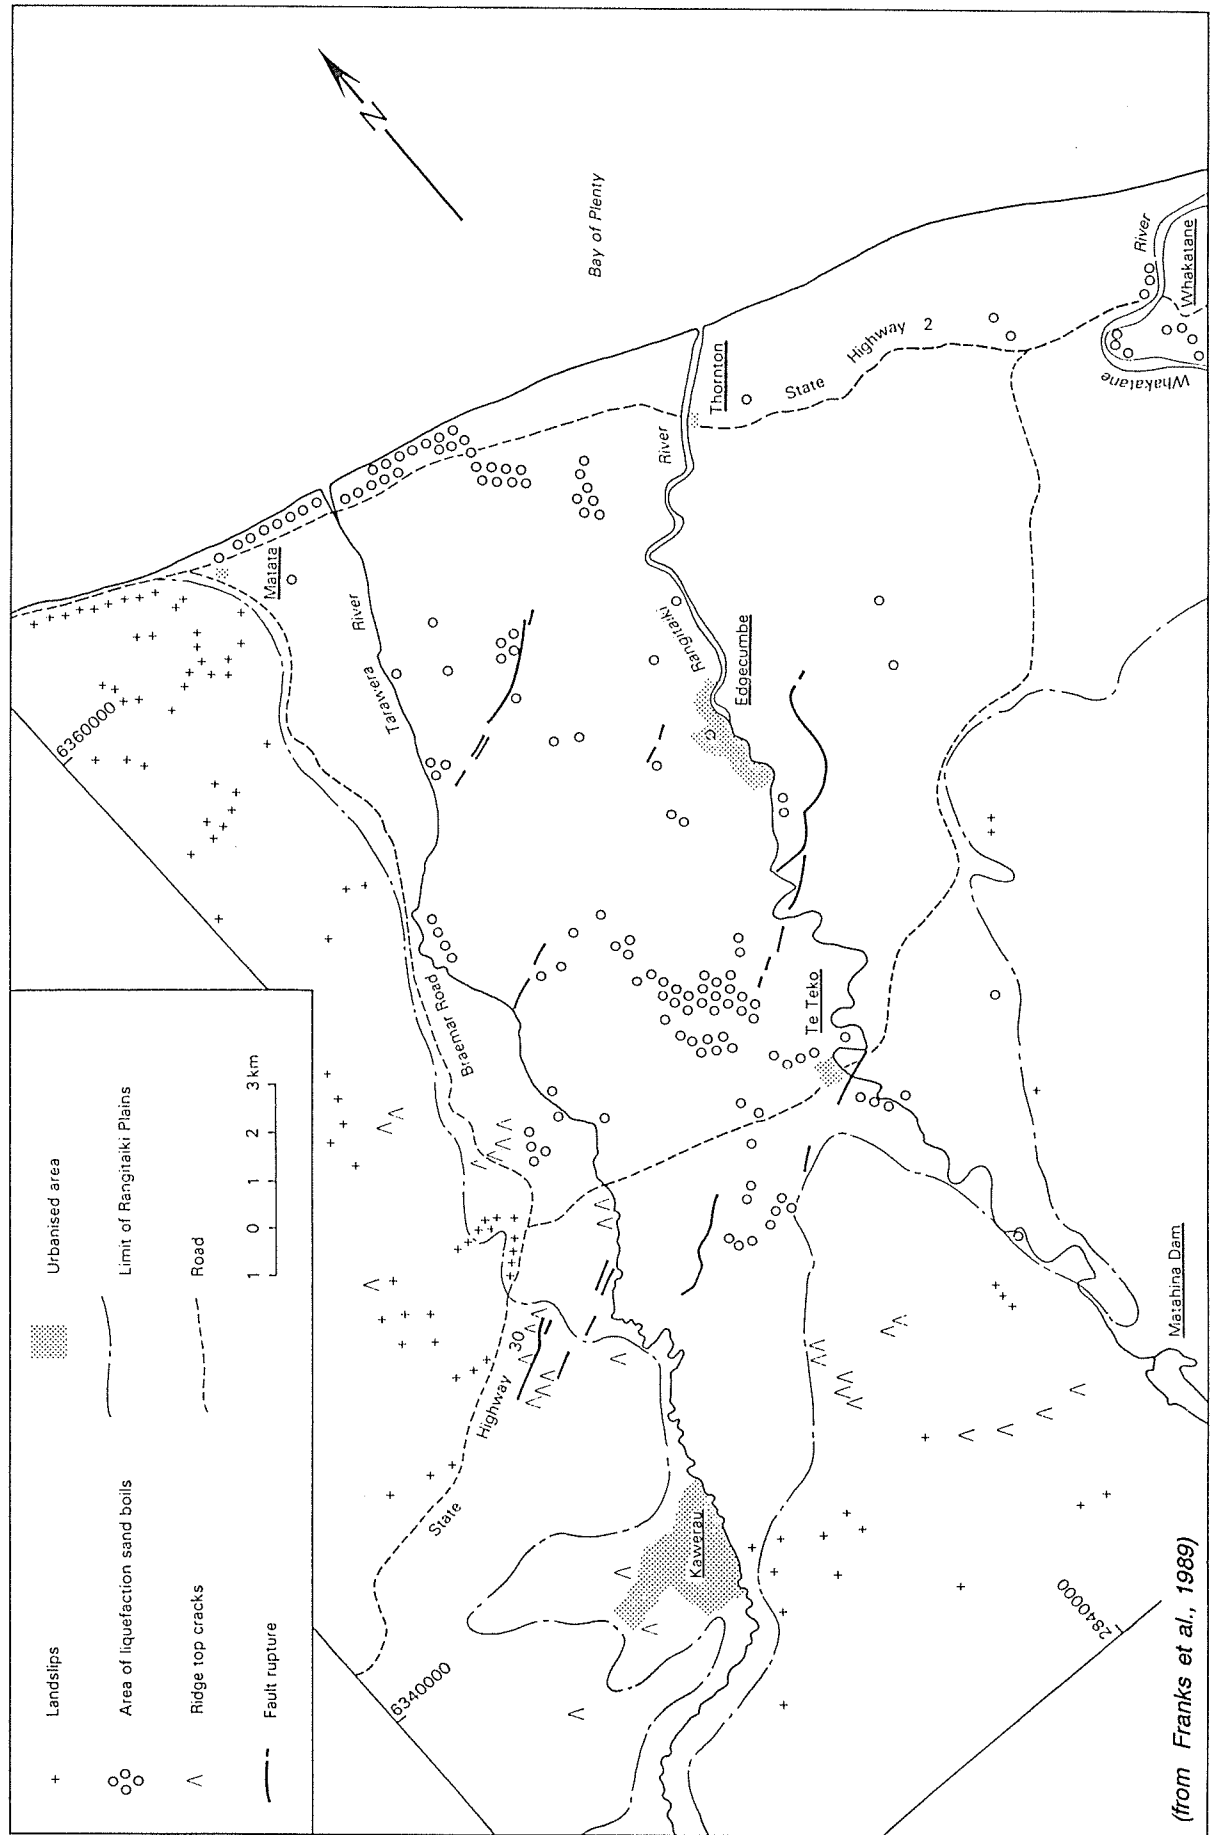
Widespread subsurface liquefaction was indicated by the ejection of sand, silt and water from linear cracks and holes in the ground forming sand boils (Figure 2), and more significant ground damage was indicated by well developed fissures, sand ejections, and lateral spreading failures along the banks of river and stream channels, particularly along the banks of the Whakatane and Rangitaiki rivers.

**FIGURE 2:** Distribution of ground damage across the Rangitaiki Plains after the 1987 Edgecumbe earthquake.

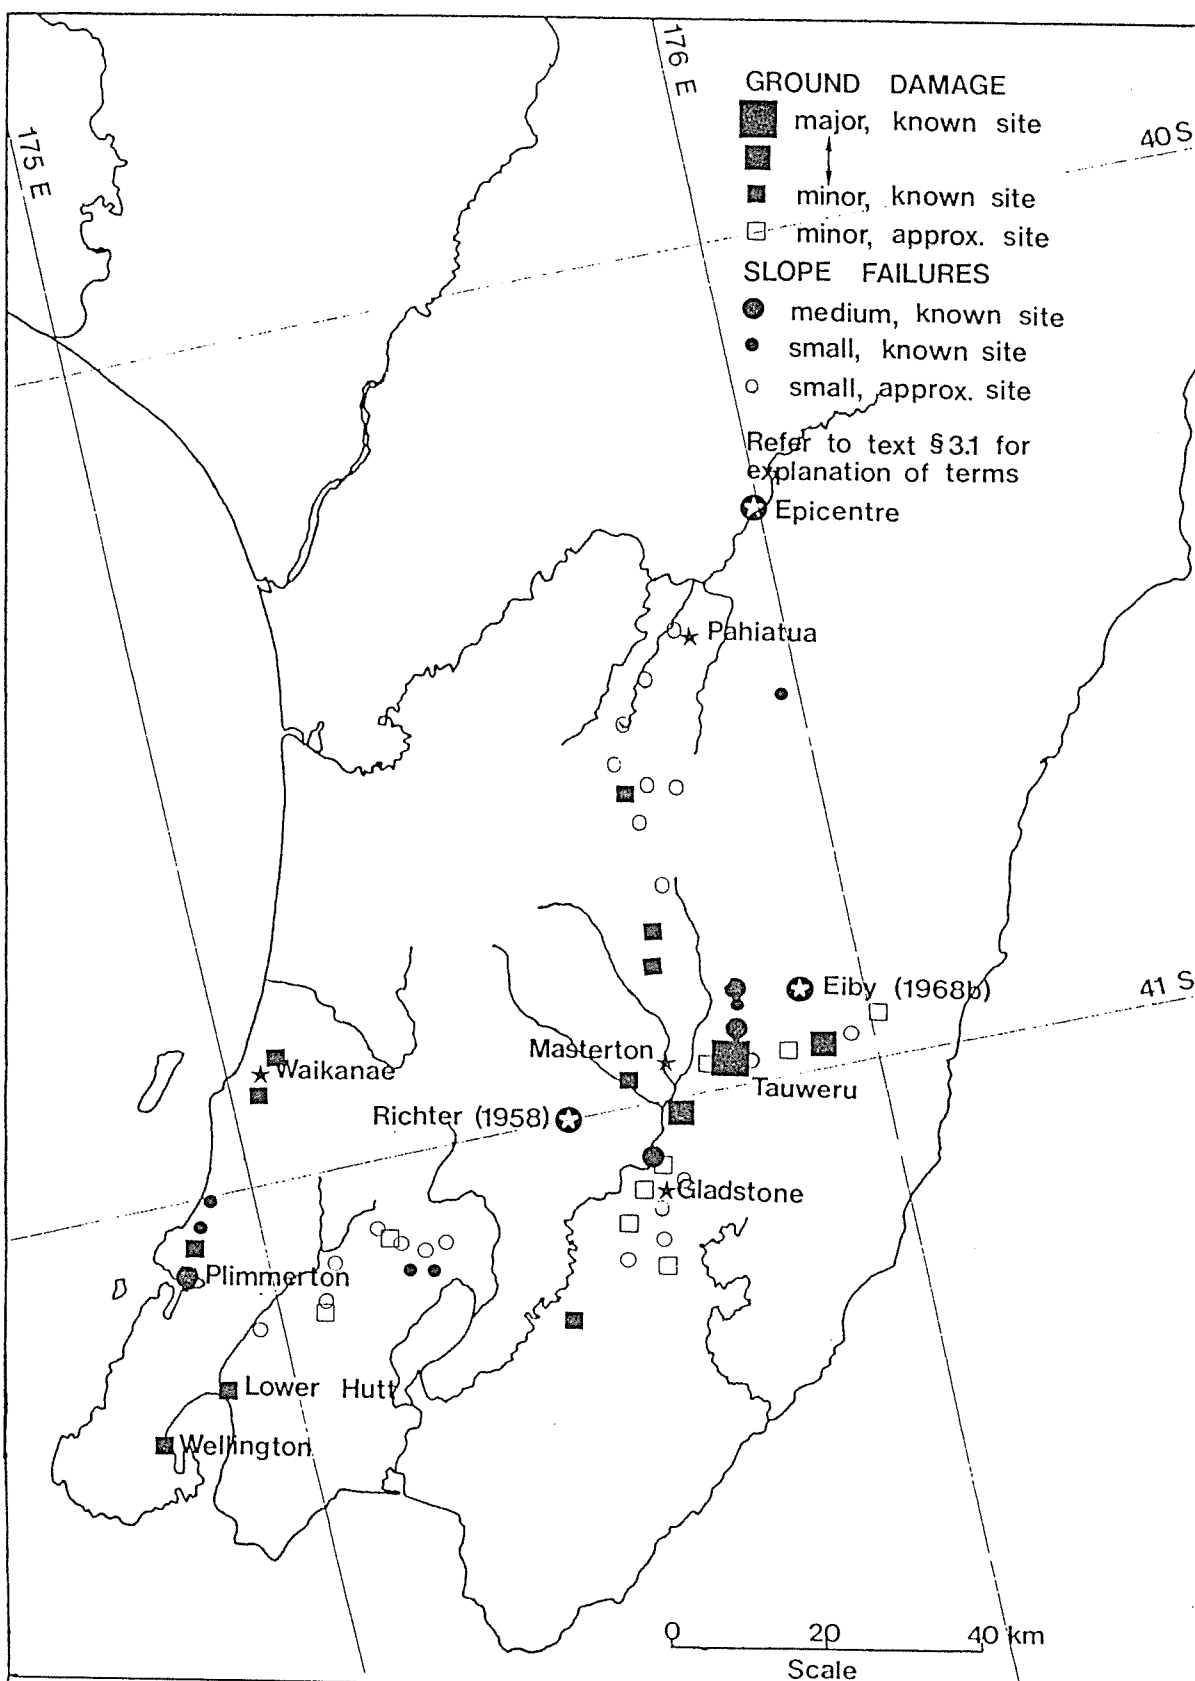
**FIGURE 4.** Slope failures and ground damage as reported from the Masterton earthquake of 24 June 1942. (from Dellow, 1988).

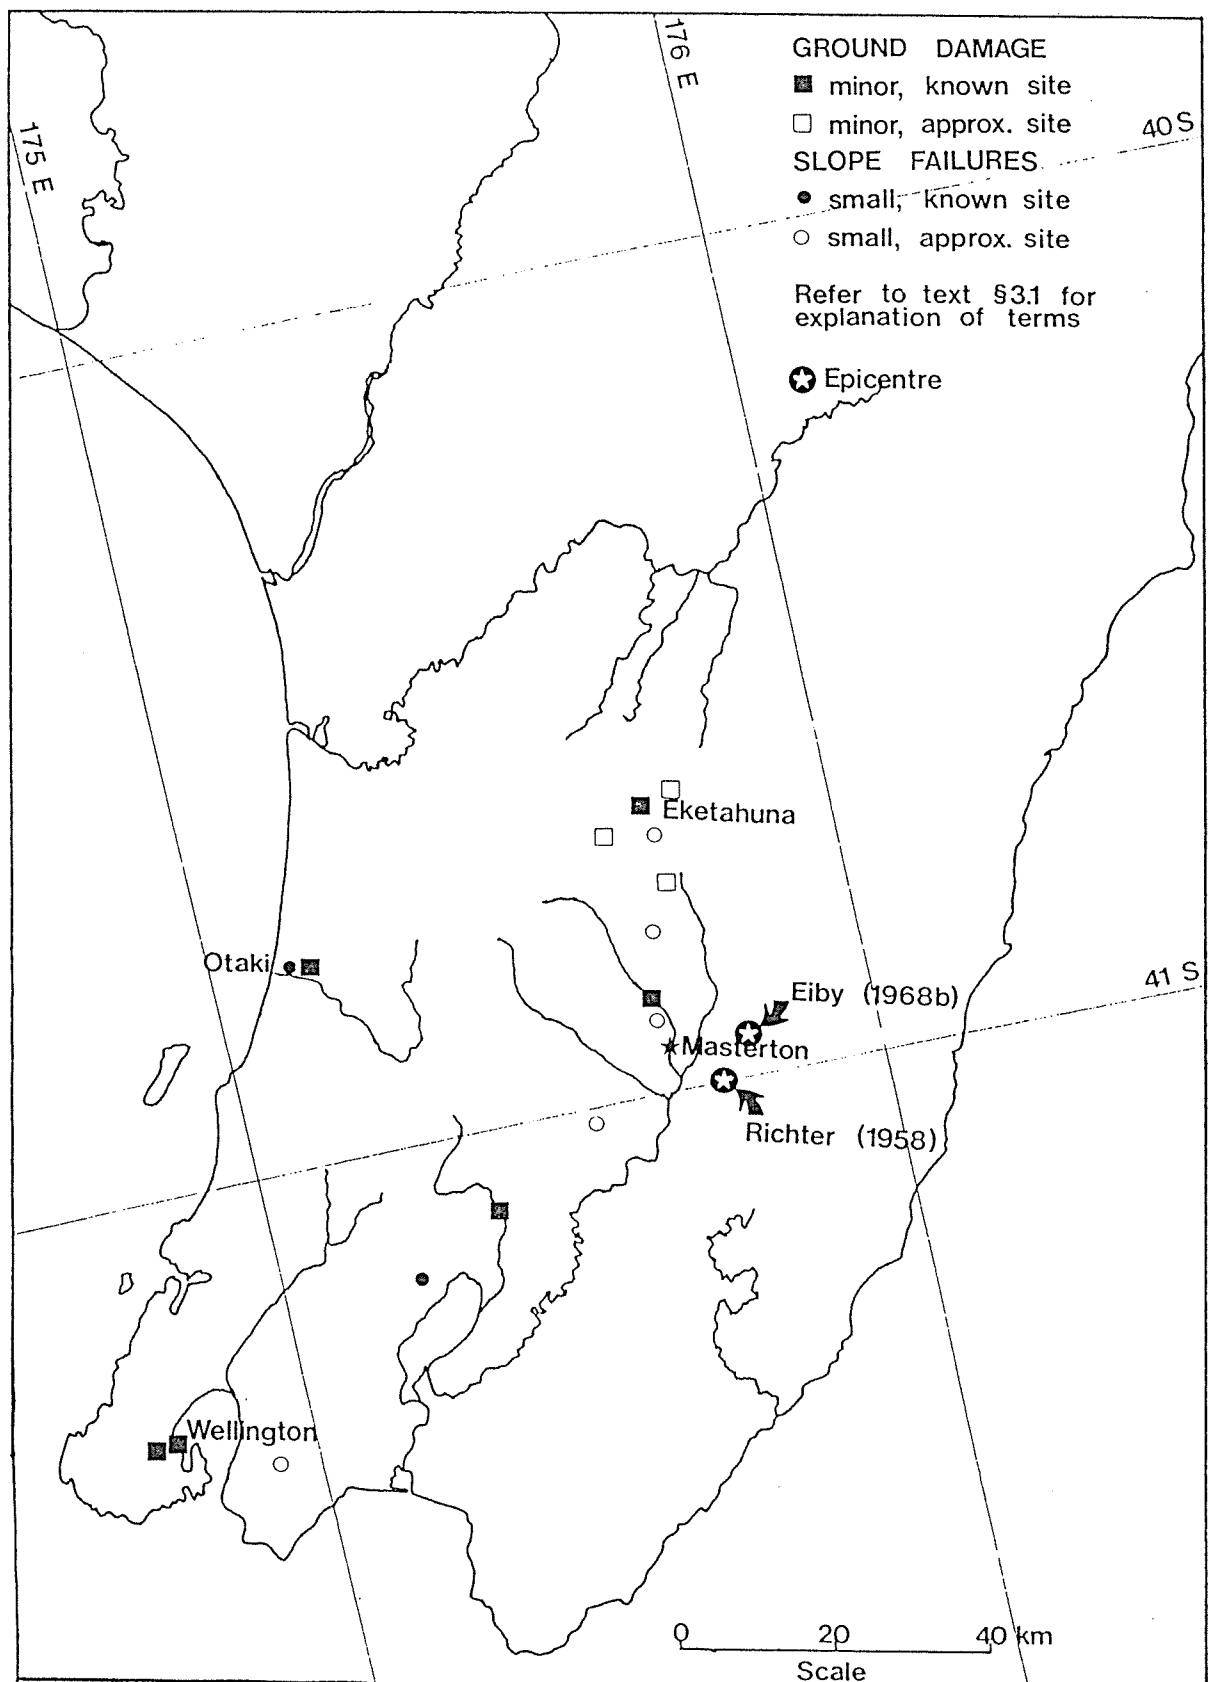
**FIGURE 6.** Slope failures and ground damage as reported from the Masterton earthquake of 2 August 1942. (from Dellow, 1988).

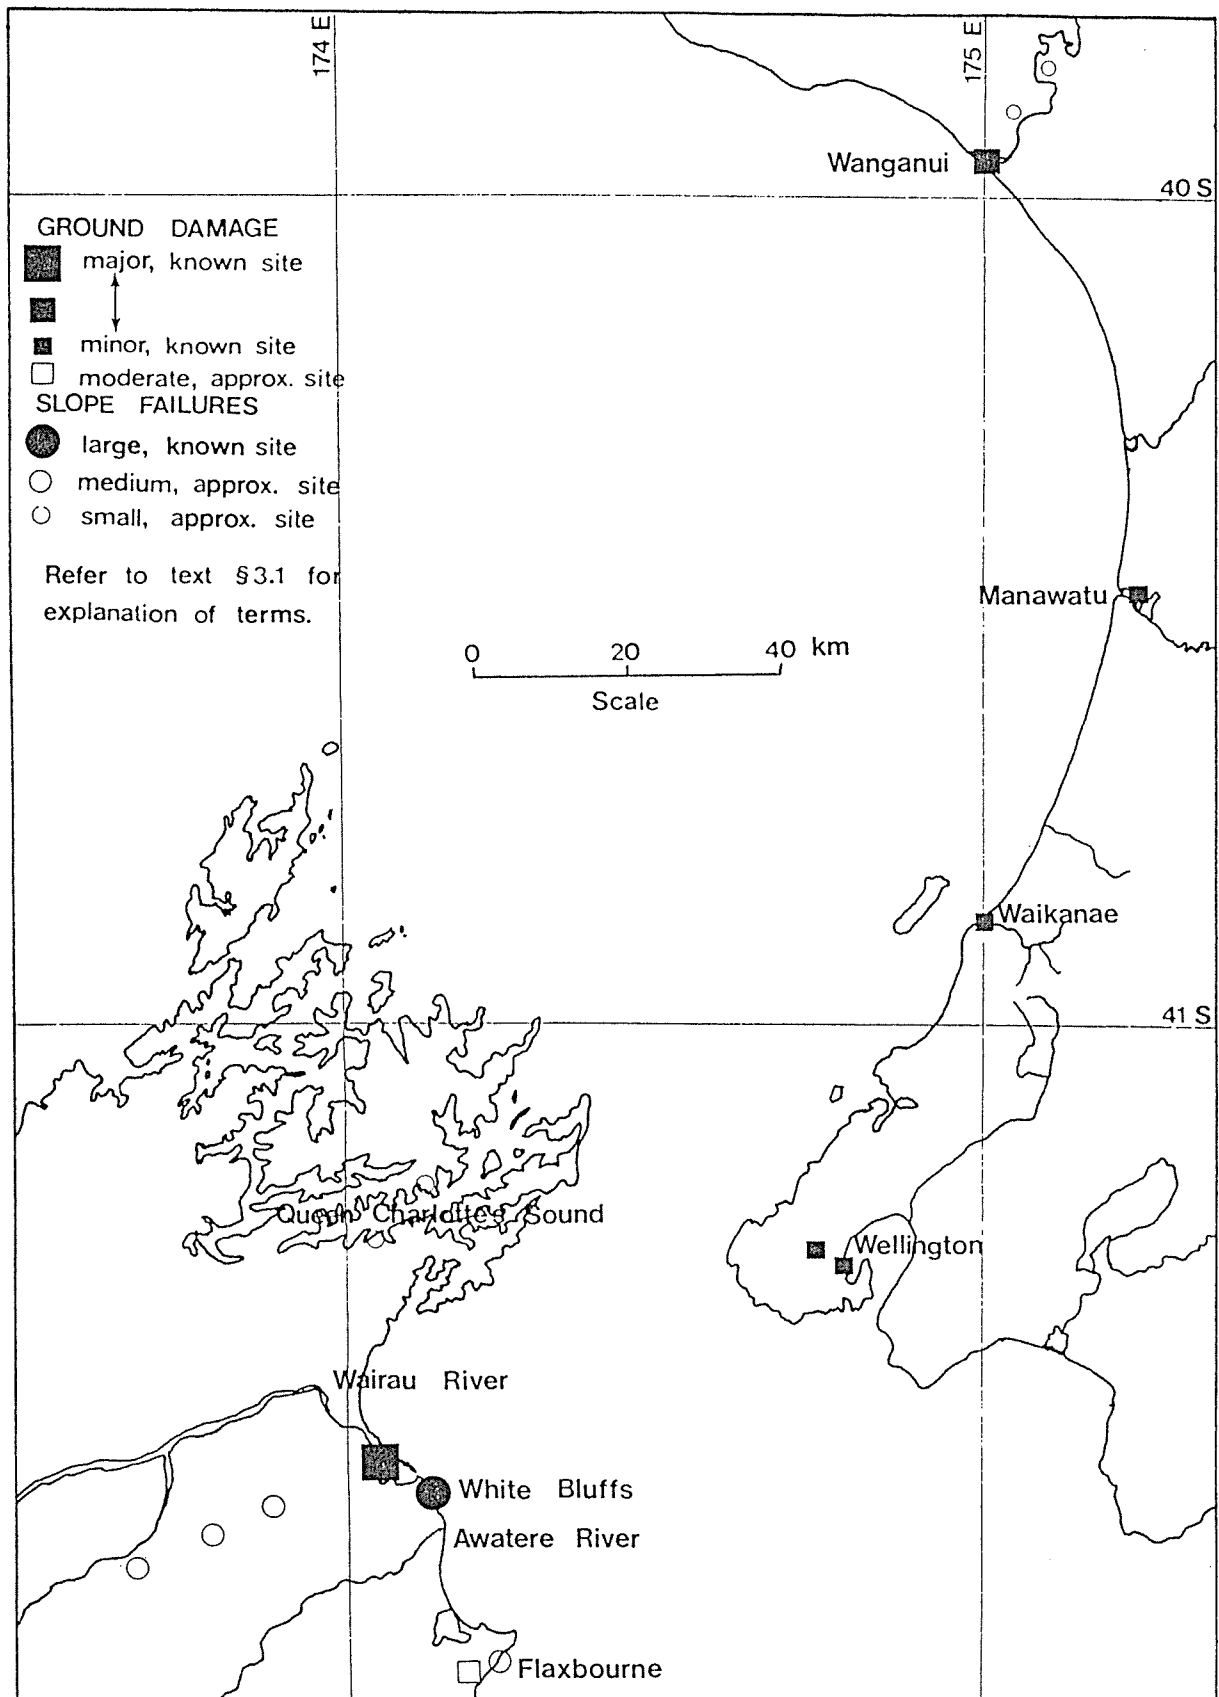
**FIGURE 8.** Slope failures and ground damage as reported from the Marlborough earthquake of 16 October 1848. (from Dellow, 1988).

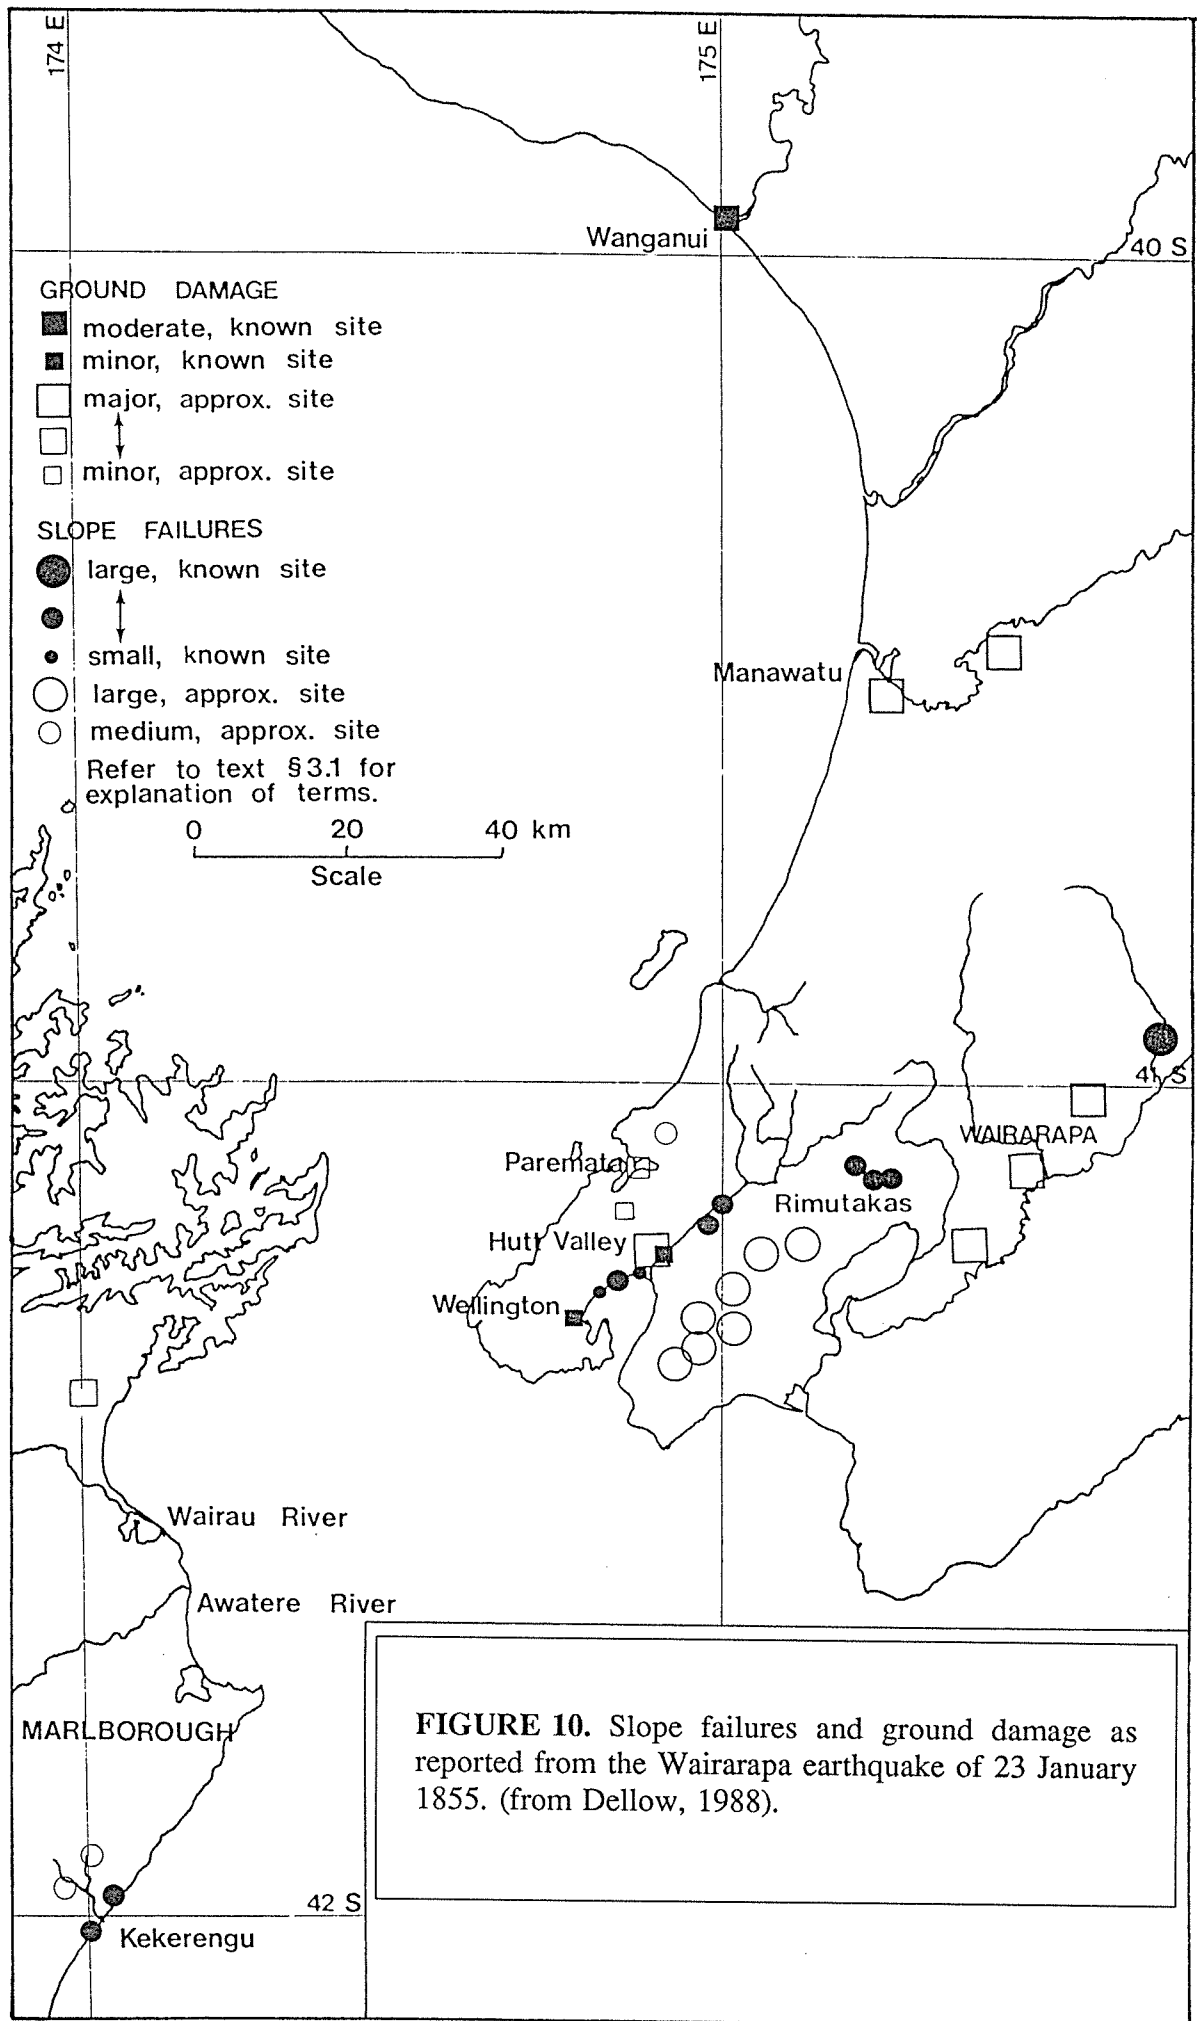
**FIGURE 10.** Slope failures and ground damage as reported from the Wairarapa earthquake of 23 January 1855. (from Dellow, 1988).
