Report 03.301
Date 4 June 2003
File B/09/02/02

Committee Utility Services
Author Keith Woolley, Asset Engineer

Relocation of the Point Howard Pumps

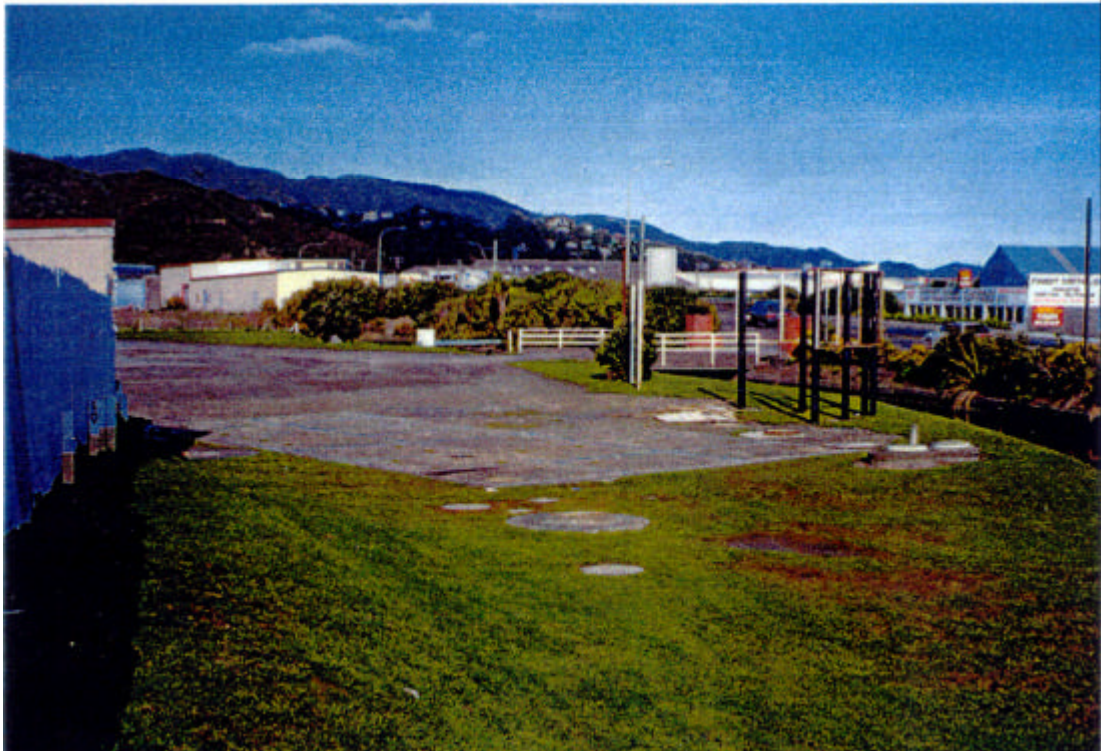
Figure 2 Existing Valve Chamber located under carpark at Randwick (above ground control room on the left)

Ground distortion at the site is highly likely due to liquefaction. Differential ground movement will mean the control building will require replacement during the restoration period and damage to pipelines at the chamber.

It is expected that the valve chamber will be filled with water and sand within an hour of a Wellington Fault event through joints opened up by differential movement between tunnel segments and roof panels. Even for smaller earthquakes (with return periods of 30 to 100 years) the chamber is likely to be flooded in a number of hours due to opening of the joints.

Mitigation would include construction of a new control building, decommissioning of the access tunnel, provision of new roof access to the valve chamber and modification of roof panel seals. The estimated cost of mitigation is \$200,000.

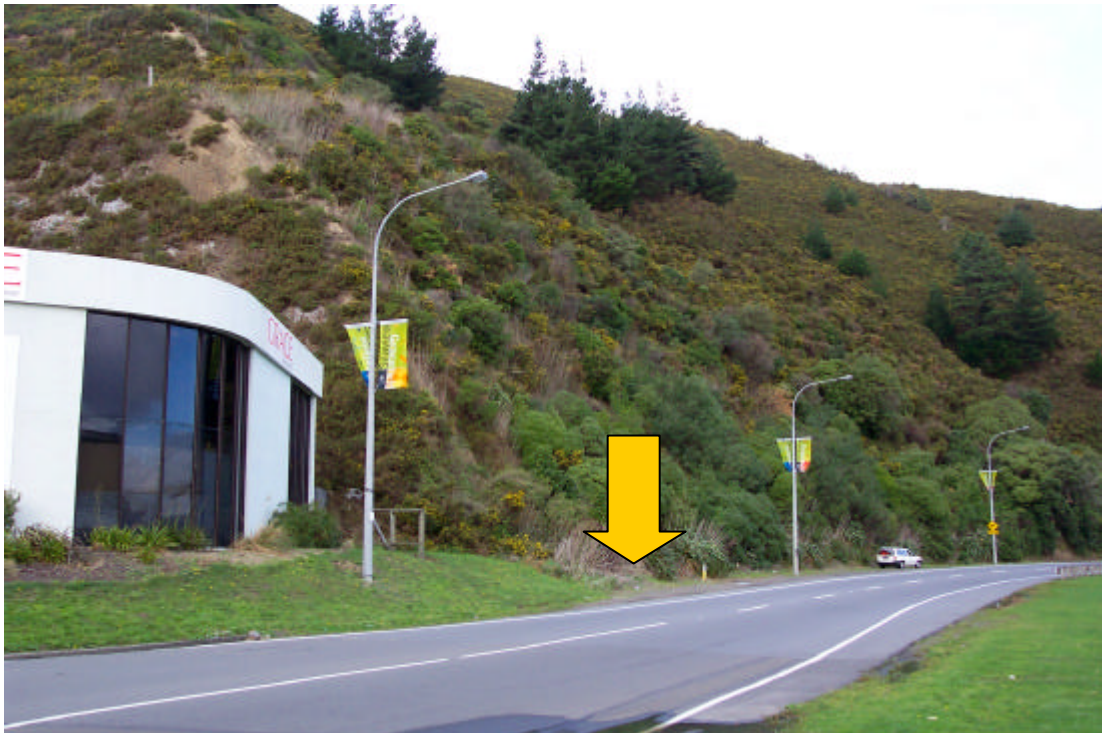
Figure 3 Proposed Point Howard Pumping Station site

A specially designed pumping station is proposed that will withstand rock falls from the hillside above the site. Small irregular falls are likely throughout the life of the structure. A major seismic event could trigger large rock falls of up to approximately 200m³ of material falling onto the pumping station. Subsequently rock falls would need clearing to reach the pumping station.

A new pumping station with a specially designed sloping roof and a strong back wall will be constructed to house new pumping equipment and switch boards at the Eastern Bays Marine Drive site. Existing pumps, motors and switchgear at Randwick Valve Chamber would be decommissioned and removed. The existing Randwick Valve Chamber control building, transformer and tunnel would be demolished. A new roof accessway into the valve chamber would be provided.
