## **FILE NOTE**

DATE	2 April 2025
AUTHOR	Ella Boam – Senior Project Manager, Investigations
SUBJECT	Waipoua River flood risk management - geotechnical report addendum

This file note acts as an addendum to the 'Stage 2 Report - Stopbanks Assessment, Waipoua River Stopbanks, Masterton' report that was prepared by ENGEO in October 2024. This note contextualises the conclusions presented in the report and highlights key points made in the Stage 1 Report – Preliminary Desktop Review, Waipoua River Stopbanks, Masterton, which was prepared by ENGEO in May 2024.

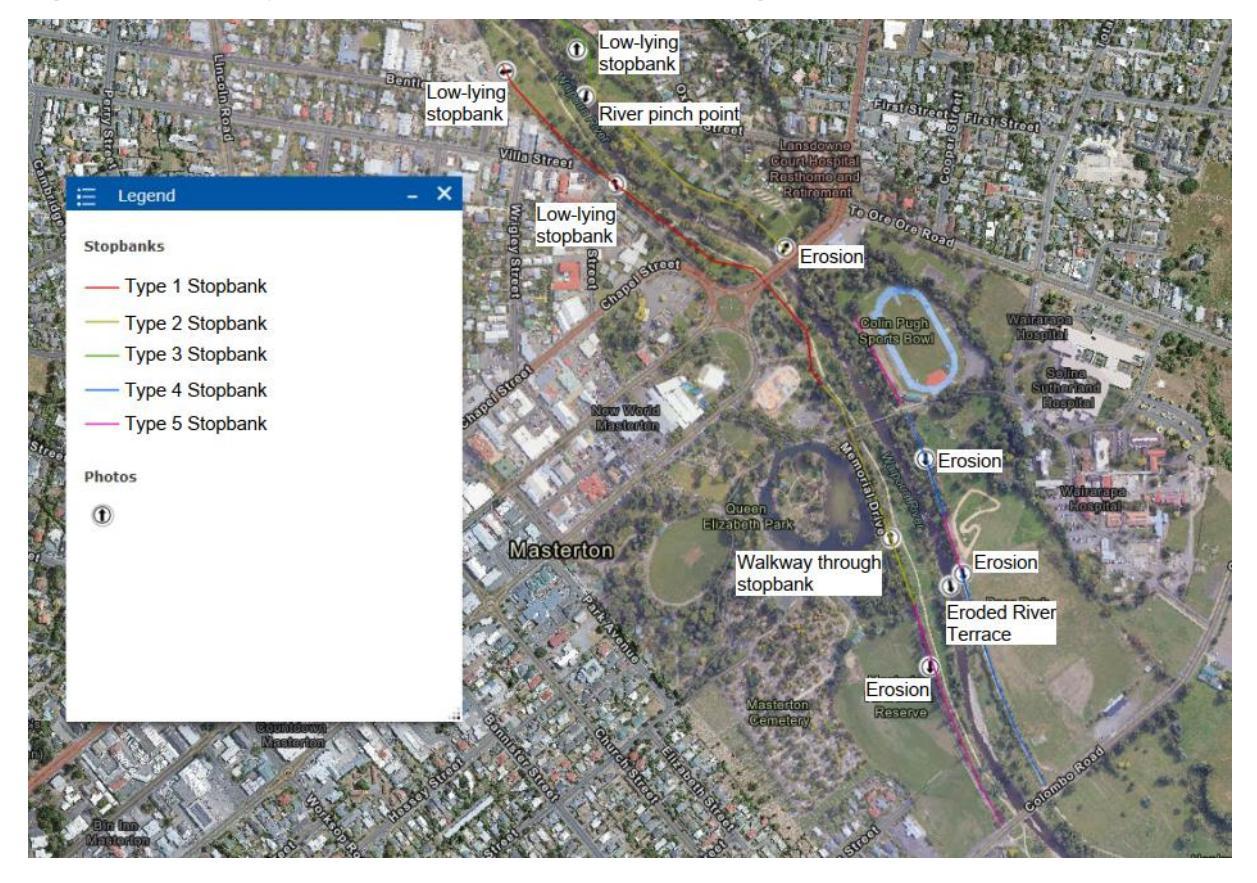
Figure 5: Stopbank Types and Points of Interest Identified during Site Walkover

- We have identified five different configurations of stopbanks which span along the area of interest, shown in Figure 5.
  - Type 1 Simple vegetated berm without any hard facing. We consider this to be most susceptible to erosion during flood events but with the least difficulty for future improvement / replacement.

- Type 5 Embankment retained by cobble mortar. We consider this to be the least susceptible to erosion during flood events but with highest difficulty for future improvement / replacement.

- The cobble mortar facing appears to have been in place for a long time and there are several places where its functionality was comprised due to damaged or was missing cobbles.

- Generally, the stopbanks appear to be made of non-homogeneous materials such as sandy silty gravel or some cobbles. In most instances, the stopbank is covered in vegetation and topsoil. Nevertheless, they appear to be in stable condition under normal (static) conditions.

- We have identified several low-lying lengths of stopbank which might create concentrated seepage flows during flooding events.
- Multiple small failures, possibly due to surficial erosion are observed on both sides of the stopbank inconsistently throughout the area of concern.

- There is a potential river pinch point where the river narrows at the point near the motorhome parking area. This may cause increased flow velocity and result in erosion of the riverbank at the pinch point. Discussions with GWRC indicate that these areas have scoured out in previous flood events.

- There is a break in the stopbank that is used as a footpath near the lake in Queen Elizabeth Park.
- Based on discussions with GWRC, we understand that the area beside the holiday park / motorhome area has the greatest risk (Stopbank Type 2). Based on our review of the provided 2D floodplain model, this area has the worst inundation (up to 3.5 m) and water velocities (up to 2.4 m/s).

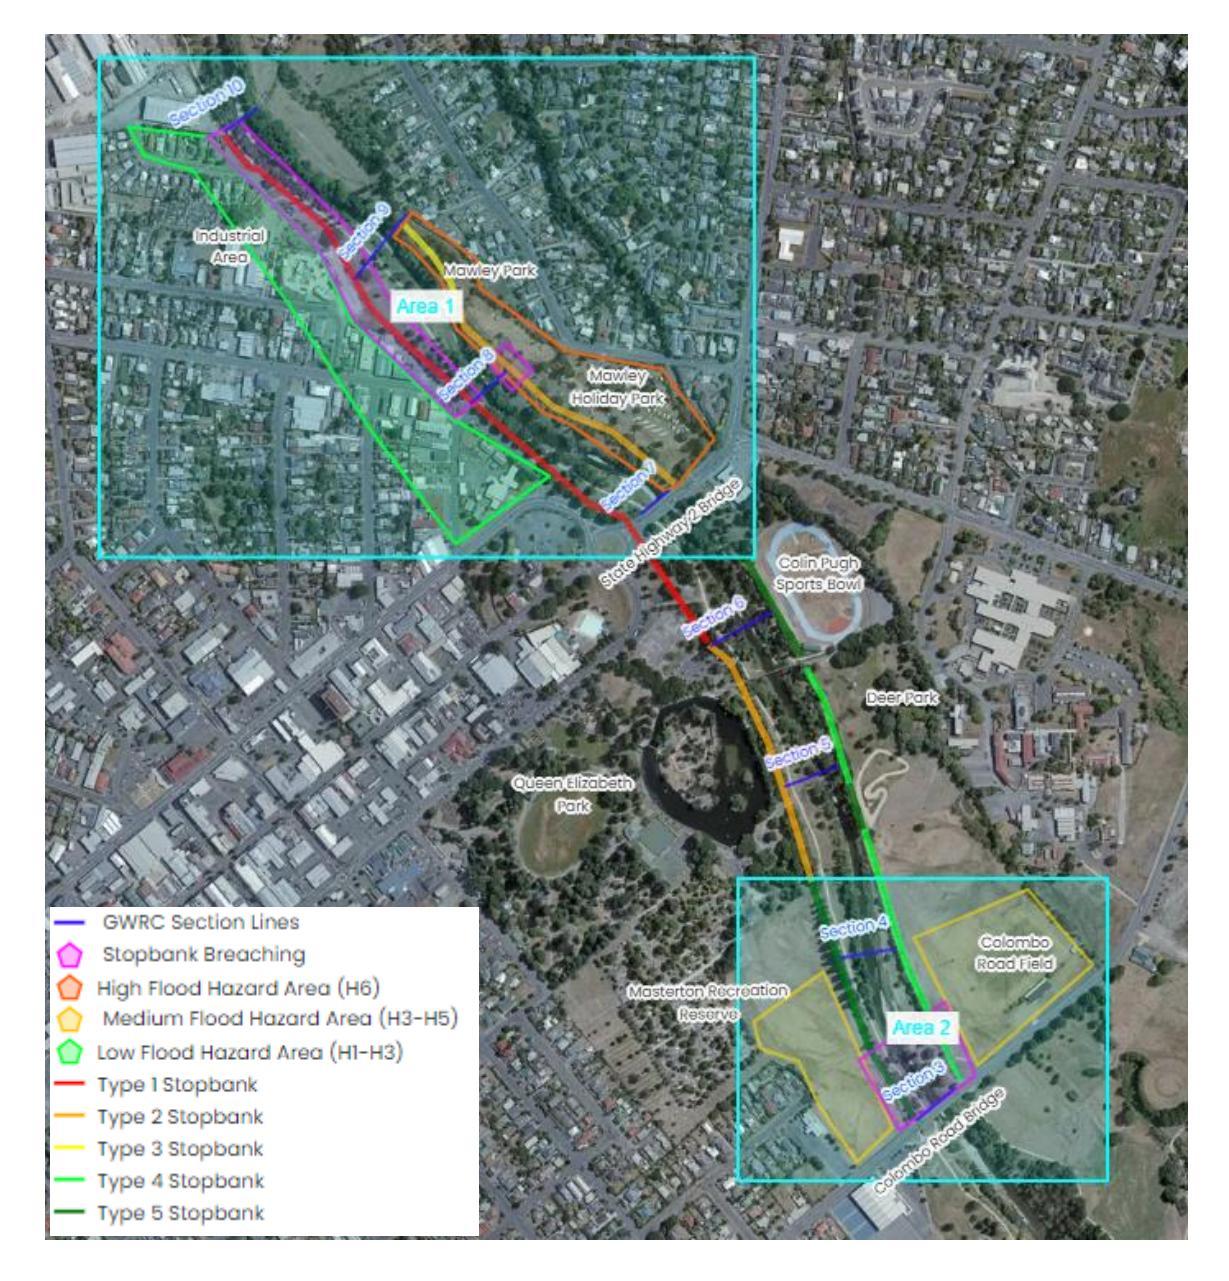
#### Figure 6: Site Plan Showing Recommended Stage 2 Investigation Areas

Location	Affected Stopbank Types / Approximate Lengths	Remarks
Area 1 (North) – Higher Priority	Type 1 / 520 m Type 2 / 410 m Type 3 / 140 m	We recommend Area 1 as the higher priority area due to the flood water level potentially breaching the western stopbanks and flowing into the industrial area, causing public disruptions. There is also a high flood hazard (H6) at the eastern bank of Waipoua which is likely to cause building damage / failure if the stopbanks are breached. In our opinion, it is relatively simple to improve / replace the affected stopbank types.
Area 2 (South) – Lower Priority	Type 4 / 110 m Type 5 / 115 m	We recommend Area 2 as the lower priority area due to lower flood hazards (H1 to H3). In a flood event, we assume that there will be less impact to the community as there is no permanent dwellings in the affected areas. There might be some difficulty in improving / replacing the stopbank types due to the hard cobble mortar facings.

- Shallow boreholes up to 2 m depth are completed along the stopbank in Area 1. This is to
  ensure that the stopbanks are kept mostly intact. At this stage, we recommend approximately
  10 no. of machine boreholes spaced at 100 m centres along a combined length of
  approximately 1 km (both the true right and true left side) of the Area 1 stopbank (two days of
  investigation).
- We would also undertake shallow boreholes along both the true left and true right side of the Waipoua River Stopbanks along Area 2 for a combined approximate length of 230 m. At this stage, we recommend approximately 10 no. machine boreholes spaced at 50 m centres along approximately 230 m length of the true right and true left side of the Area 1 stopbanks (two days of investigation).

- Test pits along the Area 1 stopbanks. The larger test pit footprints will cause more damage to the stopbanks and more public disruption during the investigation works and require careful placement and re-compaction of the excavated material upon completion. The same extent of test pits will be undertaken as the shallow borehole scope along the true right and true left side of the Waipoua River for a combined length of 1 km (two days of investigation).
- We would also undertake test pits along both the true left and true right side of the Waipoua River Stopbanks along Area 2 for a combined length of 230 m. The same extent of testpits will be undertaken as the shallow borehole scope along the Waipoua River stopbanks (two days of investigation).

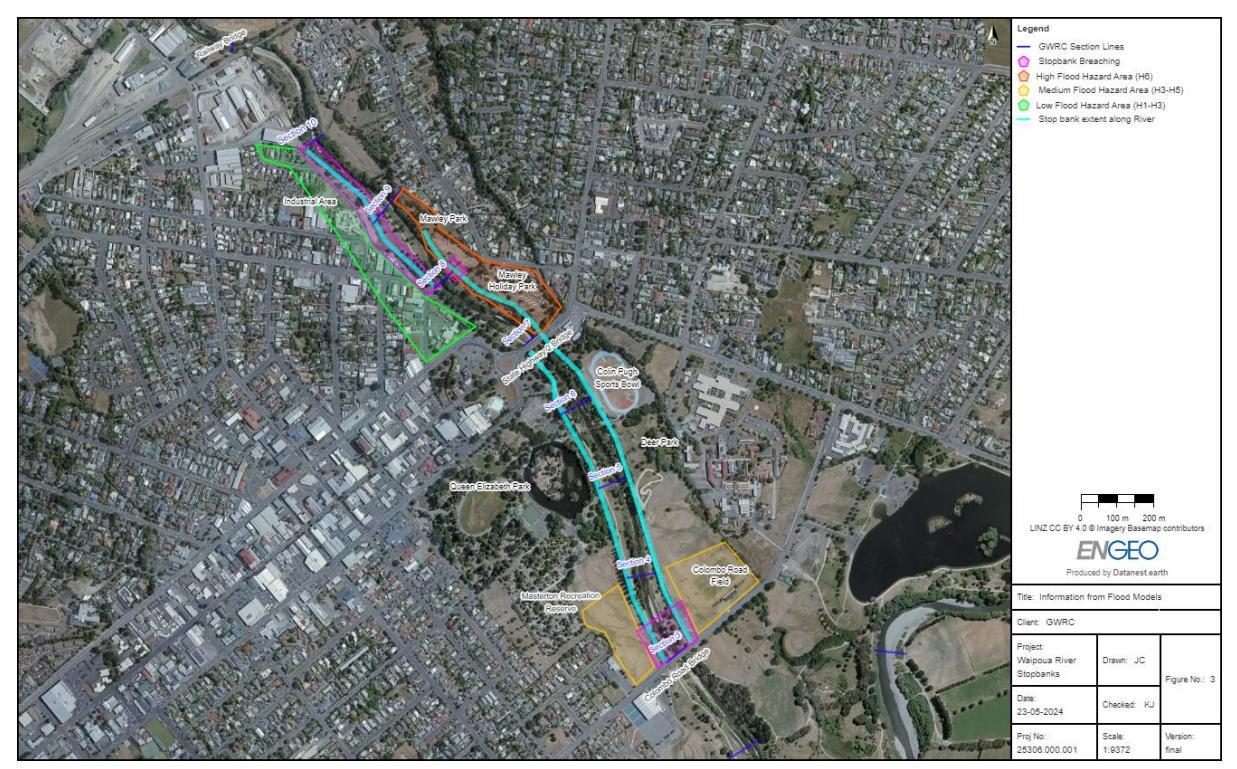
#### Figure 1: Critical Stopbank Areas (ENGEO, 2024)

ENGEO previously identified critical stopbank locations where potential breaches of the stopbank occur, and evaluated their hazard level in the preliminary desktop study (ENGEO, 2024). These areas are shown in the site location plan in Figure 1.

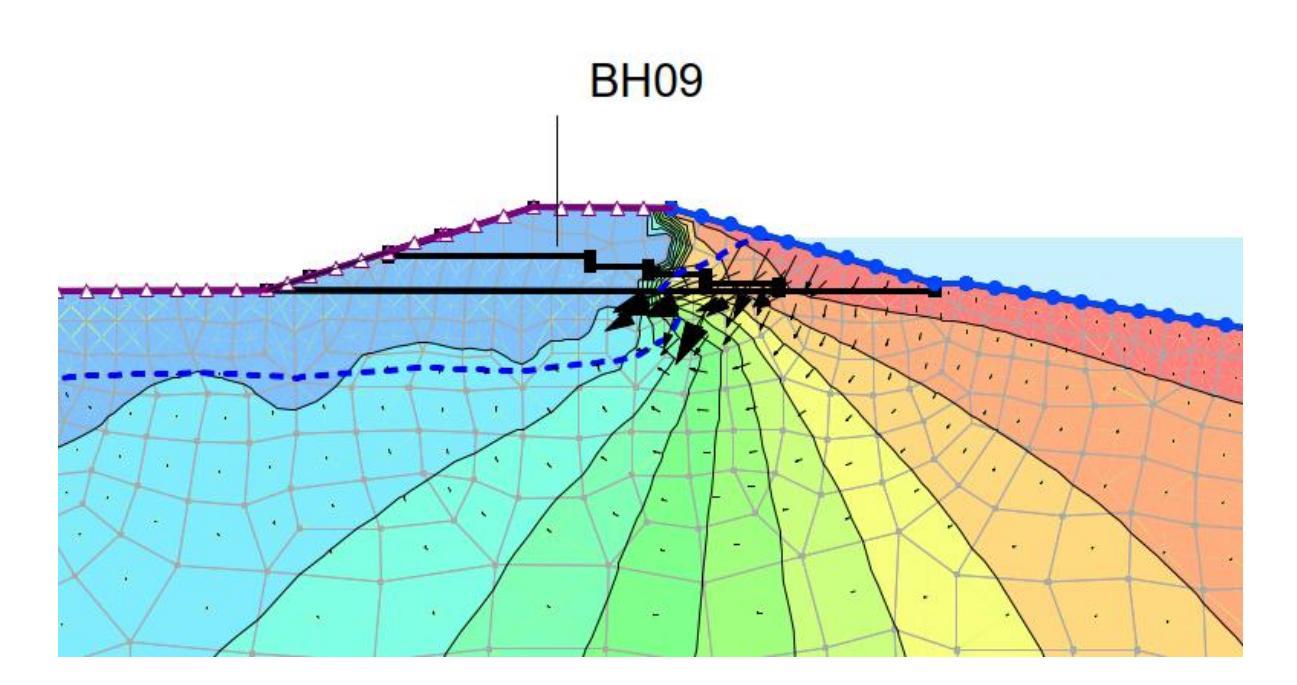
#### Figure 5: Extract of Seepage Analysis Flow Net Model

The flow net model provides information on seepage water flow and hydraulic gradients through the embankment. Seepage flowing out of an embankment, especially at the downstream toe of the embankment meeting level ground may eventually cause internal erosion, piping failure or heaving of the embankment toe.
