Titahi Bay Five Year Restoration Plan

Prepared for Porirua City Council and Greater Wellington

June 30th 2009

Report Number: CCERL/R27-28/03/2009

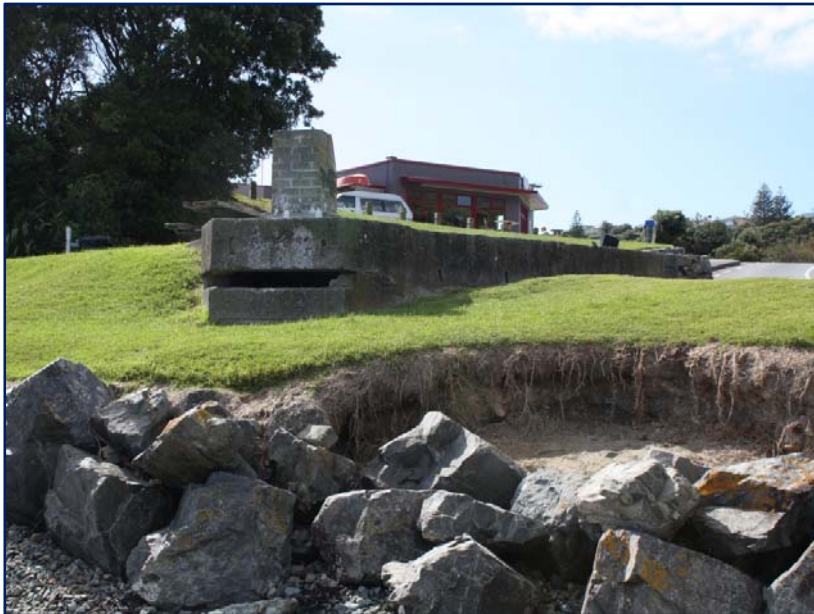
Figure 2:

- The western boat ramp off the corner of Richard Street and Bay Drive is a significant road that leads directly from built-up area onto the beach.
- There is often loss of windblown sand from the beach up the road.
- The mown kikuyu (*Pennisetum clandestinum*) area adjacent to the boat ramp comprises fill, a historic defence machine gun concrete bunker with unconsolidated rock placed along the foreshore (Figure 2) and a major storm water drain next to the boat sheds. The area is a well used recreation and viewing area.

A historically significant concrete gun emplacement within a kikuyu grass area and rocks placed at high water mark at the northern end of Titahi Bay Beach. Despite placement of rocks, note erosion by high seas of the grassed bank landward of the rocks.

- There is little scope for establishing even a small incipient dune in the vicinity of the boat ramp and grassed area to reduce windblown sand without undertaking major site works to remove rocks and fill along the seaward edge of the grassed area and/or the access road itself. Considerable resources and consultation would be required to achieve this.

- If the road access is retained in the long term, there may be scope to redesign the access to minimise windblown sand losses from the beach. In principle, any management actions should aim to minimise any loss of sand from the beach system. Wherever possible, this should include returning any clean sand collected from the road back to the beach.

- Providing signage to warn motorists that the road is a 'No Exit' could reduce vehicle movements on the beach. Encouraging parking away from the beach and closing this ramp in favour of developing the boat ramp immediately adjacent to the rock platform at the north-western end of the beach off Vella Road could be considered.

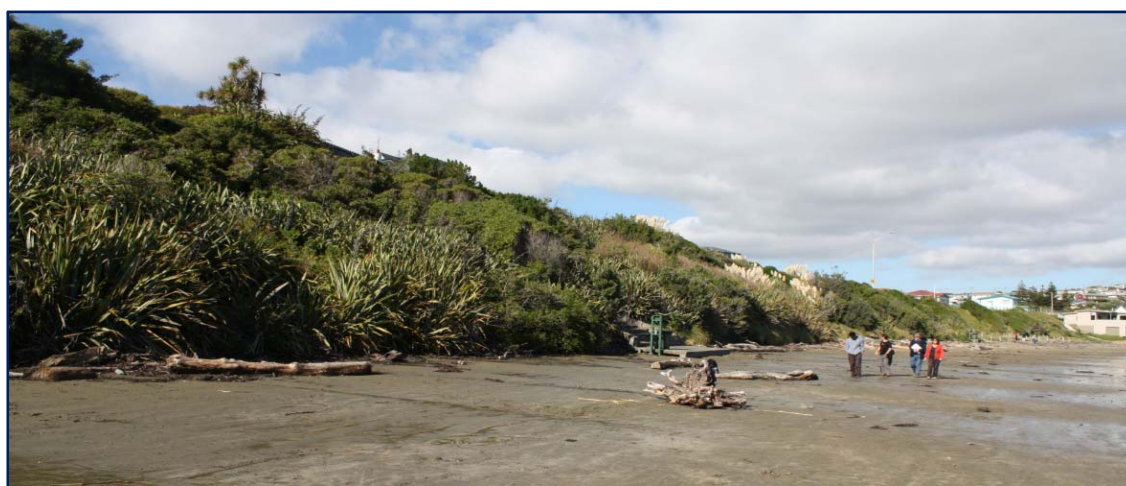
- High water mark is located at the toe of a steep densely vegetated bank dominated by a range of native and scattered exotic species (Figure 3).
- There are a number of concrete structures on the foreshore in this area. They appear to be associated with rubbish containers and drains.

Figure 3: View of the densely vegetated steep bank where there is no high tide beach. The backdune comprises a dense mixture of native and exotic species.

- It is impractical to establish foredune native sand binding vegetation in this area.
- Where practical the number of concrete structures along the foreshore should be reduced to enhance amenity values.
- Restoration should focus on removing major weeds such as pampas (*Cortaderia selloana*, *C. jubata*) and karo to allow natural regeneration of various native backdune shrub and tree species such as taupata (*Coprosma repens*), harakeke (*Phormium tenax*) and ngaio (*Myoporum laetum*).

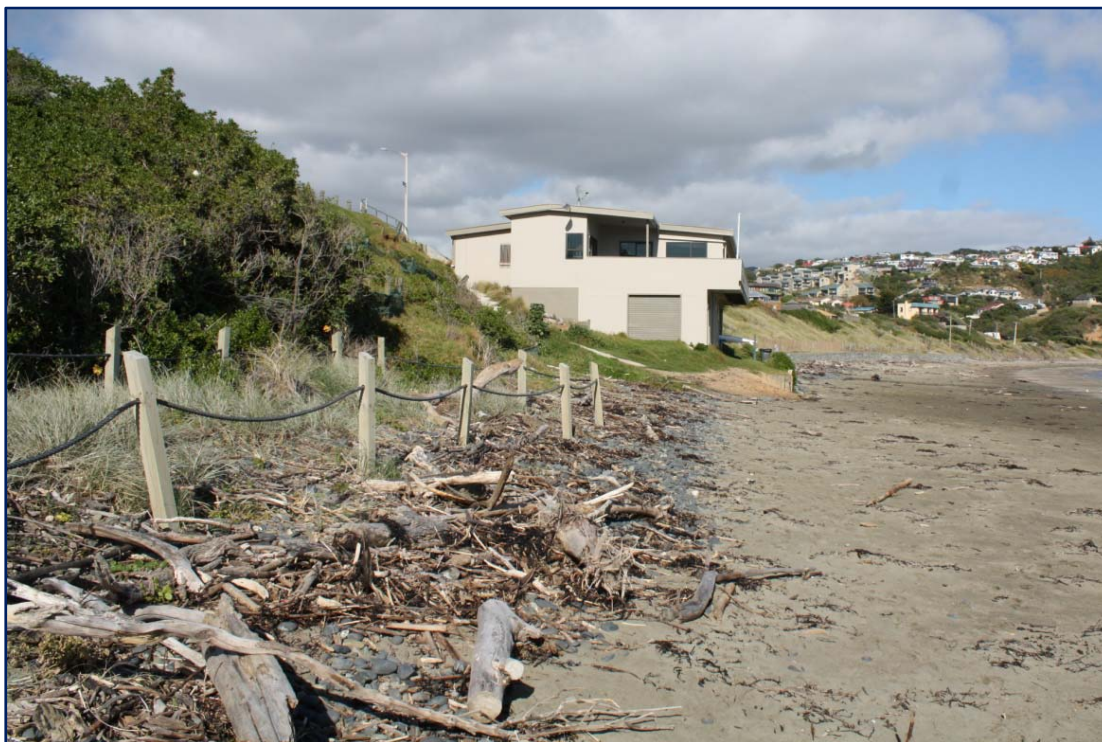
- This area comprises a low sloping foredune from the high water mark to a steep bank dominated by exotic grasses including marram (*Ammophila arenaria*), kikuyu and a range of exotic and native shrubs further inland (Figure 4).
- Beach users gain access to the beach through this area although this is not formalised.
- As there is a small zone of sand between the high water mark and the backdune where a small incipient dune of sand binding plants has established. This comprises two plots of spinifex (*Spinifex sericeus*) planted within the last year. One plot is dominated by vigorous spinifex while the other has become dominated by marram grass (*Ammophila arenaria*).

Figure 4: Two plots of spinifex planted within the last 12 months protected from pedestrian traffic by a fence and a steep back landward dominated by shrub hardwoods.

- The spinifex plantings have demonstrated some early success. However, the plots highlight the need for control of invading marram grass and other exotic species including kikuyu. Future plantings will require weed monitoring and control.

- Spinifex plantings could be extended including into the small area immediately south of the surf club building.
- Control the invasion of marram with careful spraying of gallant and replant gaps with native sand-binders spinifex and pingao (*Desmoschoenus spiralis*).

- Landward of the sand binding zone – control kikuyu by spraying herbicide and gradually replace by planting native backdune coastal species such as wiwi (*Ficinia nodosa*), taupata (*Coprosma repens*), pohuehue (*Muehlenbeckia complex* and *M. astonii*) and wharariki (*Phormium cookianum*).

- Determine where access-ways should be sited within this zone and formalise these with fencing and signage.

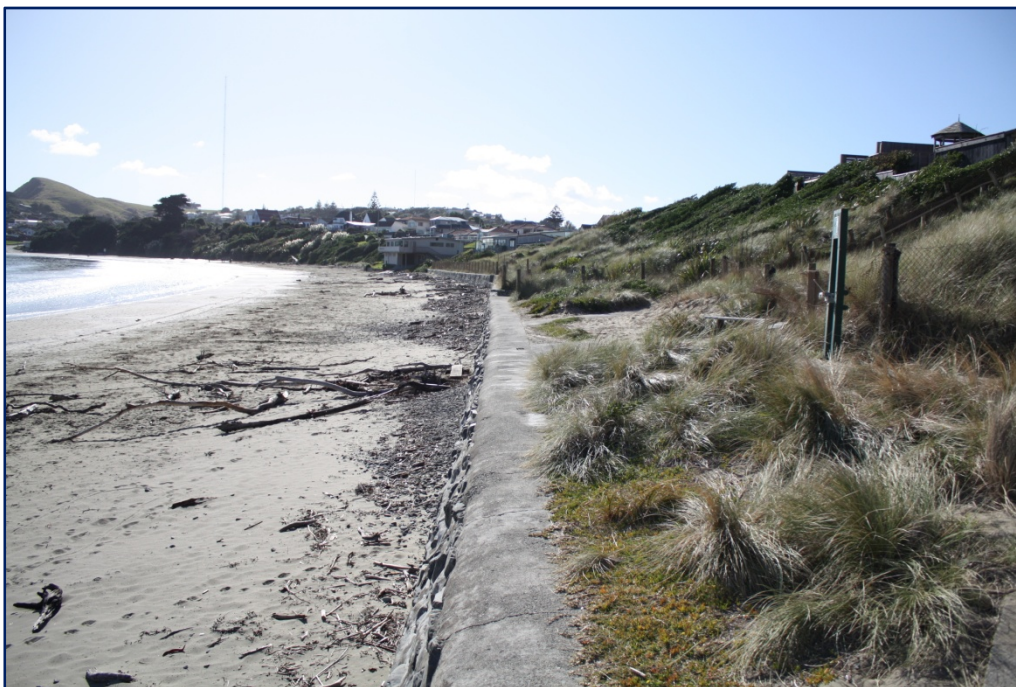
- A concrete seawall up to 1.8 m high from current level of beach dominates the central part of the bay (Figure 5).
- There is no vegetation seaward of concrete wall. Storm waves come up to the base of the structure along most of the wall where a strandline of coarse driftwood occurs.
- At the Surf Club end of the seawall there appears to be less disturbance from high seas and storm waves. Here 1-2 natural spinifex plants survive amongst driftwood just above high water mark.
- A steep dune landward of the seawall is dominated by marram grass with scattered exotic and native shrubby species.
- Analysis of shoreline positions since 1942 indicates that the shoreline position has not varied significantly. This suggests that the seawall is within the active cut and fill zone of a foredune.

Figure 5: View along the seawall that dominates the central portion of Titahi Bay beach. The seawall is located at or near high water mark where the active foredune zone that historically native sand binding plants is likely to have occurred. Analysis of shoreline positions on aerial photographs since the 1940s indicates the shoreline position has not varied significantly.

- The location of the seawall at or near high water mark precludes the establishment of sand binding vegetation seaward of the seawall. Ideally the wall should have been constructed further landward so that foredune with normal cut and fill cycles could have formed in front. Had this been the case, potentially the wall would have been covered most of the time by a dune, thereby retaining values of a sandy foredune beach.

- Removing the wall from its current position would require a distinct and separate project to specifically assess the potential impacts and for the design of alternative protection measures. In particular, any vision of returning a functioning foredune system dominated by native sand binding plants would require a detailed study to determine if there is sufficient space to restore a foredune and the risks of erosion associated with removal of the wall.

- It is unlikely that native sand binders could be established along the zone above the seawall in the long term, as there is insufficient sand blown from the beach.

- A couple of small spinifex plants existing at the base of the seawall at the Surf Club end could be boosted with a light dressing of fast release fertiliser and with further planting of spinifex and pingao just above the high water mark. However, any vegetation at the base of the seawall is highly vulnerable to wave action during storm events and is therefore unlikely to establish a permanent dune.

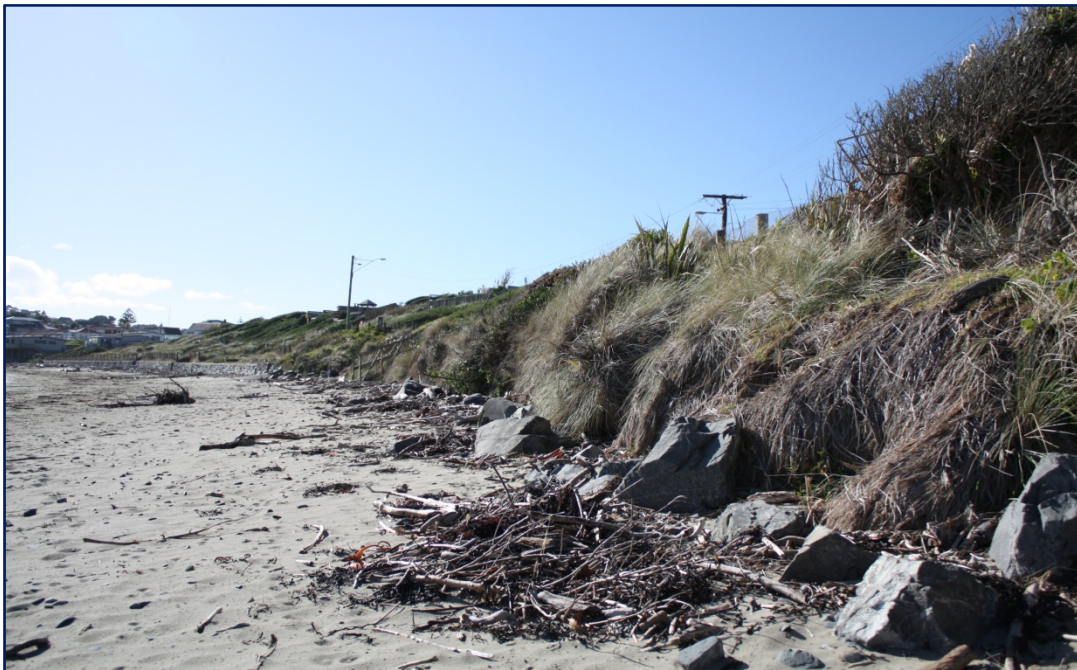
- There is a line of unconsolidated rock along the toe of the foredune at the high water mark (see Figure 6).
- Immediately landward of the high water mark is a current steep foredune dominated by marram grass and other exotics resulting in no natural dune form and function.
- Landward of the concrete path is a fenced area which has been planted over several years with a large array of local semi-stable and backdune coastal species. The area was dominated by marram grass. This is an excellent demonstration area of key local species that can be planted on the semi-stable marram grass zone that dominates parts of the back-dunes within this area and behind the seawall in Area D to the north.

Figure 6: View northwest along Area E. Note the scattered rocks and debris associated with the high water mark at the toe of the vegetated bank.

- There is no scope to establish native sand-binders at the toe of the dune without removal of rocks, clearing the dense exotic vegetation and reshaping the foredune.

- There is considerable scope to establish a small demonstration trial of a mechanically reshaped foredune planted with native sand binders. There are several aspects to consider if a dune reshaping trial is to be established including:

- For Titahi Bay, any dune reshaping works will require:
 - Development of a separate project that will comprise detailed design, planning and costing;
 - The reshaped foredune is likely to require a reformed zone from high water mark that is at least 10 m wide (preferably wider);

- All soil and rock fill needs to be removed from the site to successfully re-establish foredune vegetation;
 - As part of the detailed design, factors such as the location of the historically significant concrete bunker buried within the dune in this area will need to be considered.

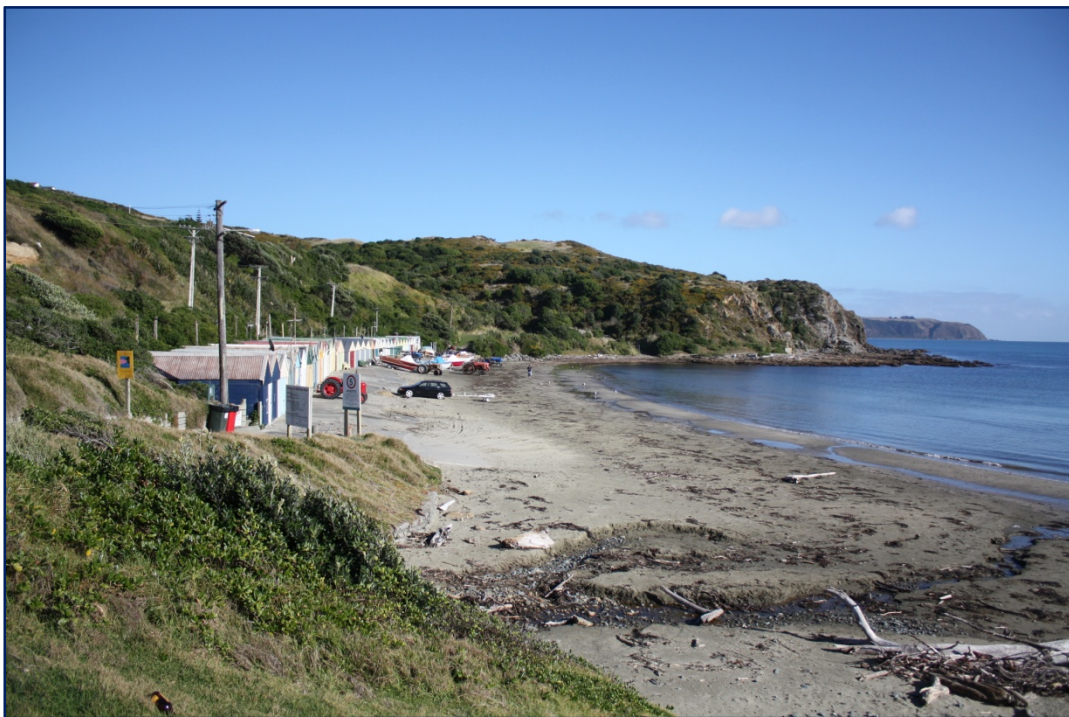
- The boat sheds in Area F are a significant historical feature of the beach that is intended to be protected into the future. Occupants of sheds have a licence to occupy.
- Beach access to the sheds, for boat launching, parking of cars and boat trailers has occurred since the turn of century and is likely to remain a feature of this area of the Bay.
- There is concern about the localised erosion created by the stormwater flow onto the beach adjacent to the boat ramp off South Beach Access Road (see Figure 7)
- Fill is a significant component of the short section of bank at the western end of the beach between the boat sheds and the natural rocky shore.

Figure 7: View of the southern end of Titahi Bay beach. Note the impact for the storm water outlet eroding the beach and contributing to the indent in the vegetated dune in the foreground. The vehicle access-way leading to the boat sheds in the centre left will be contributing to loss of sand inland.

- PCC staff have indicated that reducing the flow from the stormwater outlet adjacent to South Beach Access Road by establishing a wetland to help absorb nutrient runoff and act as a temporary storage is impractical as there is insufficient room within Arnold Park.

- Extending the stormwater outflow pipe out onto the beach could potentially reduce the localised scouring. However, where extended outfall pipes occur on other beaches, natural character and beach amenity values have been seriously compromised. While a small extension may be warranted to the mean high water springs mark, introducing a major new hard structure to the Titahi Bay beach environment should be considered a last resort.

- In the long term there may be scope to route the boat ramp via an elevated grassed levelled area at the extreme western end of the beach that once located an aquarium. In the meantime, boatshed owners could be encouraged to park vehicles and trailers off the beach. This may require additional landward parking facilities.
