Air quality 2008/09

Soil health and contaminated land 2008/09

Recreational water quality 2008/09

River and stream health 2008/09

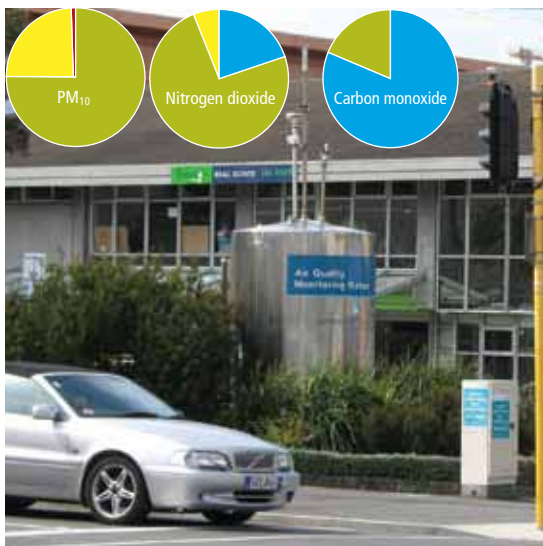
The air in heavily trafficked city areas has higher levels of some pollutants than suburban and rural areas. The pie charts show the proportion of time during 2008 that levels of air pollutants measured in central Wellington (corner of Victorian and Vivian streets) were "excellent" (blue), "good" (green) or "acceptable" (yellow). Air quality was well within the national environmental standards apart from one allowable exceedence of the PM₁₀ national standard (indicated in red).

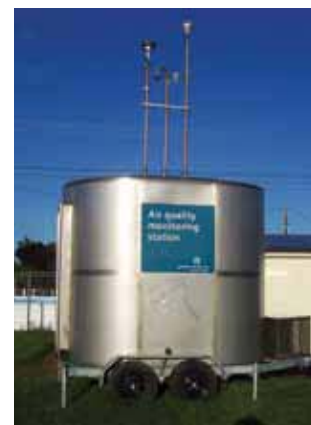
Mobile air quality monitoring station located at Featherston School during June 2009.

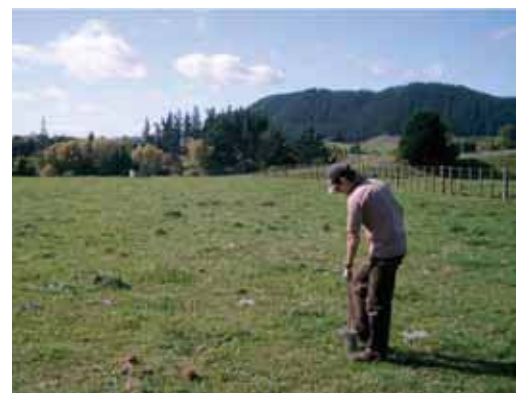
This dairy farm in Otaki is one of our soil quality monitoring sites. At each monitoring site, samples are taken from a depth of 0-10cm using a soil corer (pictured above), tested for various indicators, and the results compared with the optimum range for the soil type and land use. The soil at this site was slightly compacted but nutrient levels were satisfactory.

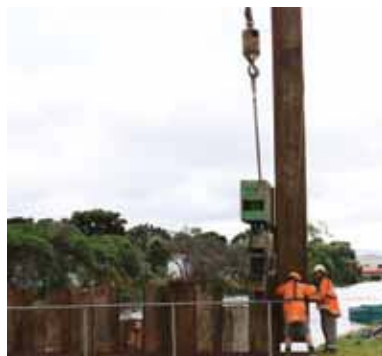
Collecting a sediment sample from the lower reaches of the Waiwhetu Stream for laboratory testing (left) and a pile rig at work installing the first sheet piles near the Bell Road Bridge (right).

The sediments in the bed of the lower reaches of the Waiwhetu Stream contain high levels of heavy metals and pesticides. This is a legacy of past practices when the stream was used to dispose of trade waste from the industries in Gracefield and Seaview. After a successful trial clean-up of a section of the stream was completed in March 2008, the full stream clean-up and flood protection works have now commenced. Earthworks and infrastructure works are underway, with the construction of permanent flood protection features and the removal of contaminated sediment on track to begin in late 2009. When stream flow reaches its average seasonal low, sheet pile cells will be constructed and the clean-up works will begin near the Bell Road Bridge, continuing downstream. This work is being jointly funded by Greater Wellington, Hutt City Council and the Ministry for the Environment's Contaminated Sites Remediation Fund.

In early 2009 baseline sediment quality and ecological monitoring was undertaken in the tidal reaches of the Waiwhetu Stream. The stream rated poorly in terms of enrichment (eutrophication), sedimentation, toxicity and habitat loss. Further monitoring will be undertaken after the stream remediation works are complete so that we can assess any improvements in the health of the stream's biological community.

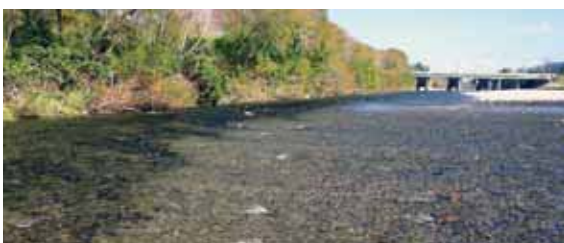
Blue-green algal mats along the left bank of the Hutt River at Silverstream late last summer. These types of mats can produce toxins that may harm animals and people, especially dogs.

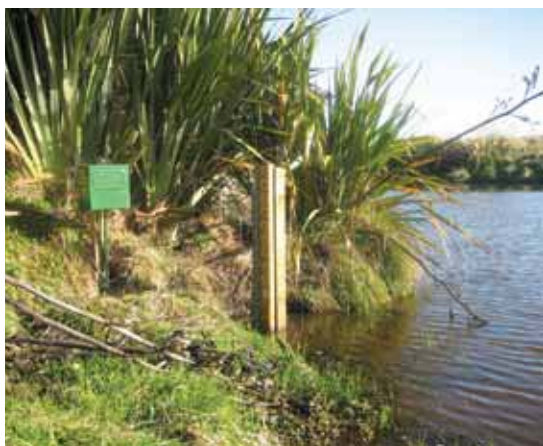
A new monitoring site in the Te Hapua wetland complex. Automatic monitoring equipment records the water level every 15 minutes. The readings are sent to the Greater Wellington office via telemetry, and can be viewed on our website.

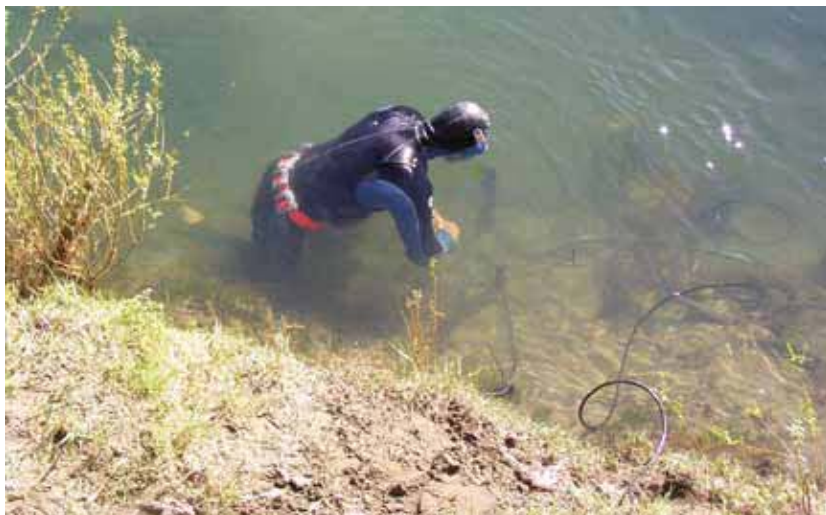
Installing dissolved oxygen monitoring equipment in a river in the Wairarapa. Low river flows may result in low dissolved oxygen concentrations, particularly in small streams with a lot of aquatic plant growth. The dissolved oxygen monitoring results will be taken into account when we recommend minimum flows for small streams.

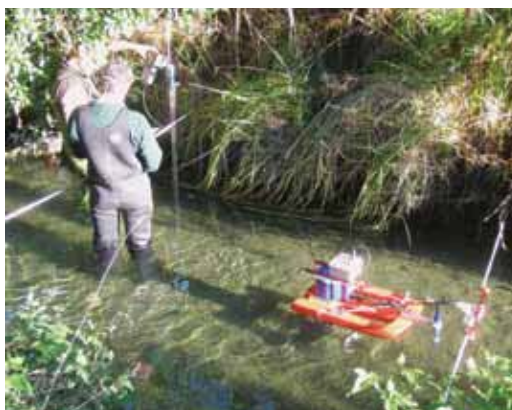
Greater Wellington staff measuring the flow in a stream in the Wairarapa. Small streams can support important values, such as providing habitat for threatened fish species. In some parts of the region, small streams are also used as a source of water for irrigation. In order to set appropriate minimum flow policies, it is important that we collect accurate information about stream flows.

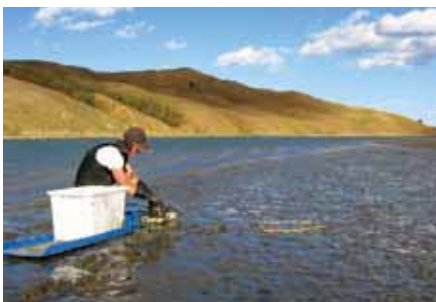
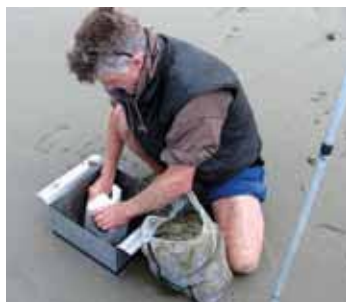
Collecting sediment from one of the monitoring sites at Whareama Estuary (left) and Castlepoint Beach (right), on the eastern Wairarapa coast. At each site, sediment samples are collected for laboratory testing and the algae and animals living in and on the sediment are identified and counted.

Ecological assessments of Whareama Estuary and Castlepoint Beach on Wairarapa’s east coast were carried out for a second time in January. Based on the National Estuary Monitoring Protocol, they included an assessment of sediment grain size and chemistry, and sediment dwelling plants and animals. The key findings were similar to those from last year’s initial surveys:

- Whareama Estuary: overall the intertidal habitat is generally in “fair” to “good” condition despite measurements from sediment plates buried in the estuary during the 2008 survey revealing a high sedimentation rate (average 14.5 mm over a year). Excessive inputs of sediment are largely a natural phenomenon given the erosion-prone mudstone soils in the catchment. While the very muddy and poorly oxygenated sediments are a concern (they create poor conditions for plants and animals), there was a slight improvement in the diversity of the estuary’s biological community over the year.
- Castlepoint Beach: the intertidal habitat is generally in “good” condition. The beach sediments consist of well-oxygenated sands and support animals commonly found in exposed low-nutrient beach environments, such as crustaceans and beetles.

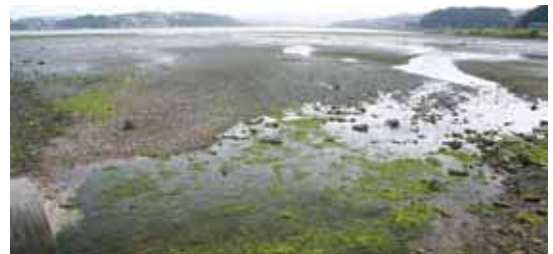
Discharge from the Semple Street stormwater outfall at the southern end of the Onepoto Arm of Porirua Harbour. A thick cover of algae can also be seen. Discharges from stormwater outfalls contain contaminants that run off hard surfaces such as roofs, roads and footpaths when it rains. Sometimes the discharges include paint, oil or other chemicals that people have tipped into roadside gutters or down storm drains without realising that these flow to streams and the coast.

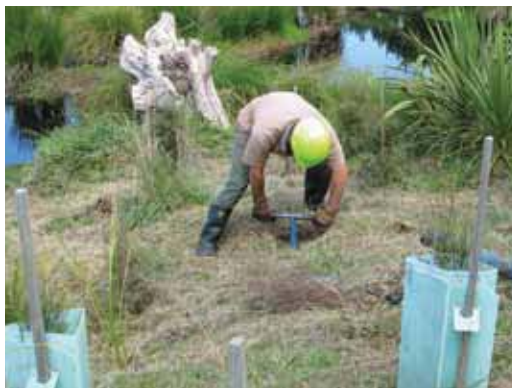
Greater Wellington staff member hand drilling a groundwater level monitoring bore at Te Hapua Wetland at Te Horo on the Kapiti Coast. As outlined in the *Rainfall and river flows* report card, we installed monitoring equipment in the Te Hapua Wetland on the Kapiti Coast to better understand how the wetland system works. The project included drilling two groundwater monitoring bores.
