# TE KAURU UPPER RUAMĀHANGA FLOODPLAIN MANAGEMENT PLAN

## PHASE 2 – VISION AND AIMS

*DRAFT*

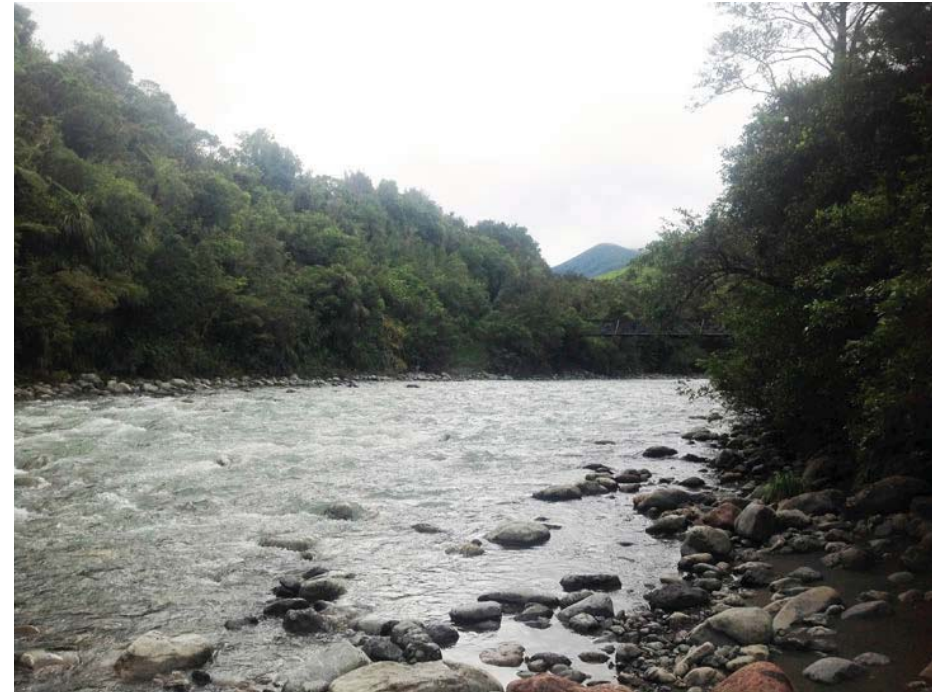
In addition the Waingawa River creates challenges for the establishment of vegetated buffer areas due to its deeply cut channel with areas of vertical river bank.

*Waingawa River viewed from Upper Waingawa Road end*

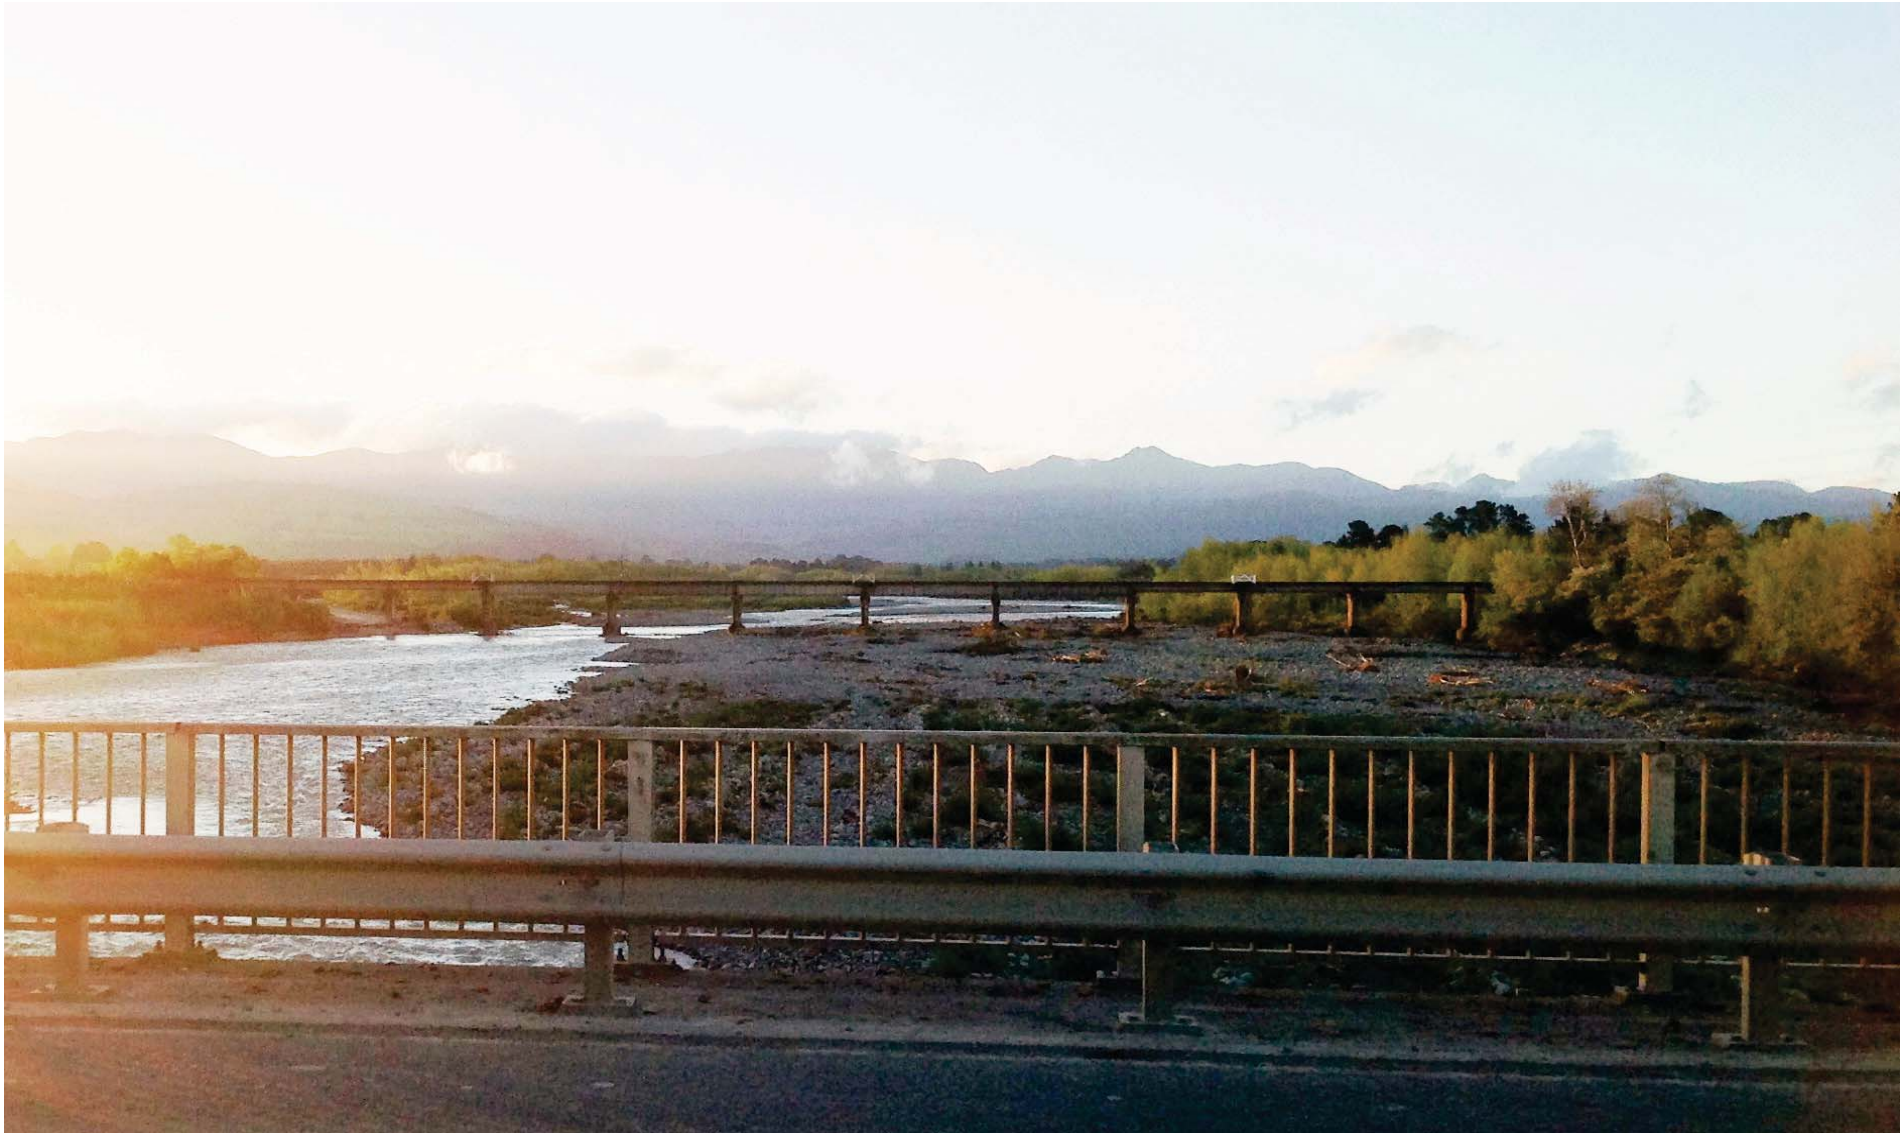
*Waingawa River viewed west from SH2 Road bridge*
