## **Te Awa Kairangi/Hutt River Valley Subcommittee**

Tuesday 22 October 2024, 2.00pm

7.	<a href="#">Wainuiomata Freshwater (Including Flood Risk) Management</a>	24.570	123
8.	<a href="#">Te Awa Kairangi / Hutt River Valley Annual Asset Management Condition Report</a>	24.360	134

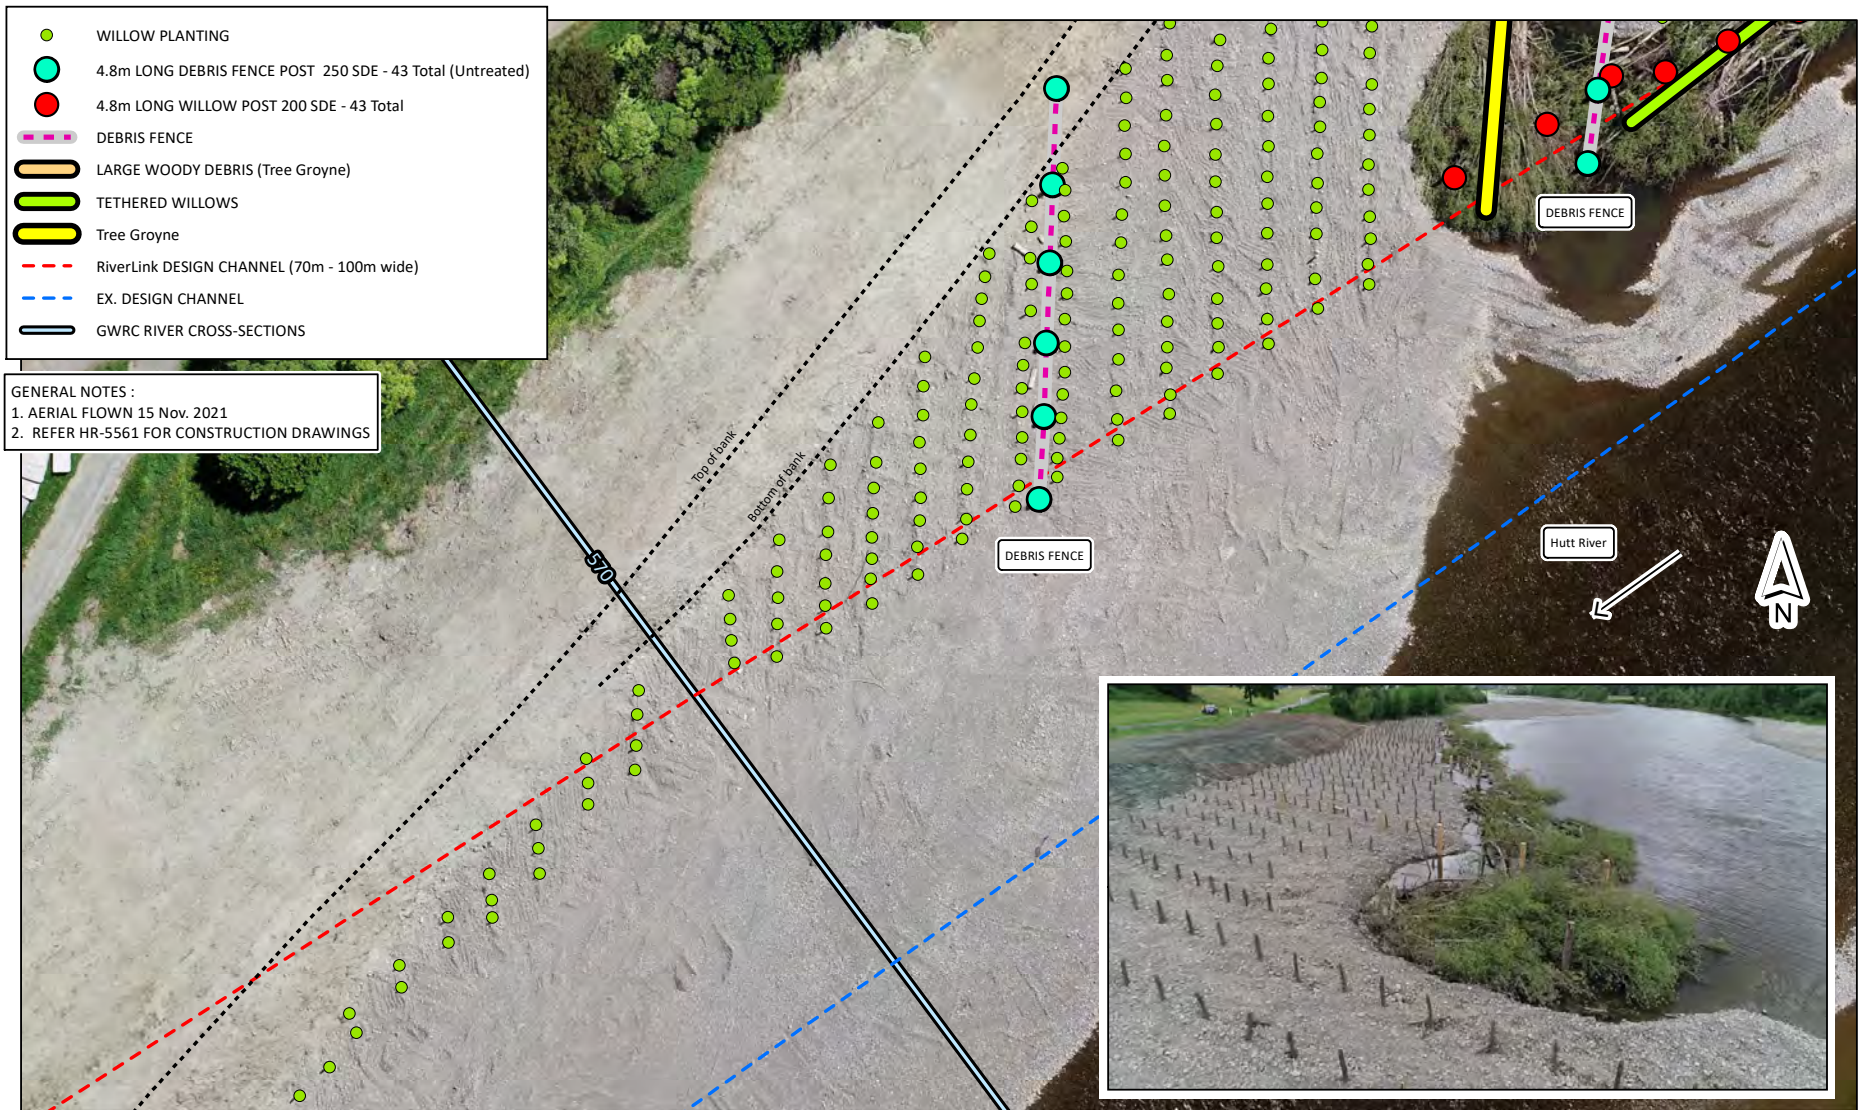
File ref : HR-5563-01\_AB

GENERAL NOTES :  
 1. AERIAL FLOWN 15 Nov. 2021  
 2. REFER HR-5561 FOR CONSTRUCTION DRAWINGS

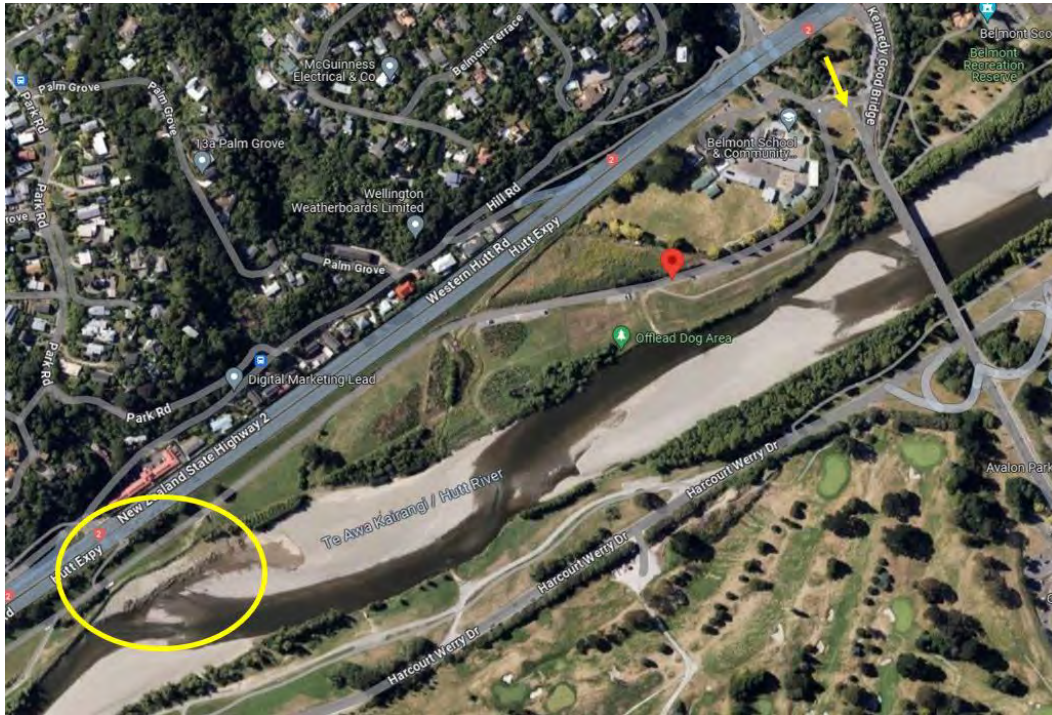
Figure 1: The location of the Belmont Trial Site and access point.

The upper reach refers to the length of river from the Kennedy-Good Bridge down to the Transpower Station, just north of the Mills Street Stopbank. Figure 1 outlines the bioengineering trial planting site where in 2021, the trial plot was constructed and planted out with willows (*Salix matsudana x alba* 'Moutere'). The trial plot sits below the entrance to Belmont on State Highway 2, it can be accessed from the west end of Kennedy-Good bridge by heading south along the Hutt River Walking Trail. The trial site was selected due to the presence of erosion in the lower berm in early 2021. This created an opportunity to measure the success of Te Awa Kairangi bioengineering design in a representative section of the river.

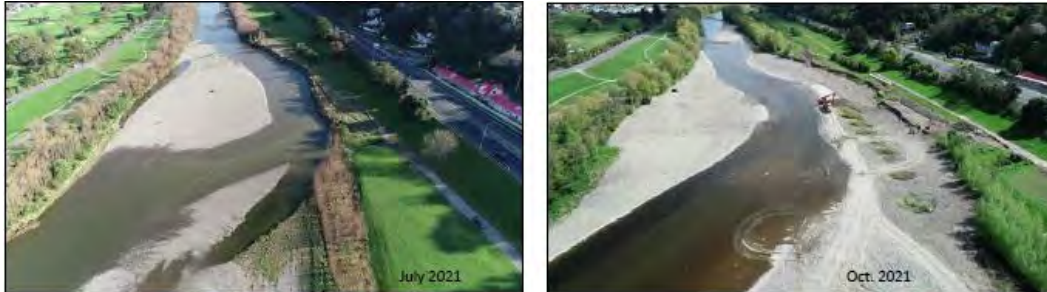
Figure 2. The river meander before and after the lower berm construction.

The construction of the trial plot started with the excavation and rebuilding of the lower berm in early 2021. The bioengineering design includes multiple components to protect the vegetation from erosion, these are listed below:

1. Tethered willows have been installed at the front edge of the lower berm, designed as the first level of protection when the river level rises. The rock in the lower berm was excavated before the trenched willows were installed. The rock was then replaced, forming the finished layer and leaving the willows semi exposed at the water's edge to grow.

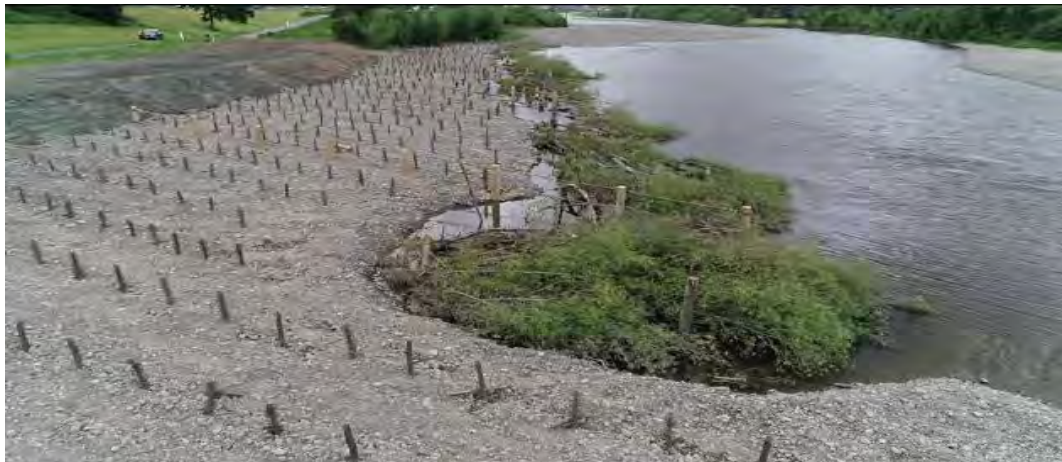
3. The lower berm was then planted with willow poles. Poles were a minimum of 3m long, embedded to a depth of at least 2m, at a maximum of 2m centres.

Figure 3. The area complete with willow poles installed.

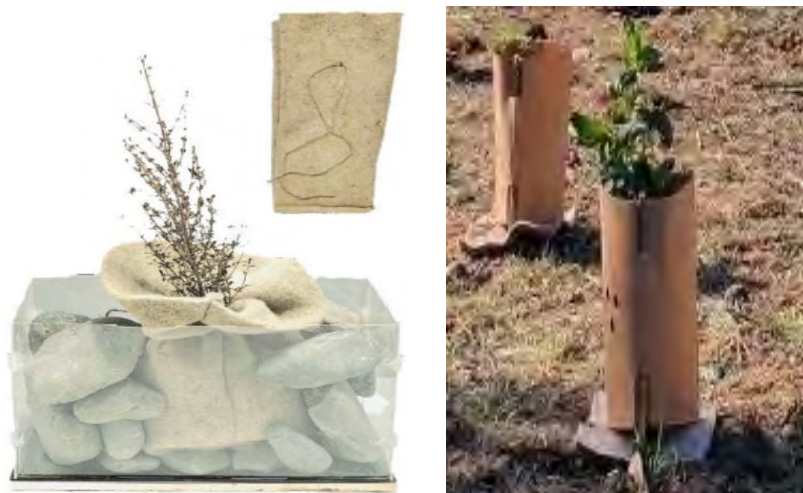
Figure 5. Left: Wool Wonton Planting Bag. Right: Biodegradable Guard + Wool Mat

This wool bag substitutes as a biodegradable plant pot, supporting plant growth in rugged areas where there is minimal soil. A small amount of soil will be added to each bag, the bag will then be tied up and placed in the hole. The wool material improves moisture retention and supports the plant through its transition period.

Biodegradable plant guards are designed to protect the plant and enhance growth, before breaking down into the soil. The guard will protect the plant from possible pest damage (hares and rabbits) turbulent winds and spray drift, all while providing warmer, preferable growing conditions. Biodegradable guards have been chosen over plastic and are expected to remain in place during small-scale flood events.

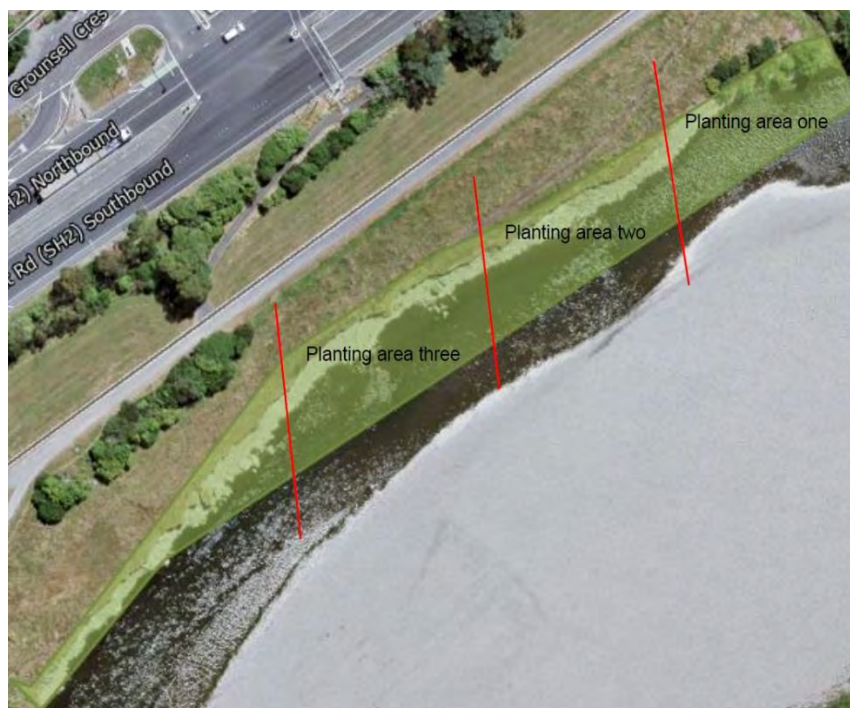
Figure 6. An aerial of the planting trial plot outlining the three planting sections.

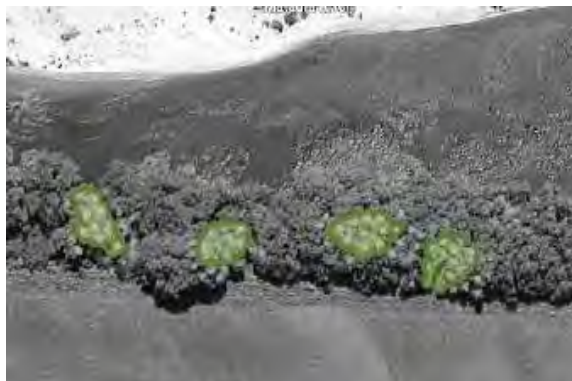
Figure 7 shows an example planting plot from GW's Native Planting Operational Guide.<sup>6</sup> This approach details the thinning out of willows to create 'light wells', encouraging natural regeneration. This allows a sheltered environment with ample light, while surrounding willows are still present to provide a stabilised bioengineering function.

Figure 7. An example planting area where sections of willows can be thinned out to support natural regeneration and native planting.

This approach is often adopted to encourage natural regeneration, however for this trial, plants will be installed where willows are thinned out, alongside self-seeded species, to accelerate the ability in measuring the success of the approach.

Willows will continue to be thinned out over the maintenance period to encourage regeneration and allow further native transitional planting.

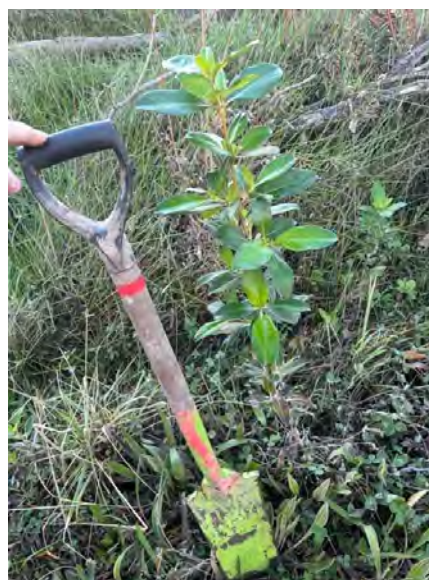
Multiple species listed in the hardy species mix are regenerating in the trial planting area, as shown by the *Coprosma robusta*, in Figure 8.

Figure 8. A naturally regenerated *Coprosma robusta* (karamu) thriving in the Planting Trial Plot.

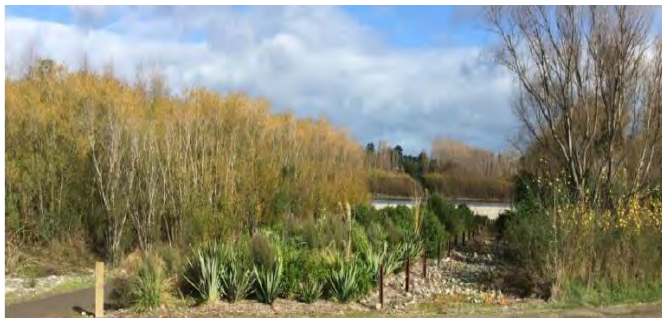
Figure 10. An example planting area where sections of willows have been removed and replaced with blocks of native plants.

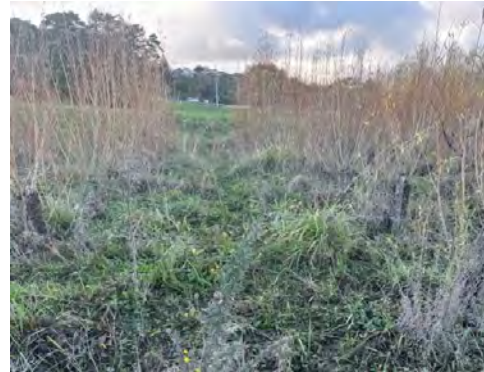
Figure 14. Existing willows growth and healthy grass coverage throughout a majority of the trial plot.

- Grass coverage, non-invasive weeds such as Clover (*Trifolium repens*) and a mixture of broadleaf weeds are present, providing shallow stabilisation. There is minimal presence of invasive vines and regional pest weeds however, certain weeds will be removed including Pampas Grass (*Cortadaria selloana*), Broad-leaved fleabane (*Conyza sumatrensis*) and Gorse (*Ulex europaeus*). While these weeds are supporting the stability of the berm, their below ground structure is inferior to native vegetation and will be removed.

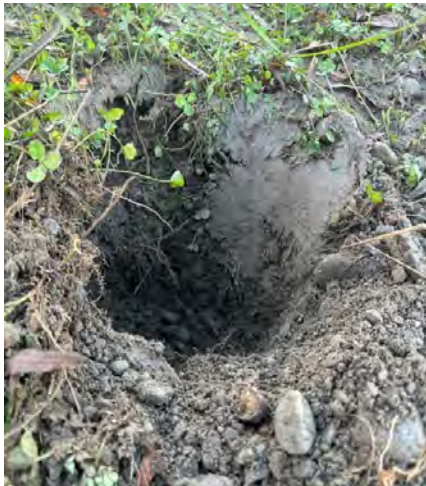
Figure 15. Exemplary hole showing sediment buildup

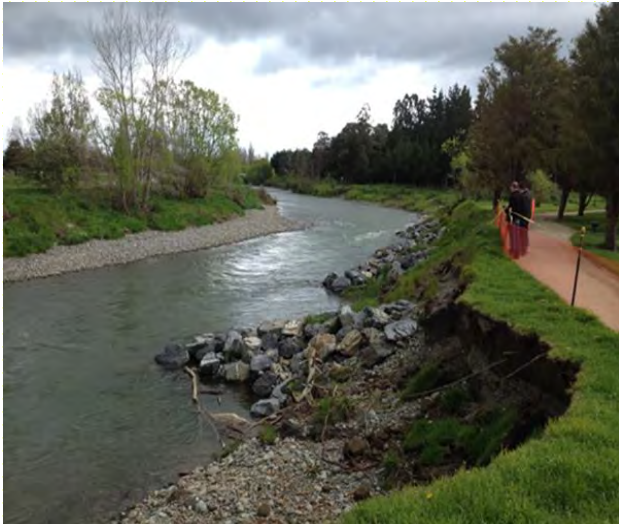
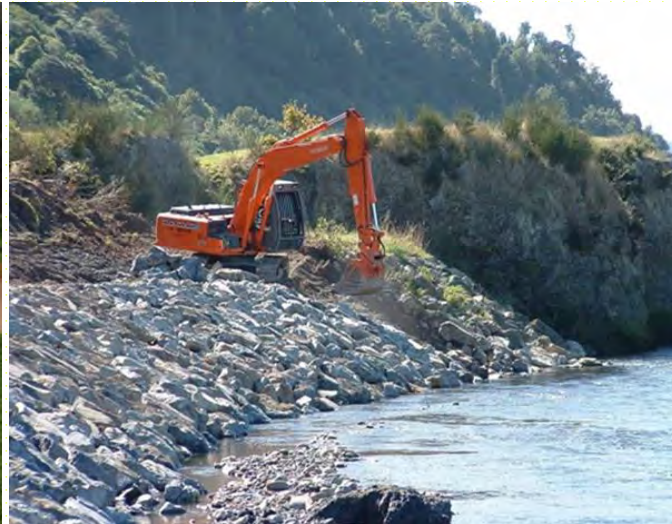
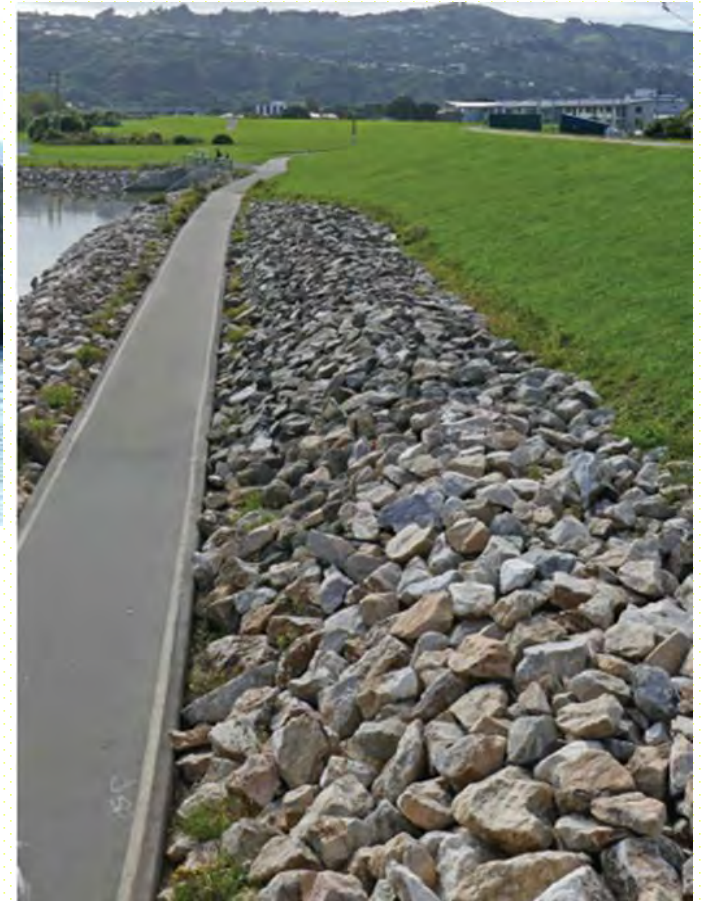
# Hard engineering – rock structures

1. Effective erosion control
2. Robust and strong
3. Risk and scheme performance

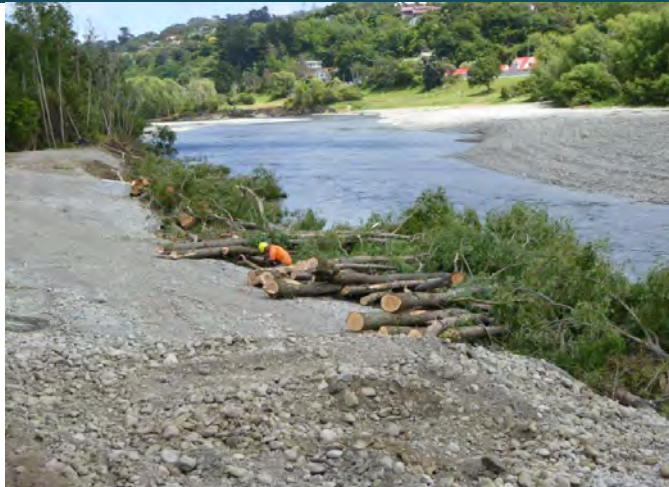
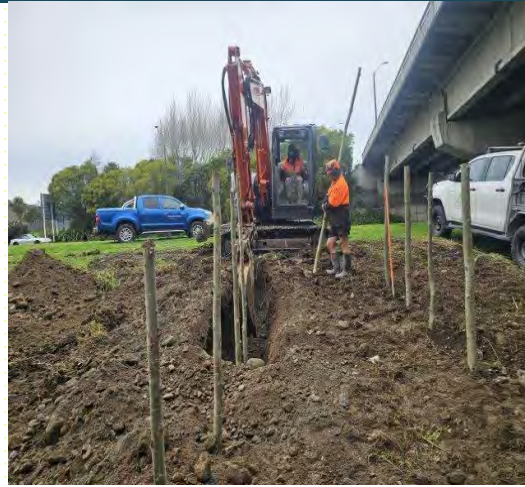
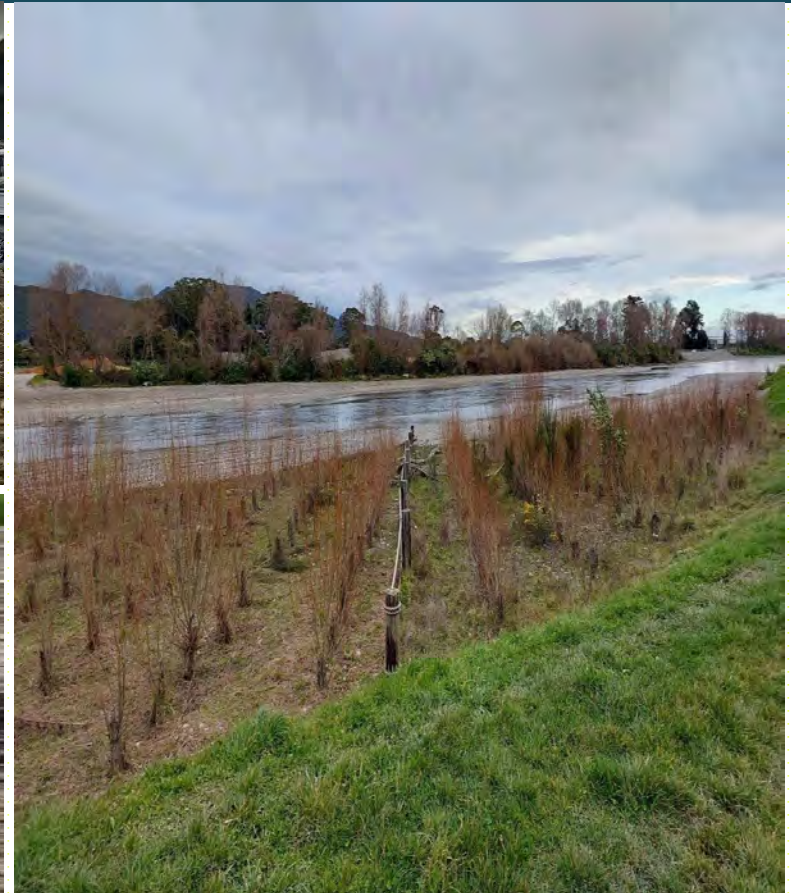
## Soft engineering – installation of vegetative willow buffers

1. Bank stabilisation
2. Flexible / sacrificial edge
3. Flood velocity mitigation

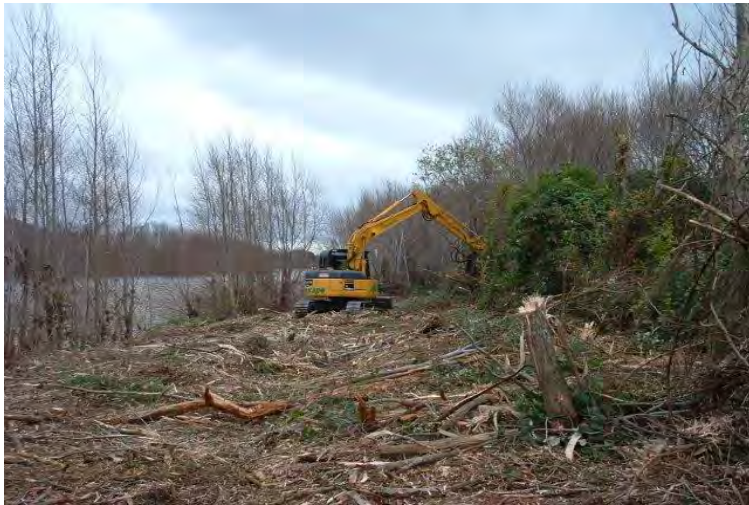
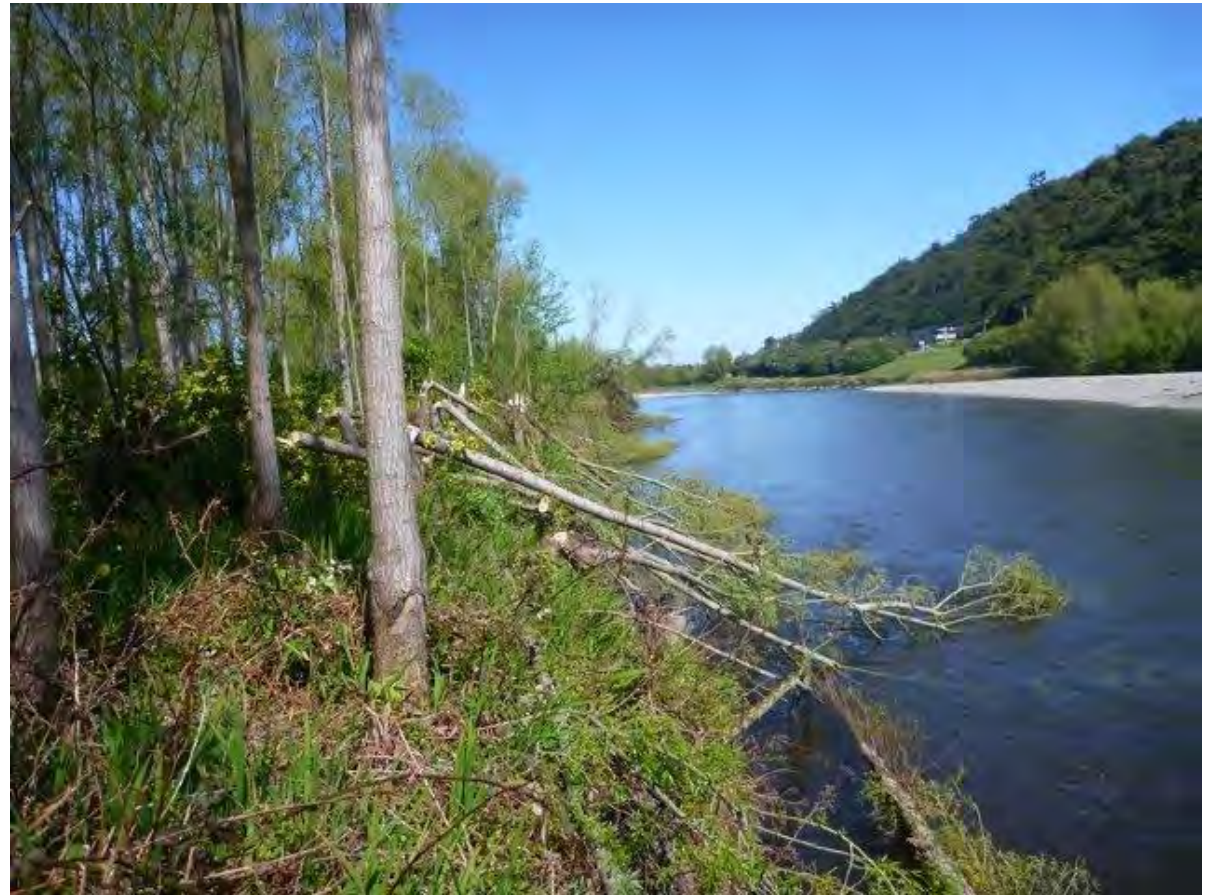
## Maintenance of willows

1. Layering
2. Pruning and mulching
3. Mowing between willows
4. Replacement

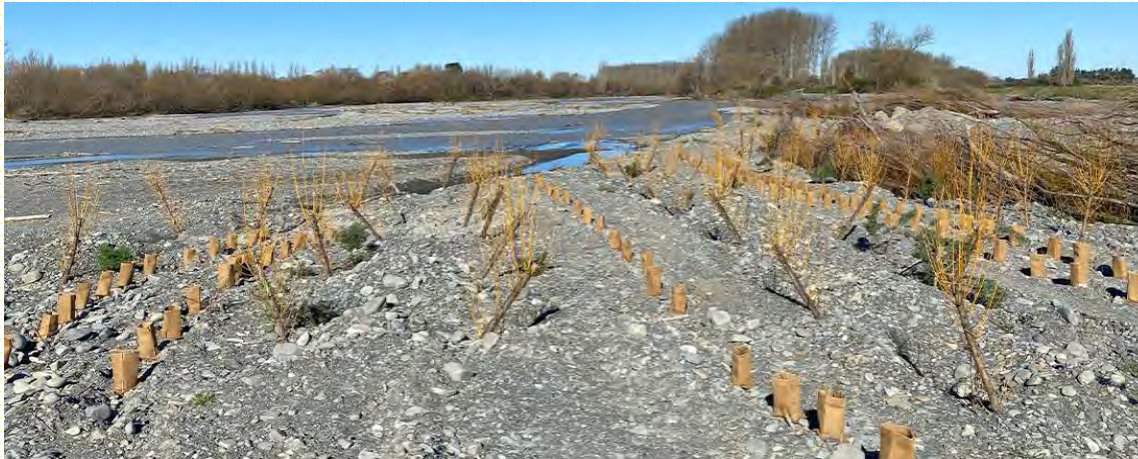
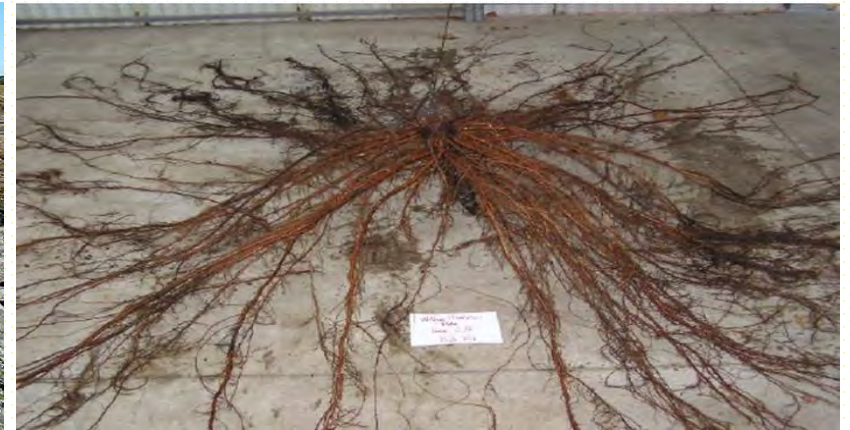
Nine - month-old *Salix matsudana x alba* 'Moutere' (Willow) – 132cm root spread

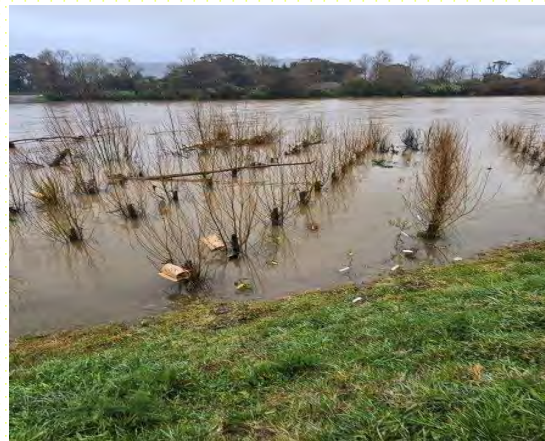
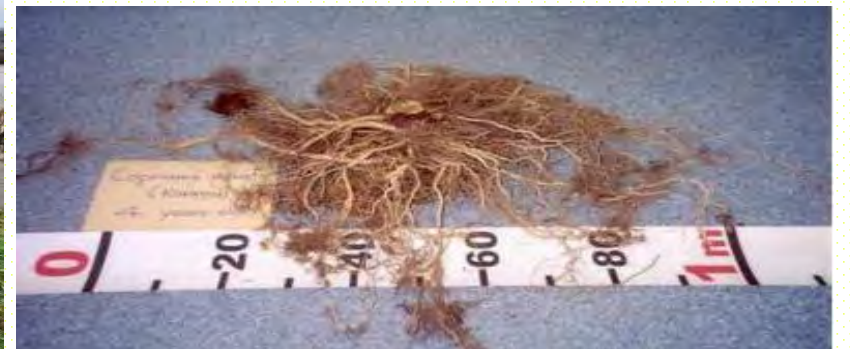
Four-year-old *Coprosma robusta* (Karamu) – 100 cm spread

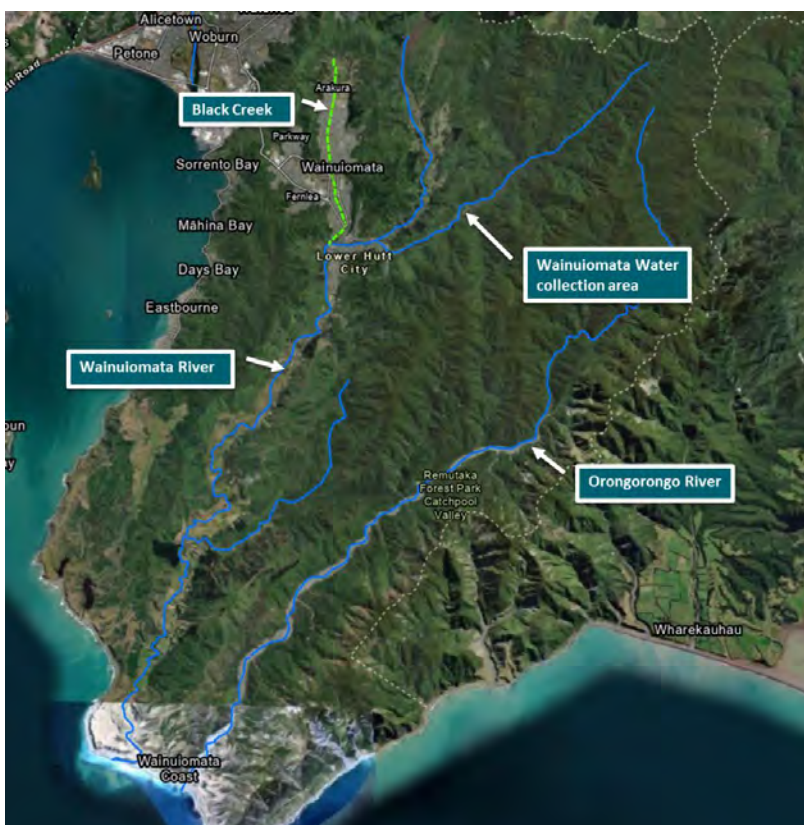
Figure 1 - Wainuiomata Map

6. **Black Creek** - Black Creek flows through the urban area of Wainuiomata to join the Wainuiomata River at the southern end of the suburb by Rotary Park.
7. **Wainuiomata River** - The Wainuiomata River flows from the Water Collection area through the south of the Wainuiomata urban area before following the valley and the coast road out to Baring head and Wainuiomata beach. There are no major urban areas in the rural portion of the catchment but a few isolated properties.

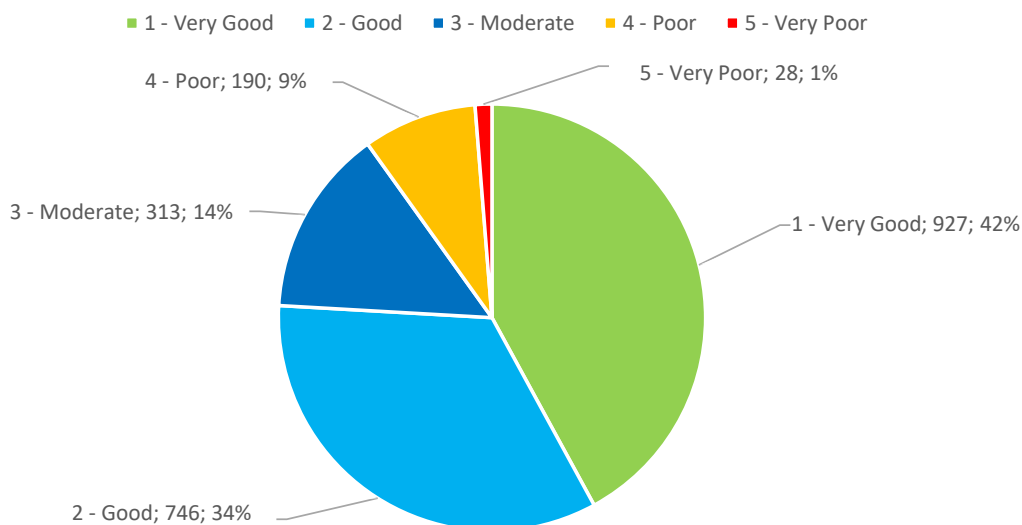
Figure 3. Summary of 2024 condition by grade.

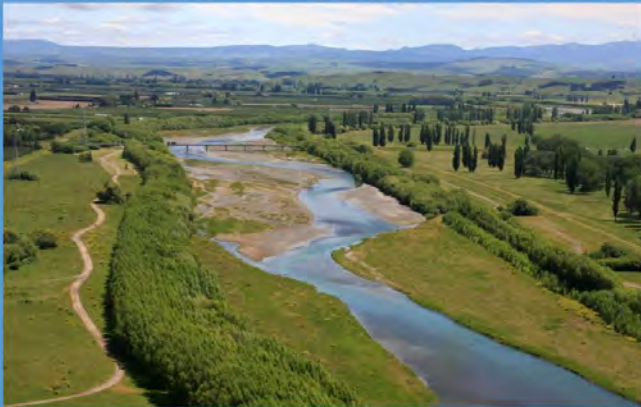
## Flood Protection Assets Performance Assessment Code of Practice

11. A comprehensive, national risk-based framework ([Figure 1](#)) is used to assess asset performance at 100-200m segments along both banks of the river. The output of the assessment produces a risk profile for each major flood protection scheme.
12. The national risk-based framework for assessing the performance of flood protection schemes was originally developed by the National River Managers

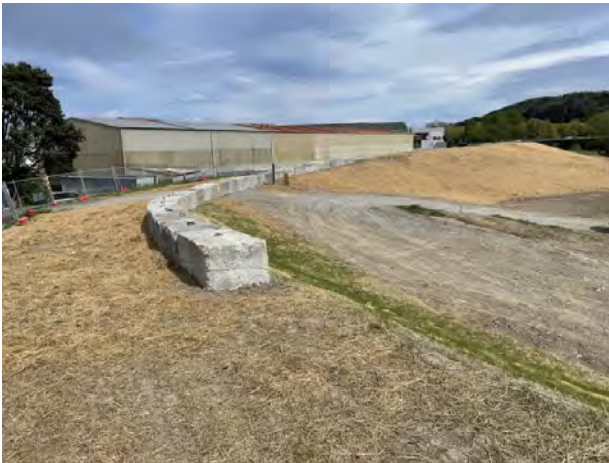
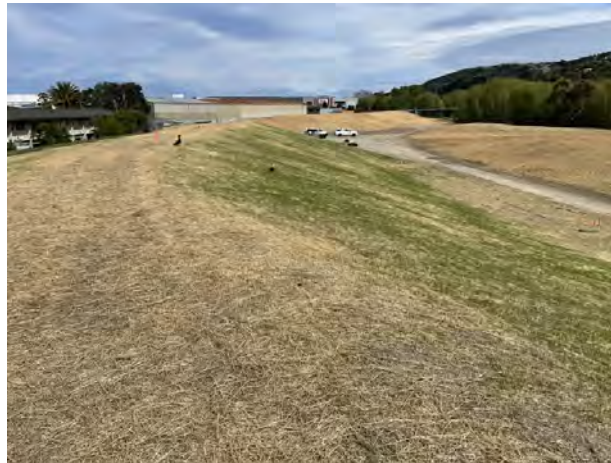
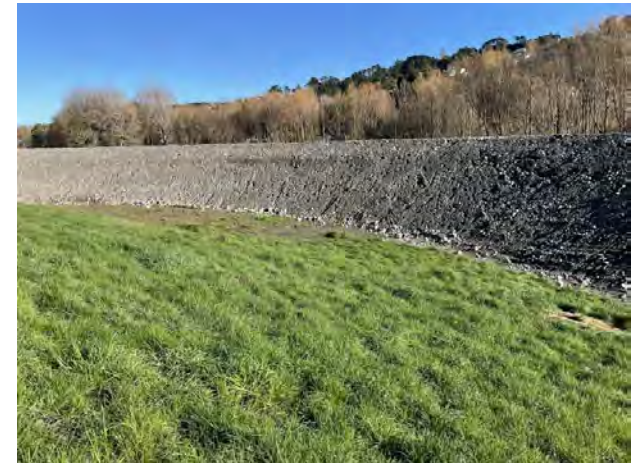
Site Progress Photos March 2024

- 2 small recent floods affected the site (2 year return period)
- Practical Completion given 4 October 2024
- Completing demobilisation and site handover
- Handover from Contractor to GW scheduled for end October.

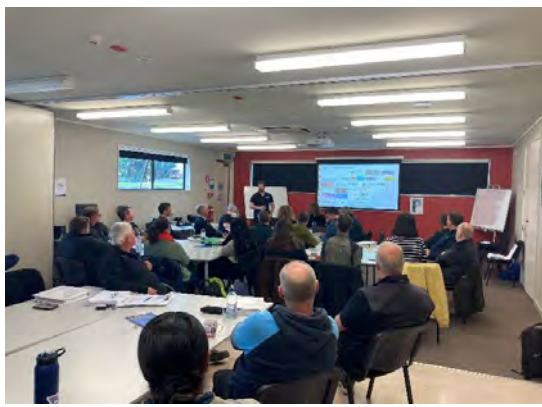
Figure 21 - Flood Incident Management Team receiving a briefing from the Group Controller.

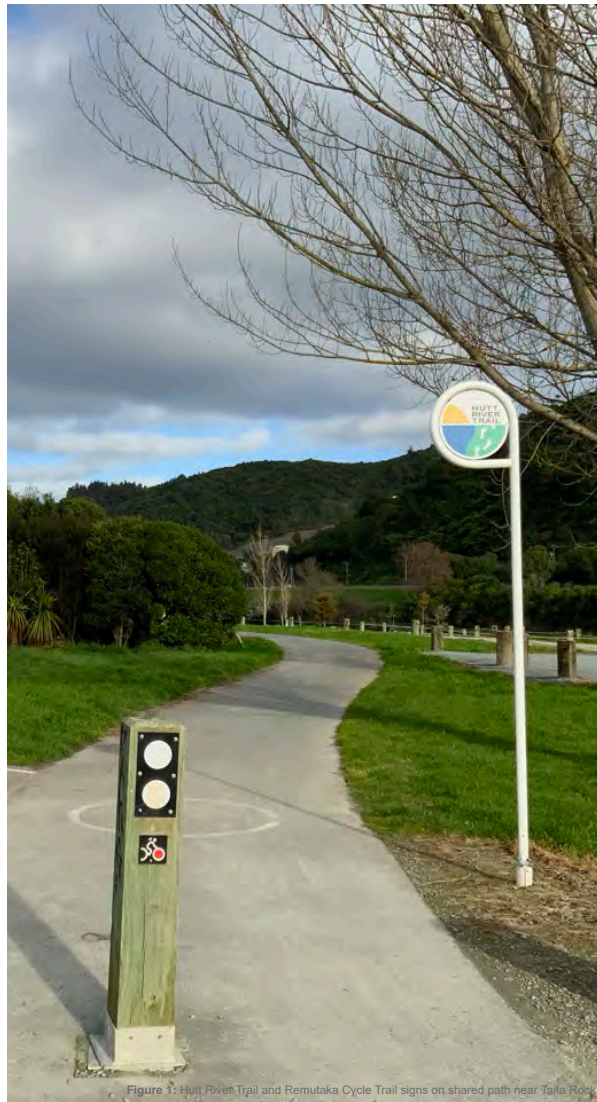
Figure 1: Hutt River Trail and Remutaka Cycle Trail signs on shared path near Taita Road

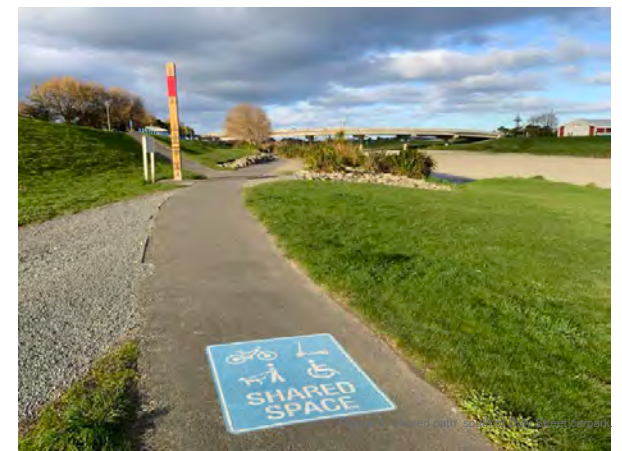
CROSS-SECTION - TRACK TYPES

Generally speaking, the following typical conditions (and any number of variations on these) are found along the length of the river.

9. The current state of the trails is a mix of sealed, compacted and loose gravel at a variety of widths. Creating a consistency of experience would benefit all users. Careful design and planning around separation and/or widening of the trail in certain areas would further alleviate concerns between different user groups.
