CERTIFIED FARM ENVIRONMENT PLAN – Example

Dairy Farm
PARKVALE CATCHMENT

Plan summary

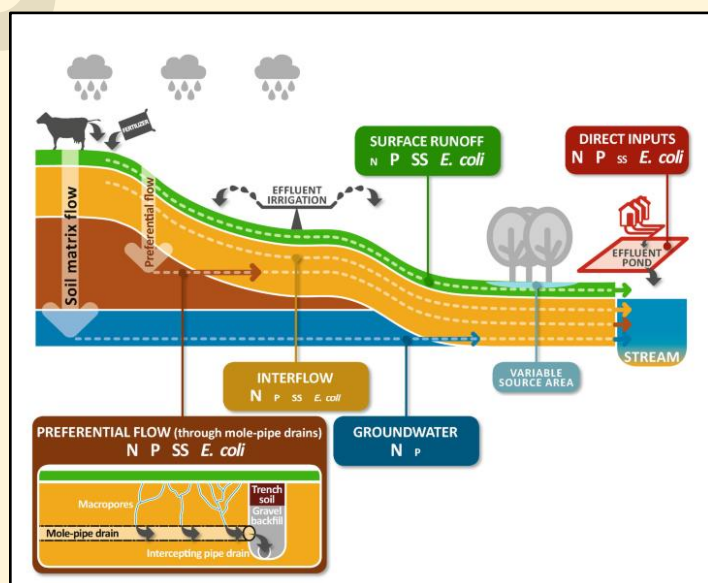
Figure 1 Source: www.lawa.org.nz

The loss of contaminants from land to water depends on several factors: availability of contaminants, presence of a transport pathway, and any treatment or reduction happening along the pathway. Both availability and transport can be significantly influenced by land use and land management. The main pathway for nitrogen loss is via leaching from the root zone of plants.

Phosphorus and microbial pathogens are principally lost to rivers and lakes via overland flow or artificial drainage. Sediment discharges result from a combination of eroded hill country, overland flows and riverbank and streambank erosion.

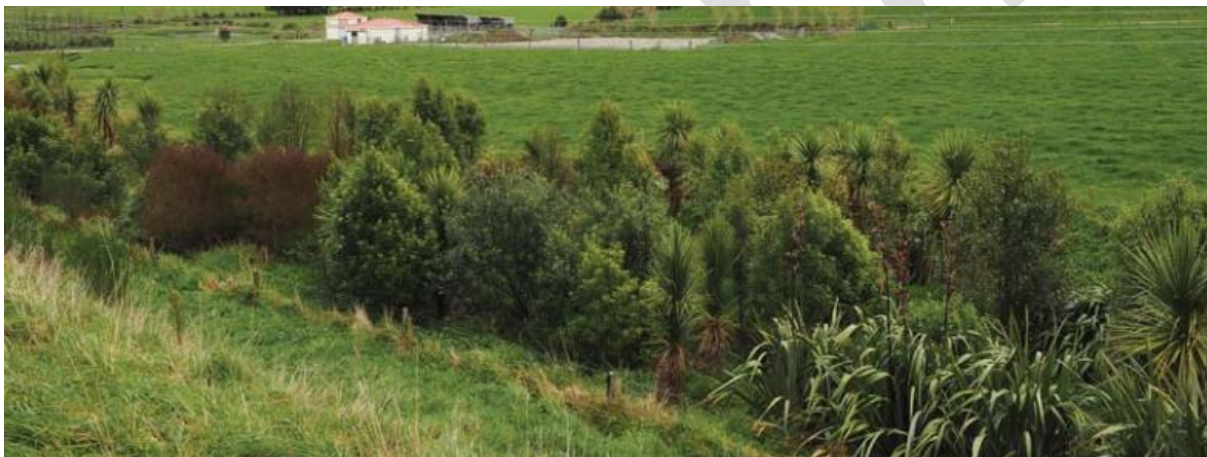
Picture above is of completed riparian planting, as a mitigation for E.Coli and sediment loss.

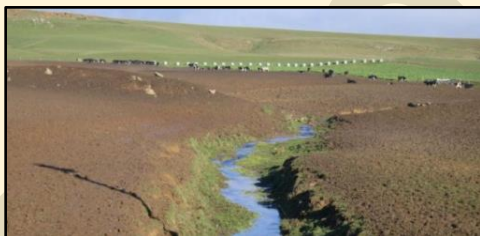
CSA Example: Post-winter grazing of an unprotected gully. (Note this photo was taken before IWG regulations came into effect)

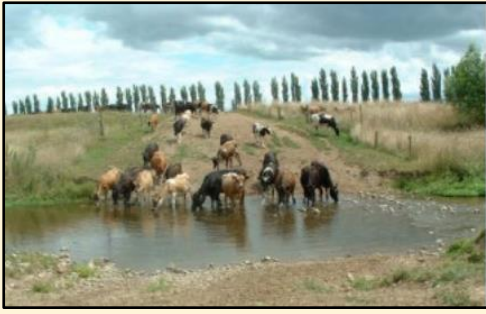
Point Source example: Due to their immediate proximity to surface water, the risk of contamination from these critical source areas is high.
