Appendix 2: Heritage Features Research Report

New Zealand Historic Places Trust Pouhere Taonga

Research Report on Heritage Features

Baring Head, Wellington

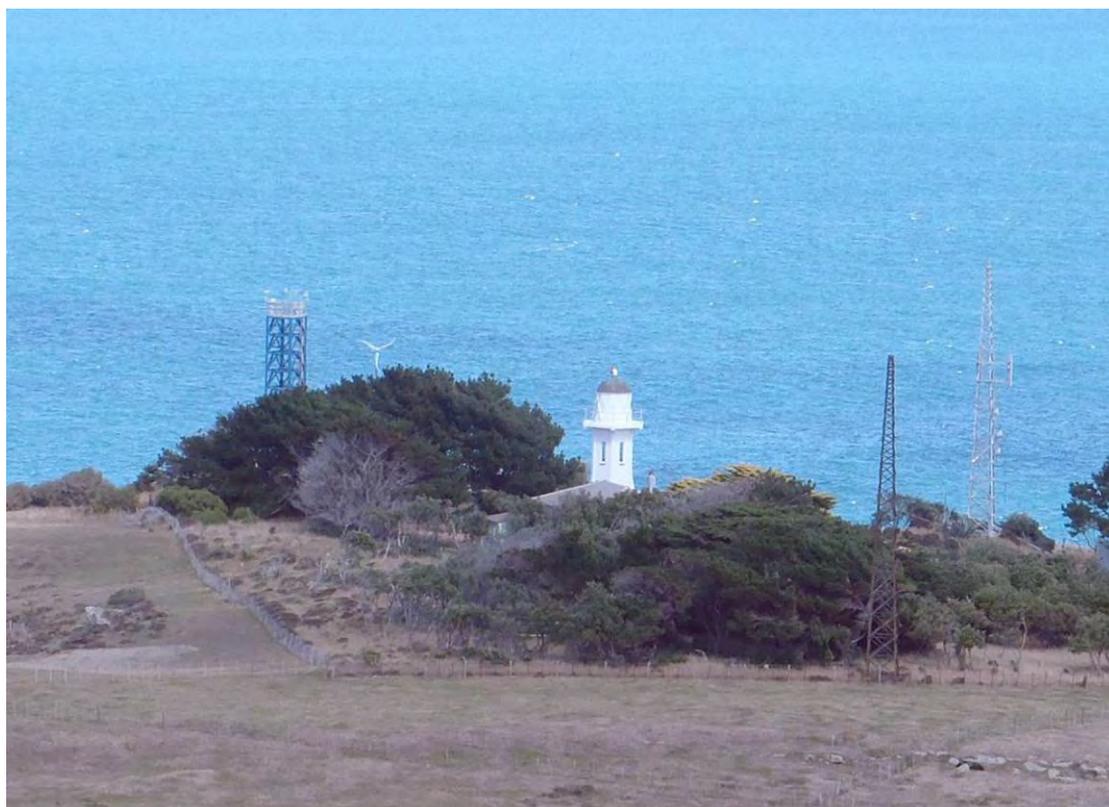
Baring Head Lighthouse Station from the trig behind. (K. Cox, NZHPT 17 February 2011)
