5.4. Appendix 4: Features contributing to heritage values

Name: Number One Keeper's House

Name: Baring Head Lighthouse

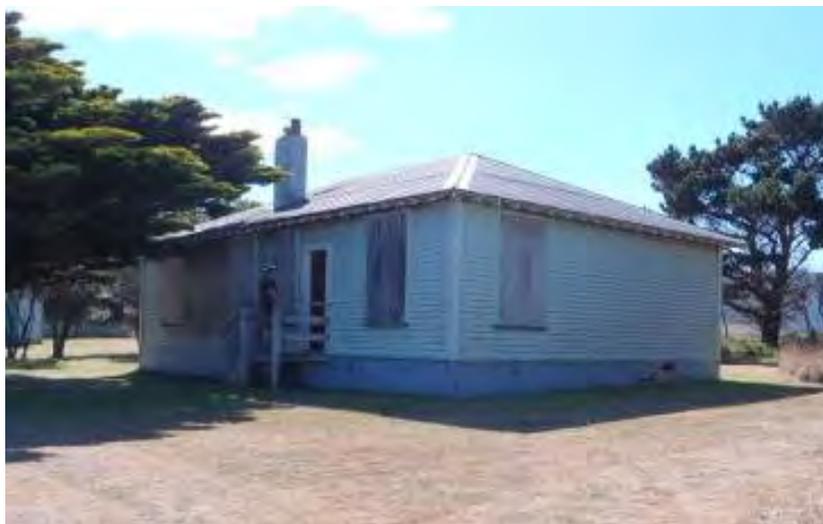
Images

The house rests on concrete piles. The hipped roof is of asbestos corrugated iron. The house is shielded to some extent from the northern aspect by a series of macrocarpa trees that were planted for this purpose. There is a porch at the rear with a lean to behind. The area between the house and the outhouses is concreted, and there is a small section of picket fence that runs from midway along the house out towards the centre of the outhouse. The remnants of the foundation of a garage are visible to the southeast of the house.

The front entrance to the house is through a door in the west elevation, which is reached by a short set of stairs and deck outside the door. There are two rooms off the front corridor. A small vestibule is created by a second door, with six panes of frosted glass in the upper panels. The first room, to the left of the corridor and past the second set of doors, was a sitting or dining room. There are two sets of windows lighting this room - double hung sashes with two lights below and six above - and this style of window is used throughout the house unless otherwise noted. There is a fireplace in this room which is backed by another fireplace in the other sitting room. Both these rooms have original varnished wooden joinery in them. The fireplace is flanked to the right by a cupboard which is again mirrored in the other parlour. There are four panelled doors.

house has had all windows and doors boarded up to protect against vandalism. For the same reason, the copper spouting has been removed.

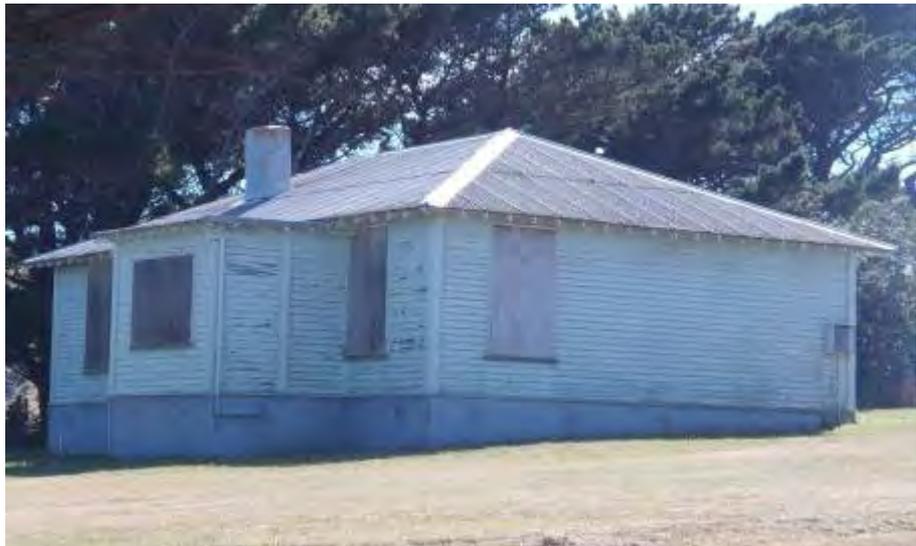
Images

This was the second keeper's house, and was built in a fashion very similar to the other house, being a timber framed and clad house of a state house design and similar to those built in New Zealand from the 1930s to the early 1950s. The second keeper was withdrawn in 1960 and from that date this house was used by visitors and relieving keepers.

Jones in his 2010 report.¹⁰⁸ This states that the interior is ostensibly the same as Number One Keeper's House, with 1980s wallpaper and painted wainscoting a noted difference between the two. Another notable difference between the two buildings is the addition of a third bedroom on the western elevation of the second house. Jones states that there was a similar addition to the first house that was subsequently removed. This house is more original than the first. The house has had all windows and doors boarded up to protect against vandalism. For the same reason, the copper spouting has been removed.

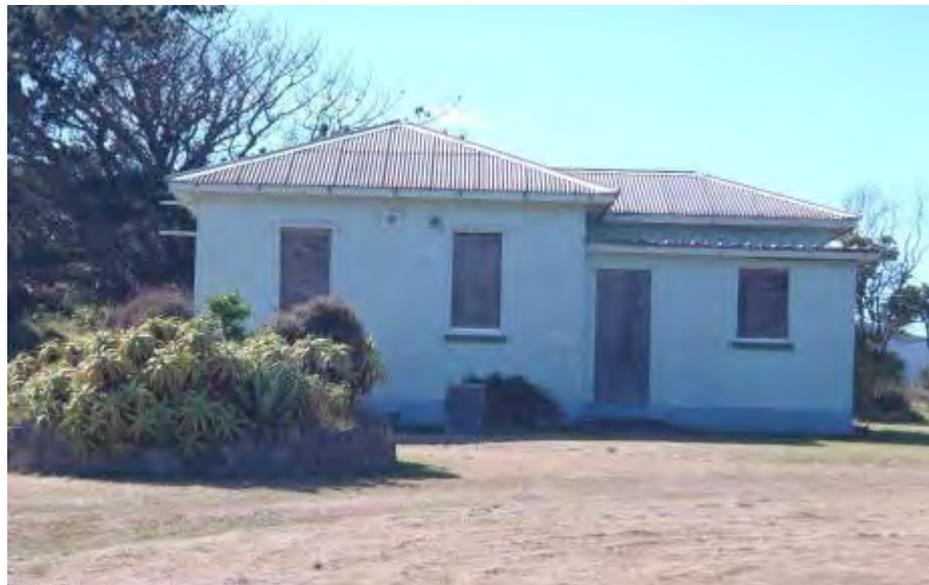
As part of the powering of the lighthouse (and the rest of the station) a building to house the diesel generators was required. The PWD opted to design the building in a domestic style to fit in with the two keepers' houses. Unlike the latter, this building was constructed in concrete, most likely to guard against fire. It is not known who built the structure. In 1948 work began on the construction of a power line to Baring Head. It was completed in 1950 and the diesel generators were no longer required, except perhaps as a back up. When they were removed is not known.

loading bay, a radio room, a generator room and what is probably a battery and electrical equipment room.’¹¹⁰ There is a plaque attached to the front wall of the building made from wood in the shape of a steering wheel of a boat. The roof is hipped and clad in corrugated asbestos sheets. Directly in front of the building is a circular garden enclosed in a stone wall.

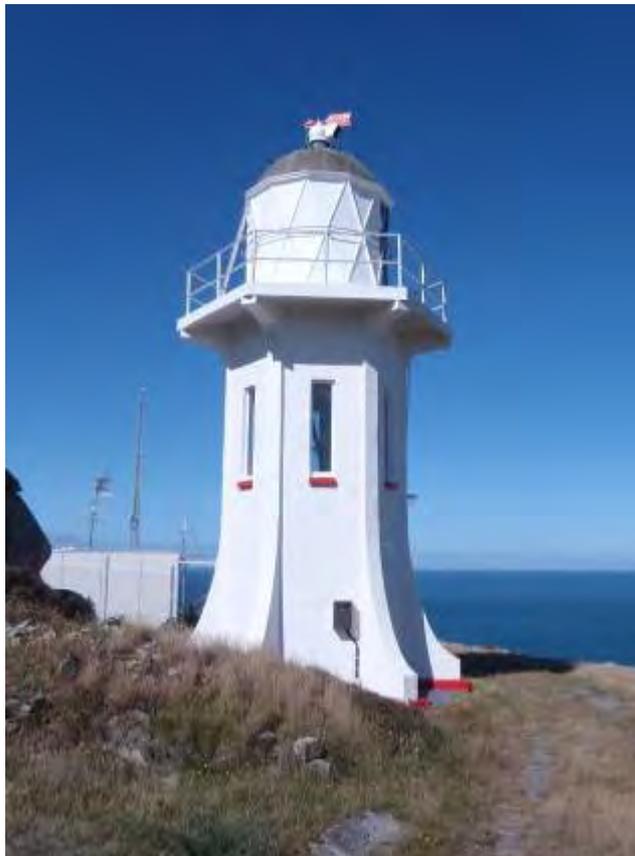
The lighthouse is situated at the edge of a cliff at the southern end of the station. It is 12 metres high, and 87 metres above the beach below. Its base is hexagonal, with fine buttresses tapering from the base to the platform approximately three quarters of the way up the structure. On each of the walls there are thin rectangular windows, each with a small sill below, currently painted red. There is an information panel on the door, summarising the history of the lighthouse. There is a safety barrier surrounding the platform that wraps around the structure and is reached by a ladder on the south-western side of the lighthouse. This platform provides access to the light. The present light is attached to the balcony, while the former light is enclosed within a series of triangular windows. These occur on the front of the light only (that is, the section facing the sea). The rear section (facing the lighthouse accommodation complex) is painted white, and possibly of the same material the lighthouse is constructed from. Above this is a copper dome. Apparently recently painted, the lighthouse is in good repair.

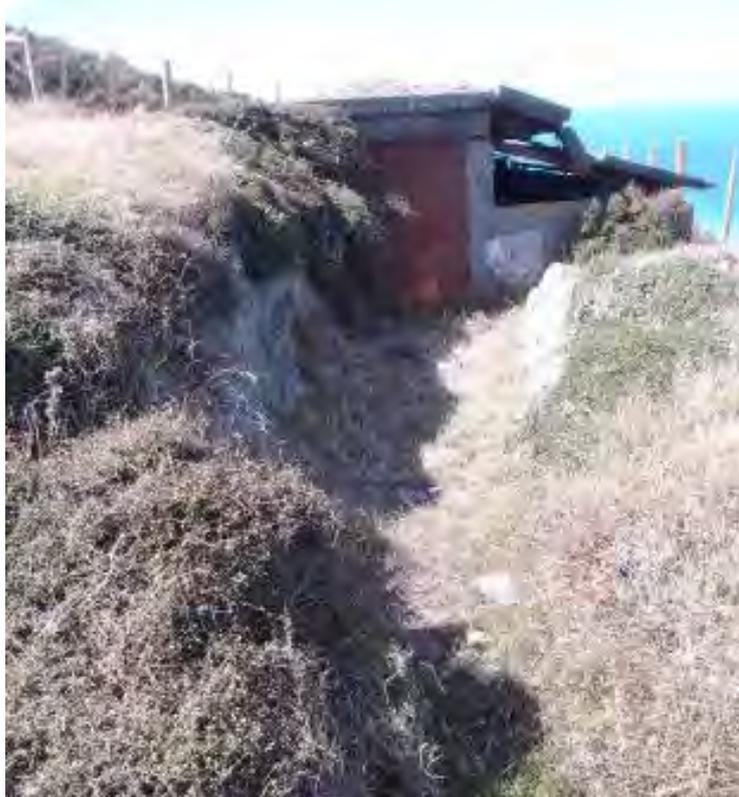
Observation post

The observation post was sunk into the western side of the hill just below the summit. Built of reinforced concrete it contains the plinth that supported the depression range finder. It retains part of its camouflage (a layer of earth and vegetation directly on its roof) but the cantilevered roof over the viewing slit has collapsed. Entrance to the building is from a pathway cut along its northern side.

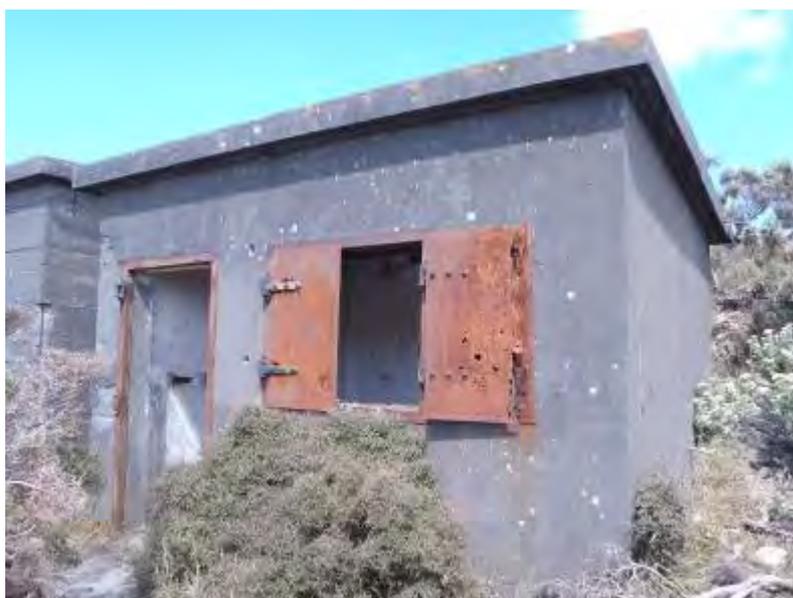
Wireless room

The wireless room is a rectangular (c.4 x 3m) reinforced concrete structure with rendered (plastered) walls. It has a mono pitched roof that slopes slightly to the rear. There is one door and window. The remains of the steel door are on the ground near the building, while the steel shutters for the windows remain in place. Both the doors and shutters are actively corroding. The slightly bigger possible mess room (c 5 x 3 m), has five windows and space for a double door, but none of these remain *in situ*. There are vents near the roof in the southern wall of the structure. Both buildings are fenced off from the public.

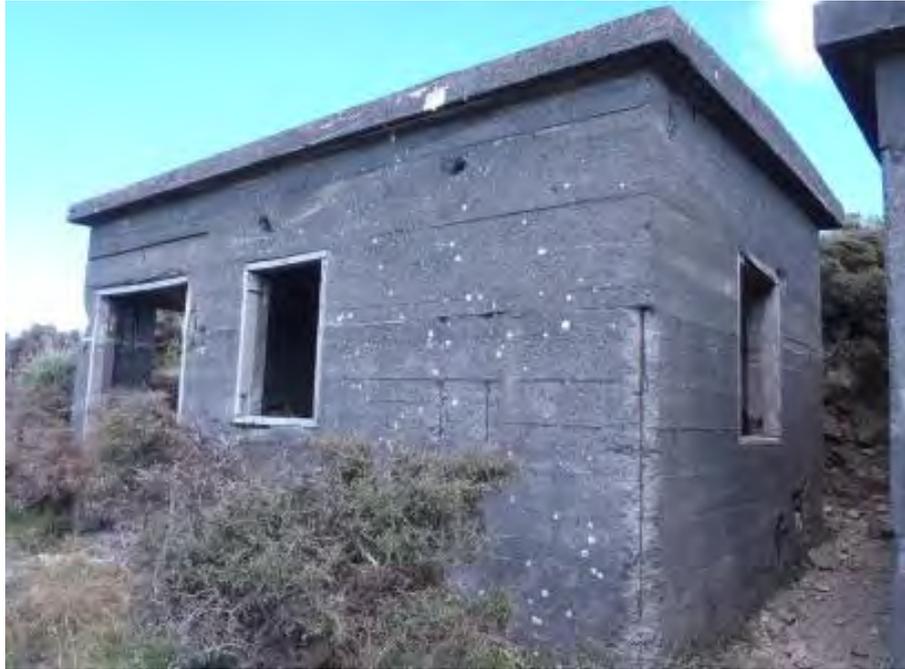
Unknown structure (possible mess)

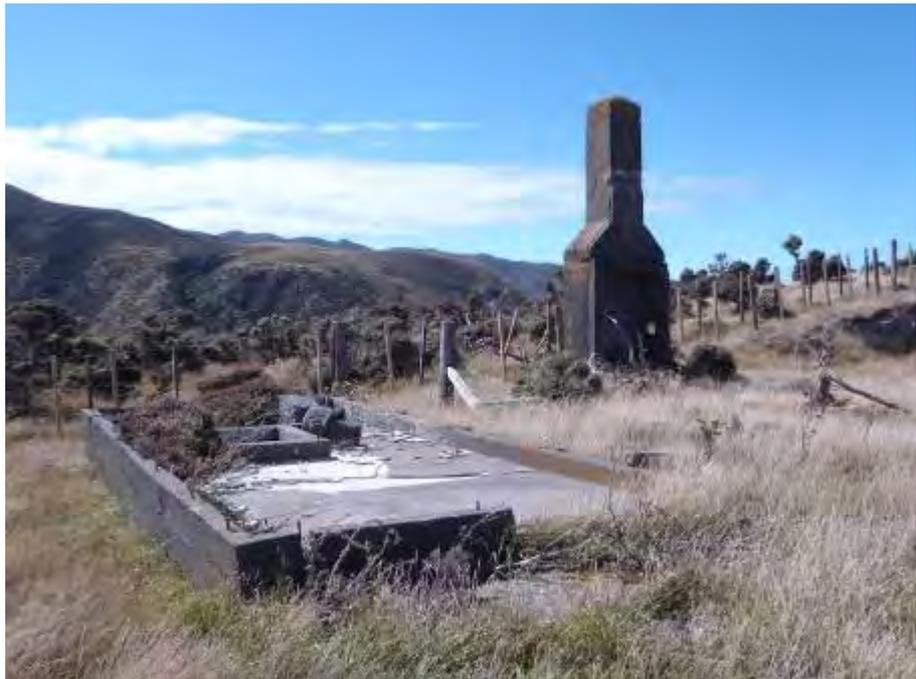
Remains of the ablutions block (foreground) and the site of the barracks to the right (with chimney extant)

The remnants of the ablution block and accommodation barracks for the men who staffed the observation post are located a short distance north and down the hill from the observation and engine room. The barracks is assumed to have been constructed of timber and is no longer evident bar a concrete

chimney. The ablutions block retains its concrete foundations, floor and drains, but is likewise missing its timber structure. Closer access to these buildings was not possible due to the danger of the collapse of the chimney. In the archaeological site recording form for these structures Walton notes that they are on a large artificially created terrace, and that the spoil from this has been dumped below and to the northwest of the terrace.¹¹⁸ Access to the ruins is restricted by a fence, as there are concerns about their structural integrity.

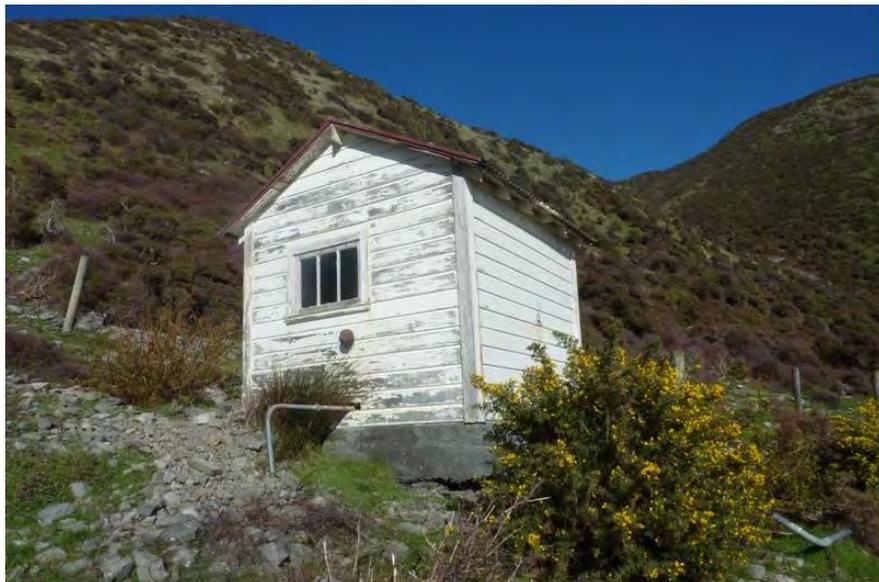
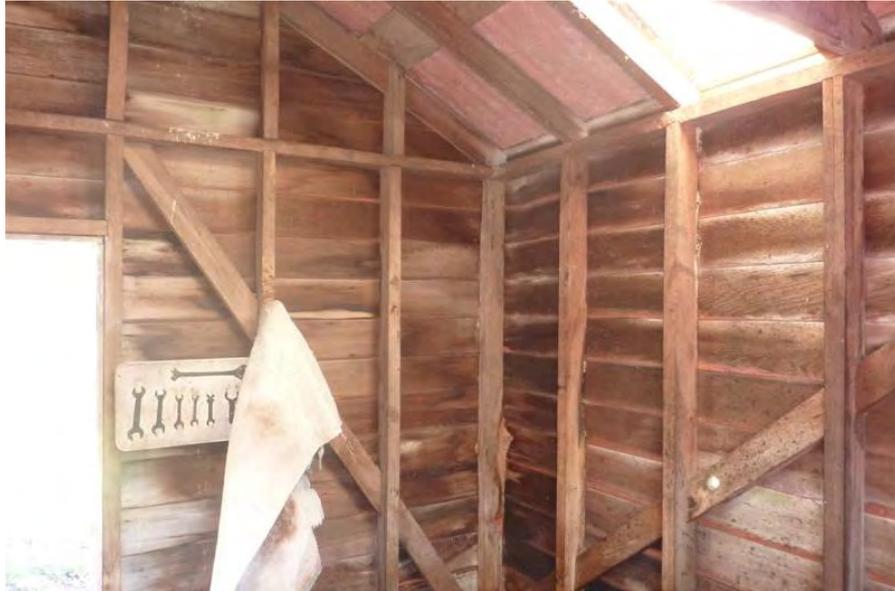
Images

The pumphouse was built about 1940 to extract water from the Wainuiomata River for use at Baring Head. From the river the water was pumped to the top of the Para trig where it was stored in a tank. From there it was distributed to the observation post buildings and down to the lighthouse station complex and naval signal station. Following the end of the war, water continued to be pumped to Baring Head from the stream. When it was ceased to function is not known but the pumphouse remains in situ as do many of the galvanised pipes that carried the water and the water tank (see Fortress Observation Post).

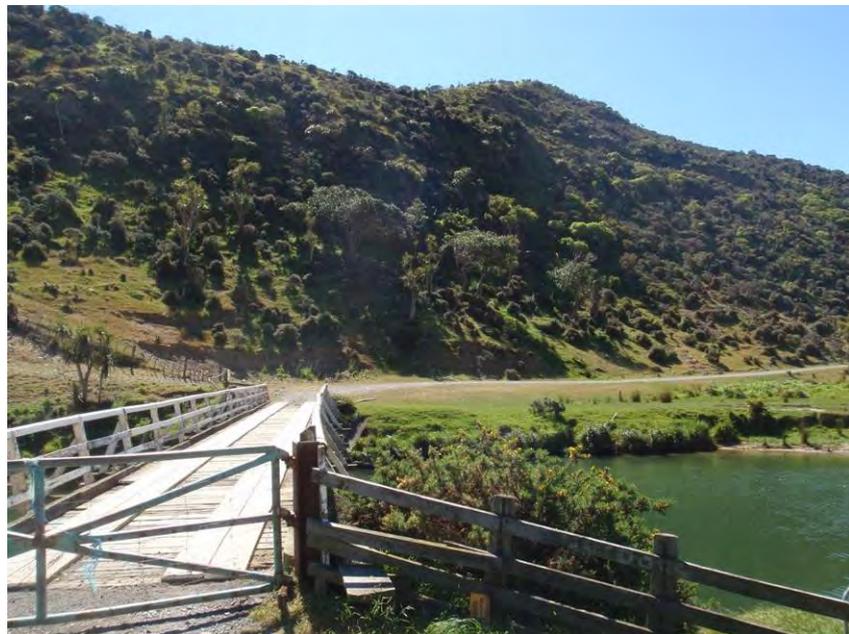
Images

The contract for the bridge over the Wainuiomata River was won by S.T. Dibble, and work took about the same time as the road, finishing in early 1932. It was not without its difficulties; piles were driven into the river bed but hard rock was located much deeper down than anticipated. It meant that sections of timber had to be spliced on to reach the bedrock. A trestle bridge, it was built with Australian hardwood. The bridge has been much repaired over its life but it has continued to provide one of the key access ways to the lighthouse, particularly during its early decades. Likewise the road has suffered from weather events that have undermined it but it continues to function as it always has.

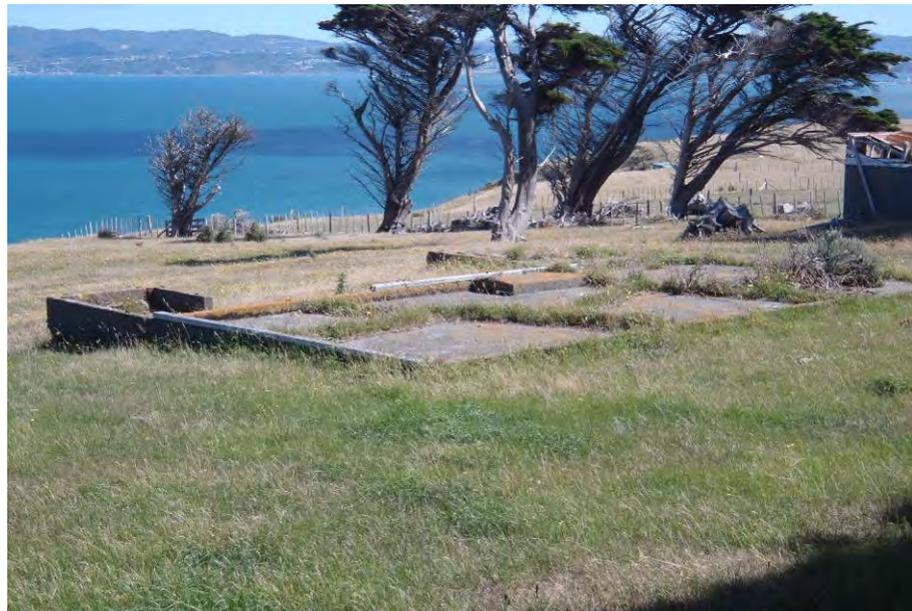
Images

A naval signal station (or Port War Signal Station), was established at Baring Head c.1942, right alongside the lighthouse itself. It was staffed mainly by WAACs, and a timber barracks building was constructed for them, to the west of the station complex, a short distance from the garage. The station closed in 1945 and presumably the WAACs also left at the same time. The building was also removed at about this time, leaving behind the concrete foundations.

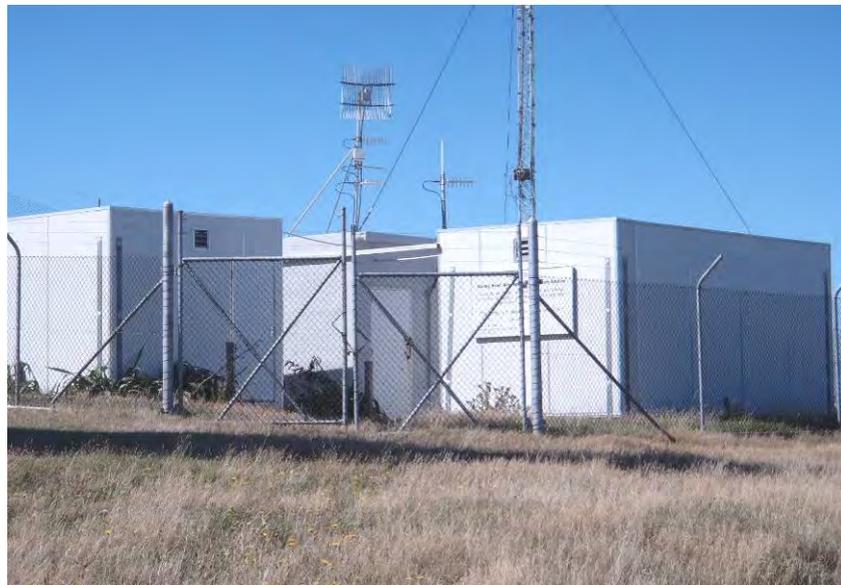
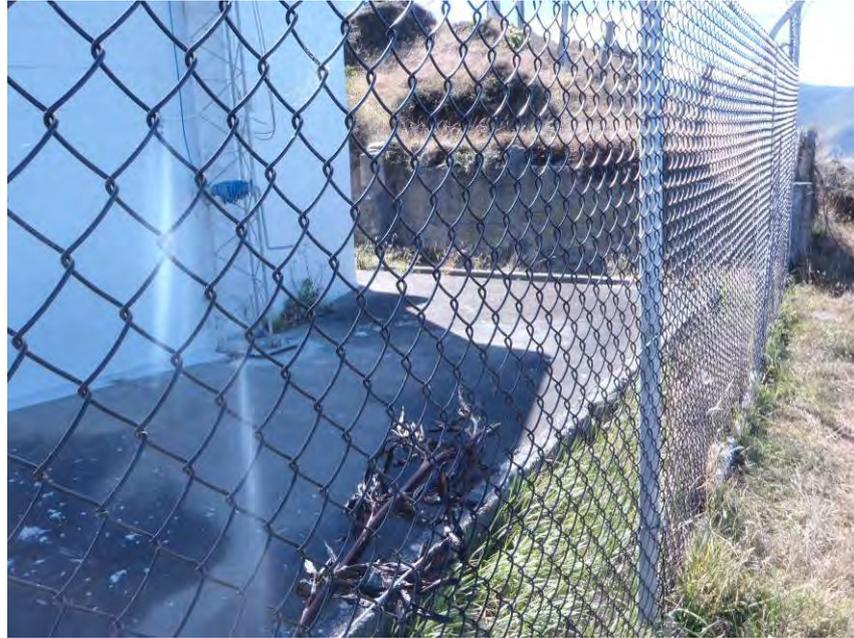
Images

The air monitoring station at Baring Head was established by the DSIR in 1974. It was preceded on the site by the naval signal station (or Port War Signal Station), established in c.1942 and staffed mainly by WAACs, and then by a DSIR research facility (using the signal station building) conducting experiments on radar. At some point before or after the DSIR took over the site, the concrete signal station buildings were demolished to their platform and new buildings, largely small boxes built from concrete blocks and fibrolite, were constructed on top and immediately to the west. A tower was built to the rear of this complex. NIWA, which was formed after the DSIR was broken into various Crown research organisations in 1992, took over the Baring Head site and continues to manage the facility. In its own words, the station, known as the Baring Head Clean Air Monitoring Station, makes 'significant contributions to our global understanding of greenhouse gases, other trace gases and related species in air that is representative of the mid latitude southern hemisphere.'¹²³
