**BEFORE THE PORIRUA CITY COUNCIL
AND GREATER WELLINGTON REGIONAL COUNCIL**

**STATEMENT OF EVIDENCE OF KYLE JOHN CHRISTENSEN ON
BEHALF OF THE APPLICANT**

Annex 1 - Extent of Erosion Protection Works Reach by Reach Figures

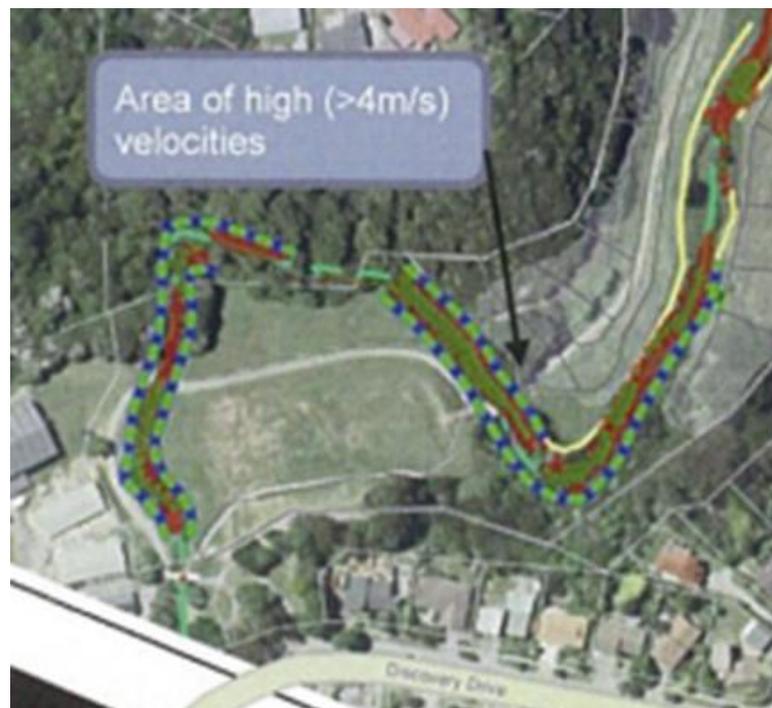
Figure 1 - Reach 1 Upstream of Site (Samuel Marsden)

Reach 1 – Upstream of Site (Samuel Marsden) Figure 1 (See Annex 1)

18. Mr Joseph has recommended rock lining almost this entire reach. I do not consider this appropriate or necessary. Firstly, the majority of this reach is outside the property boundary of the proposed development and is not being affected by the proposed works. Secondly there is mature vegetation on both sides of the channel in this reach and inspection of aerial photographs from 2002 suggests it has been stable for at least the past decade. Mr Joseph has also extended the rock proposed by Cardno on the right bank, near the downstream end of the reach, to extend all the way back to the bend. I do not consider this extent of rock is necessary in what is a straight and relatively stable reach of the creek.

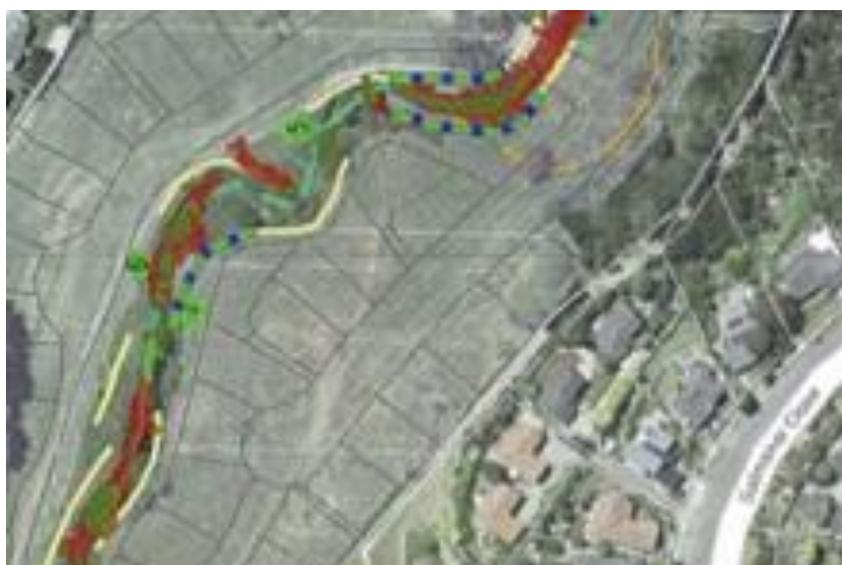
Figure 2 – Reach 2 Upstream of Bridge Nr. 3

Reach 2 – Upstream of Bridge Nr.3 Figure 2 (See Annex 1)

19. Mr Joseph has recommended additional rock protection work on the inside of two of the bends in this reach as well extending the rock protection upstream of Bridge Nr. 3. I don't consider that rock protection is required on the inside of bends and I am satisfied that the rock length for the bridge is appropriate also noting that we have provided rock protection to the earthworks batter in this location rather than to the creek bank itself.

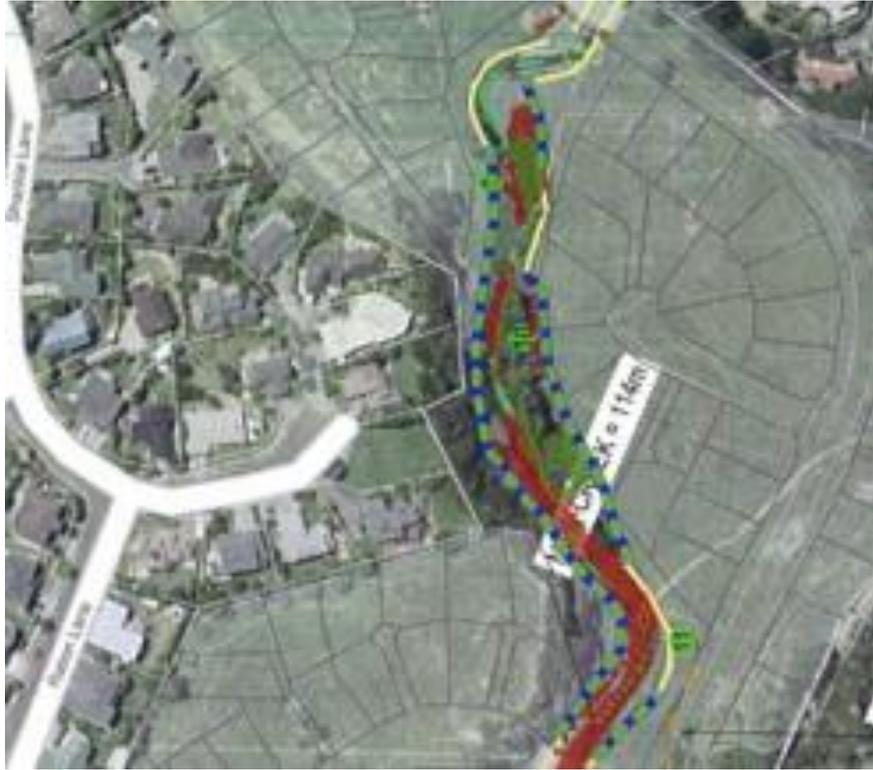
Figure 3 – Reach 3 Between Bridges Nr.2 and Nr.3

Reach 3 – Between Bridges Nr. 2 and Nr 3 (see Annex 1)

20. Mr Joseph has recommended rock lining most of this reach. Most of this reach has mature vegetation that has been stable for the past decade and the proposed landscape plan (Cardno drawing NZ0115065-PL-C800) provides extensive planting through this reach. It is also worth highlighting that the key areas around the outside of the bends have a mixture of vegetative protective cover and rock protection for the new earthworks batter. Accordingly, I don't consider rock lining of this reach as necessary.

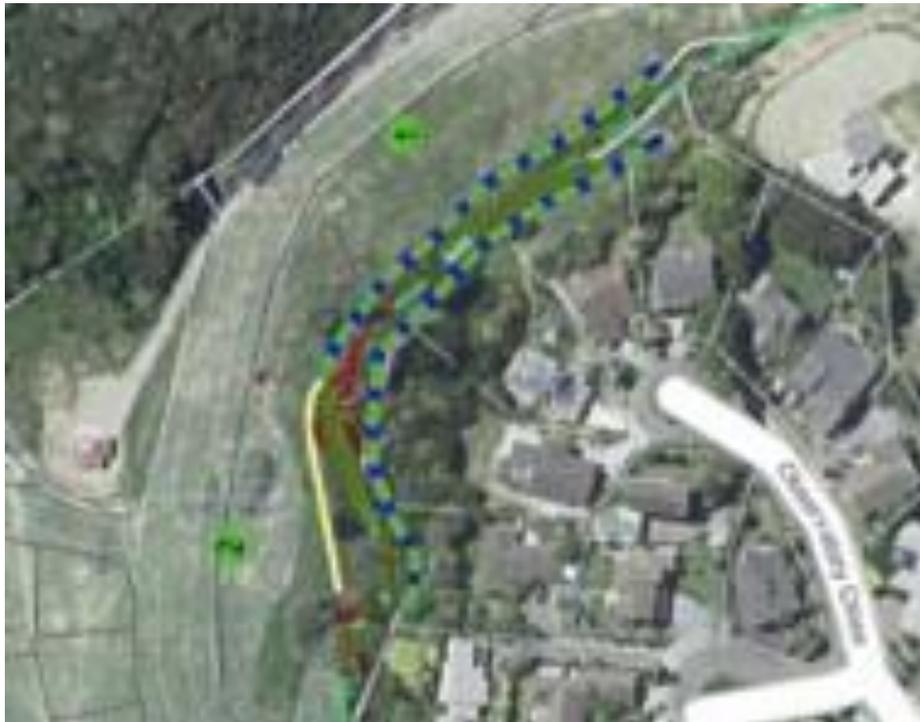
Figure 4 – Reach 4 Between Bridges Nr.1 and Nr.3

Reach 4 - Between Bridges Nr.1 and Nr.3 (see Annex 1)

21. Mr Joseph has recommended rock lining most of this reach. Similar to the reach immediately upstream there is mature vegetation through much of this reach and the extension of the proposed riparian restoration and planting through this reach will provide some additional protection. It is also noted that this is a relatively straight and stable reach of the creek and that engineered vegetative cover is provided in the current Cardno design to protect the earthworks batter.
