Peer Review of Greater Wellington Flood Protection Assets

By Horizons Regional Council 19 & 20 June 2008

Report prepared by Paul Joseph and John Eyles, September 2008

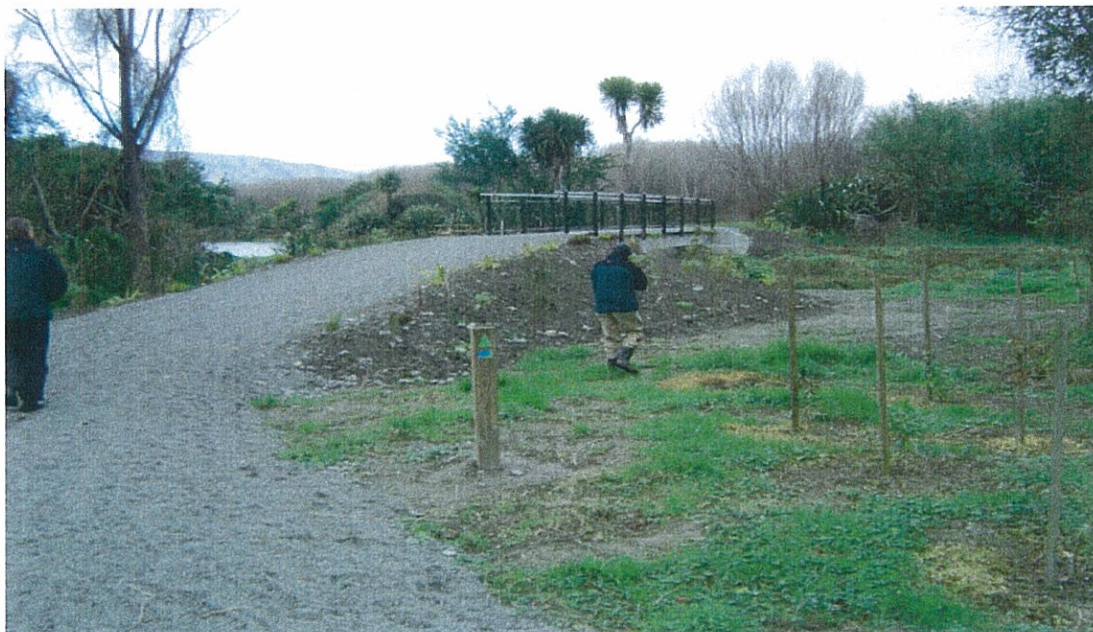
HRC were impressed in the environmental enhancement work on the Otaki, particularly the pedestrian walkway, bridge, native plantings and overall community engagement. HRC also understood that the time required to organise this level of community engagement was considerable, and could require a dedicated staff member to manage. HRC were also interested in the “Great Gravel Grab” programmes run by GW from time to time to publicise flood protection activities.
