# **ASSESSMENT OF LIQUEFACTION AND GROUND FAILURE HAZARDS IN THE GREATER WELLINGTON REGION, 1992-1993**

## **STAGE 1**

**IGNS CONTRACT REPORT No 1992/84**

*The Wellington Regional Council*

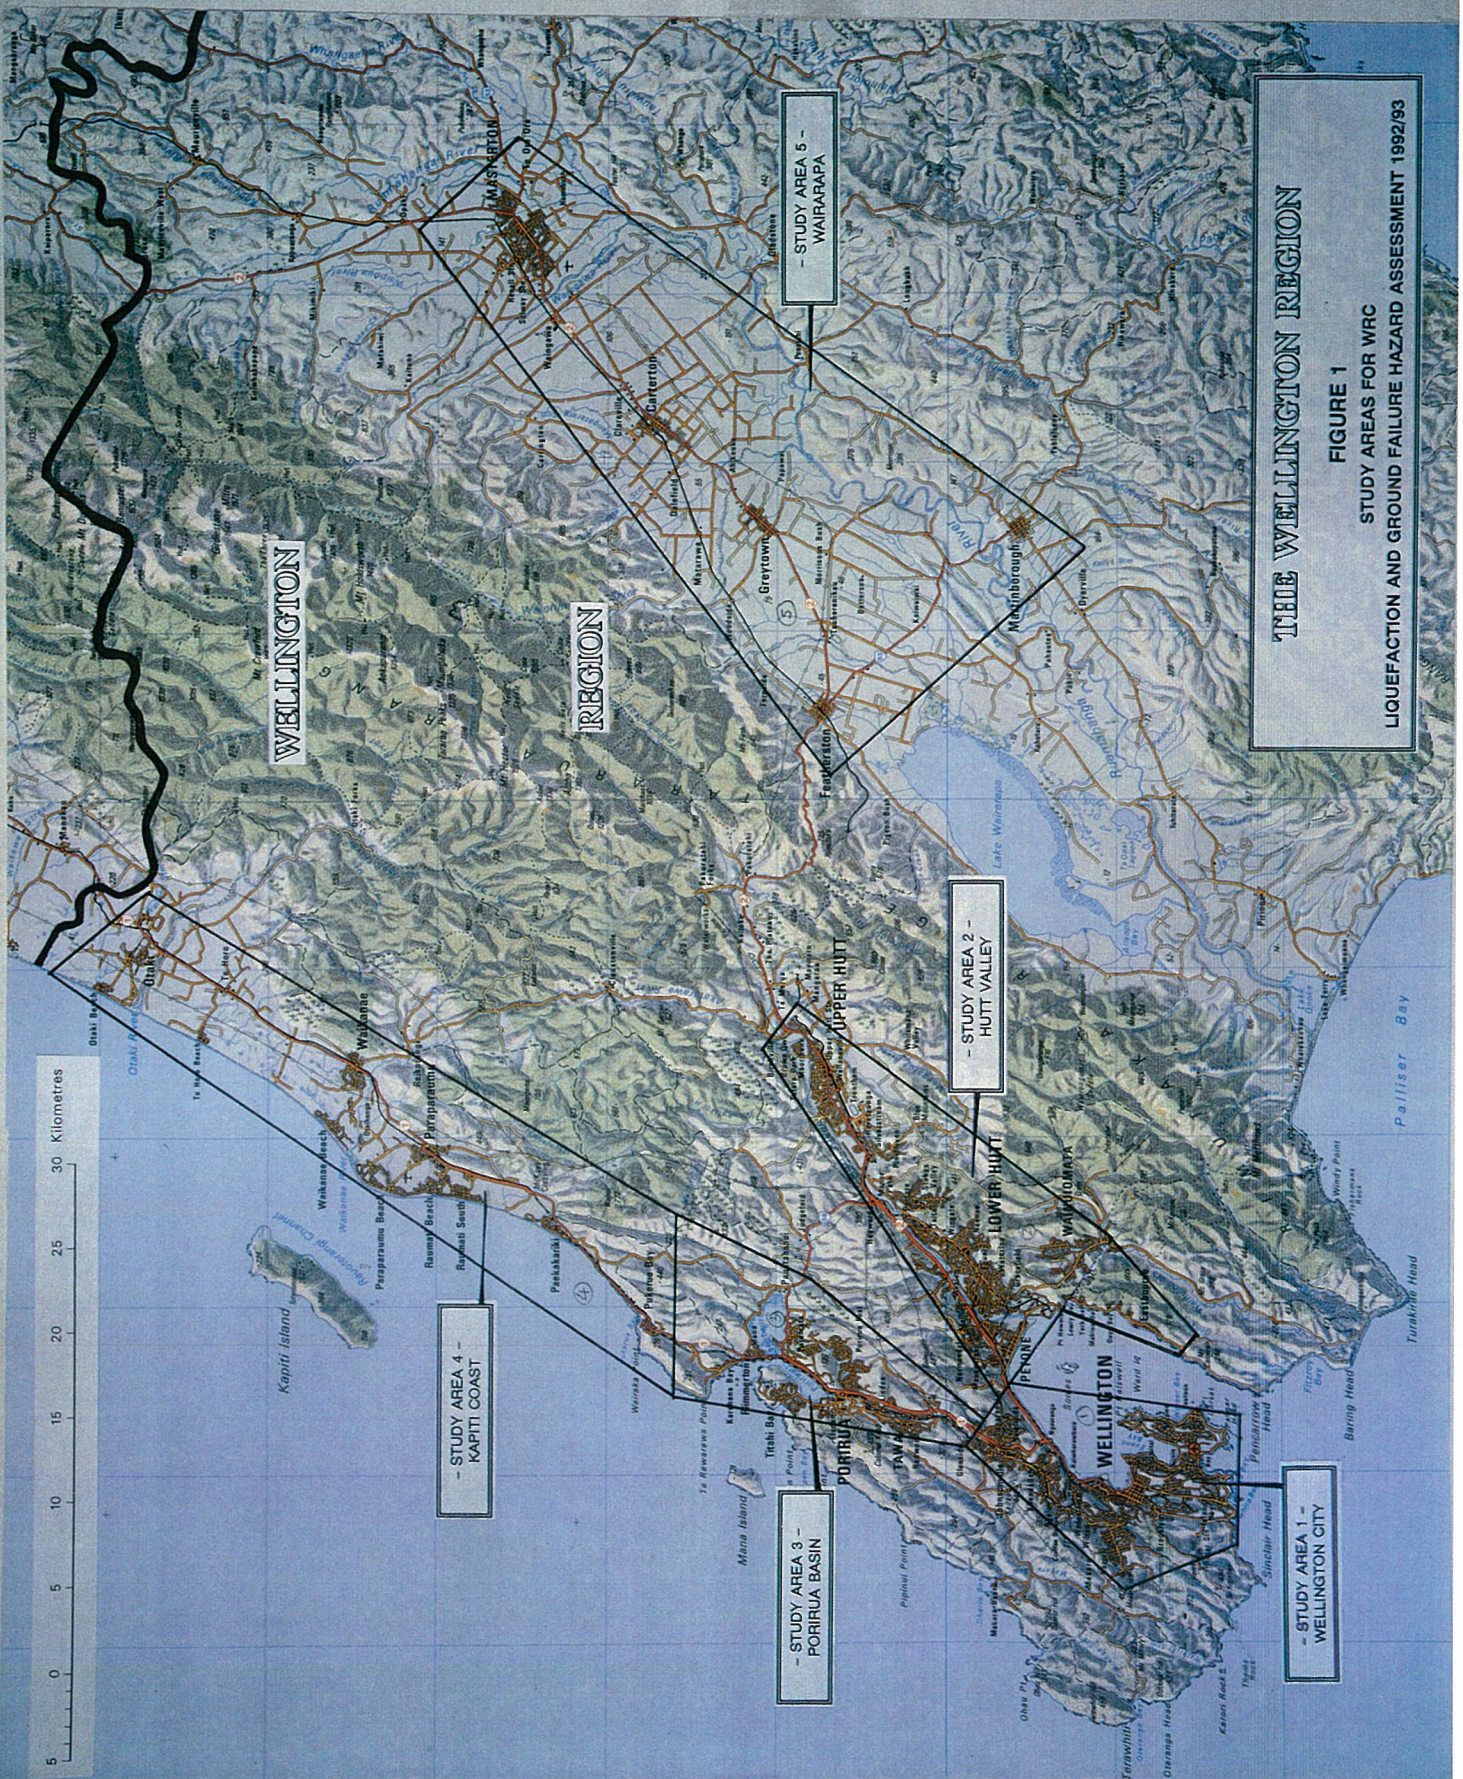
Widespread subsurface liquefaction was indicated by the ejection of sand, silt and water from linear cracks and holes in the ground forming sand boils (Figure 2), and more significant ground damage was indicated by well developed fissures, sand ejections, and lateral spreading failures along the banks of river and stream channels, particularly along the banks of the Whakatane and Rangitaiki rivers.

**FIGURE 2:** Distribution of ground damage across the Rangitaiki Plains after the 1987 Edgecumbe earthquake.
