## **FILE NOTE**

DATE	2 April 2025
AUTHOR	Ella Boam – Senior Project Manager, Investigations
SUBJECT	Waipoua River flood risk management - geotechnical report addendum

This file note acts as an addendum to the 'Stage 2 Report - Stopbanks Assessment, Waipoua River Stopbanks, Masterton' report that was prepared by ENGEO in October 2024. This note contextualises the conclusions presented in the report and highlights key points made in the Stage 1 Report – Preliminary Desktop Review, Waipoua River Stopbanks, Masterton, which was prepared by ENGEO in May 2024.

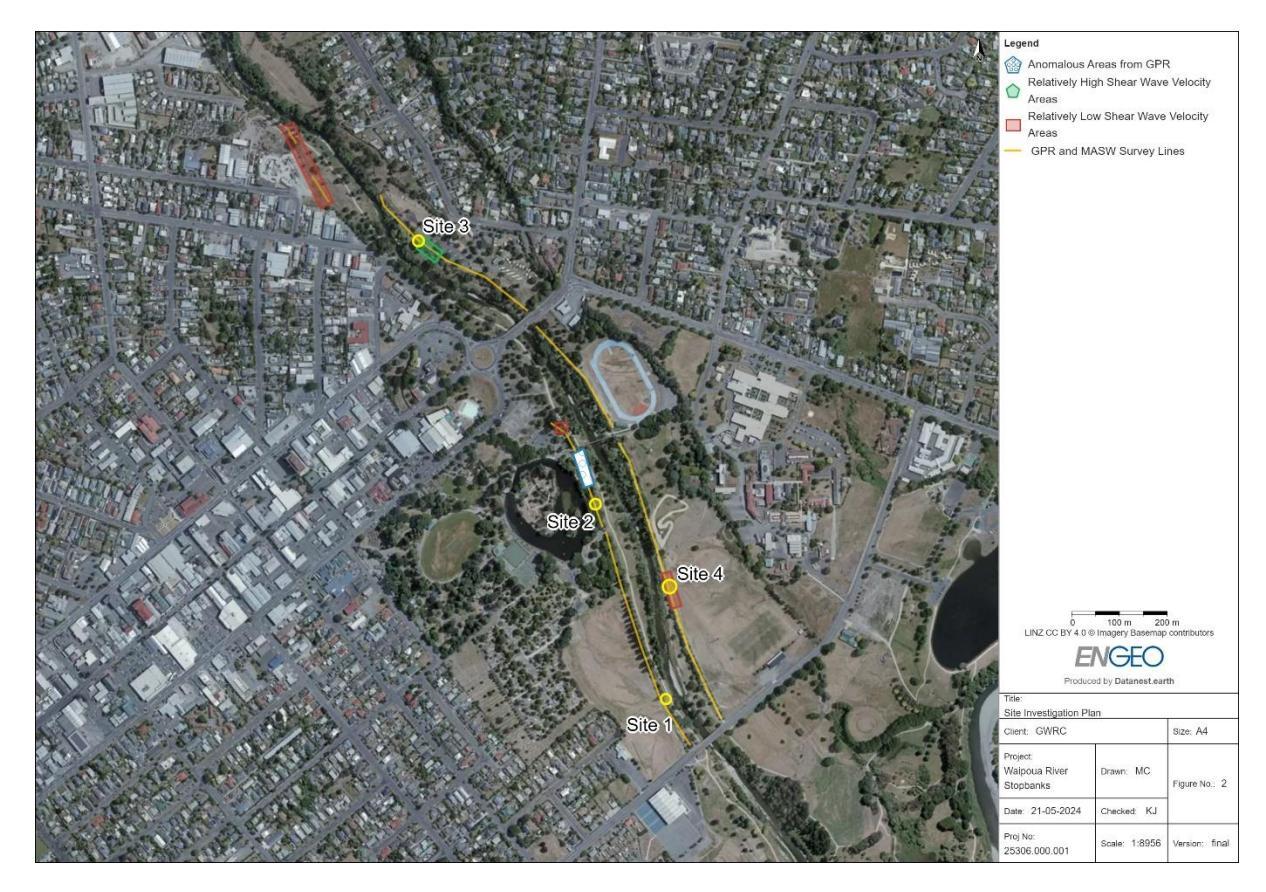
## Figure 2: Site Investigation Locations (Cardno, 2015)

The GPR survey also showed anomalous areas at the western stopbank near the lake at Queen Elizabeth Park. Based on the hyperbolic diffractions, they are inferred to be either large, buried utilities or tunneling voids. The location of the anomalous area is shown in site investigation plan in Figure 2.

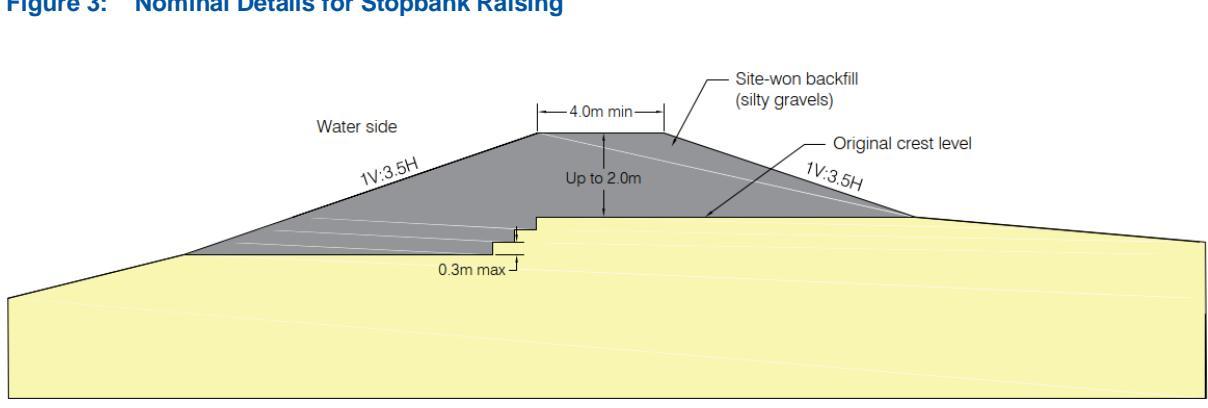
#### Figure 3: Nominal Details for Stopbank Raising

The new stopbanks are proposed to be constructed to a height of 1.0 m above the flood levels provided (i.e. to achieve 1.0 m freeboard). As the existing stopbank crest levels vary, the raised height of the stopbank will also vary. A maximum height of approximately 2.0 m was considered. We have included a conceptual stopbank profile as shown in Figure 3, which is based upon the International Levee Handbook (CIRIA, 2013). This stopbank profile has been included in our analysis model for seepage and stability assessment with soil properties as shown in Table 5 and Table 7. The raised stopbank geometries are to be confirmed during detailed design.

Site-won silty gravel materials can be used as backfill; however, it shall have engineering properties complying with those stated in Table 15. The raised stopbank should be keyed into the existing stopbank as per the nominal details shown in Figure 3. We recommend that a topographical survey is carried out along the stopbanks to be raised to obtain the up-to-date stopbank crest levels. This is to confirm the required stopbank raising height and extents.

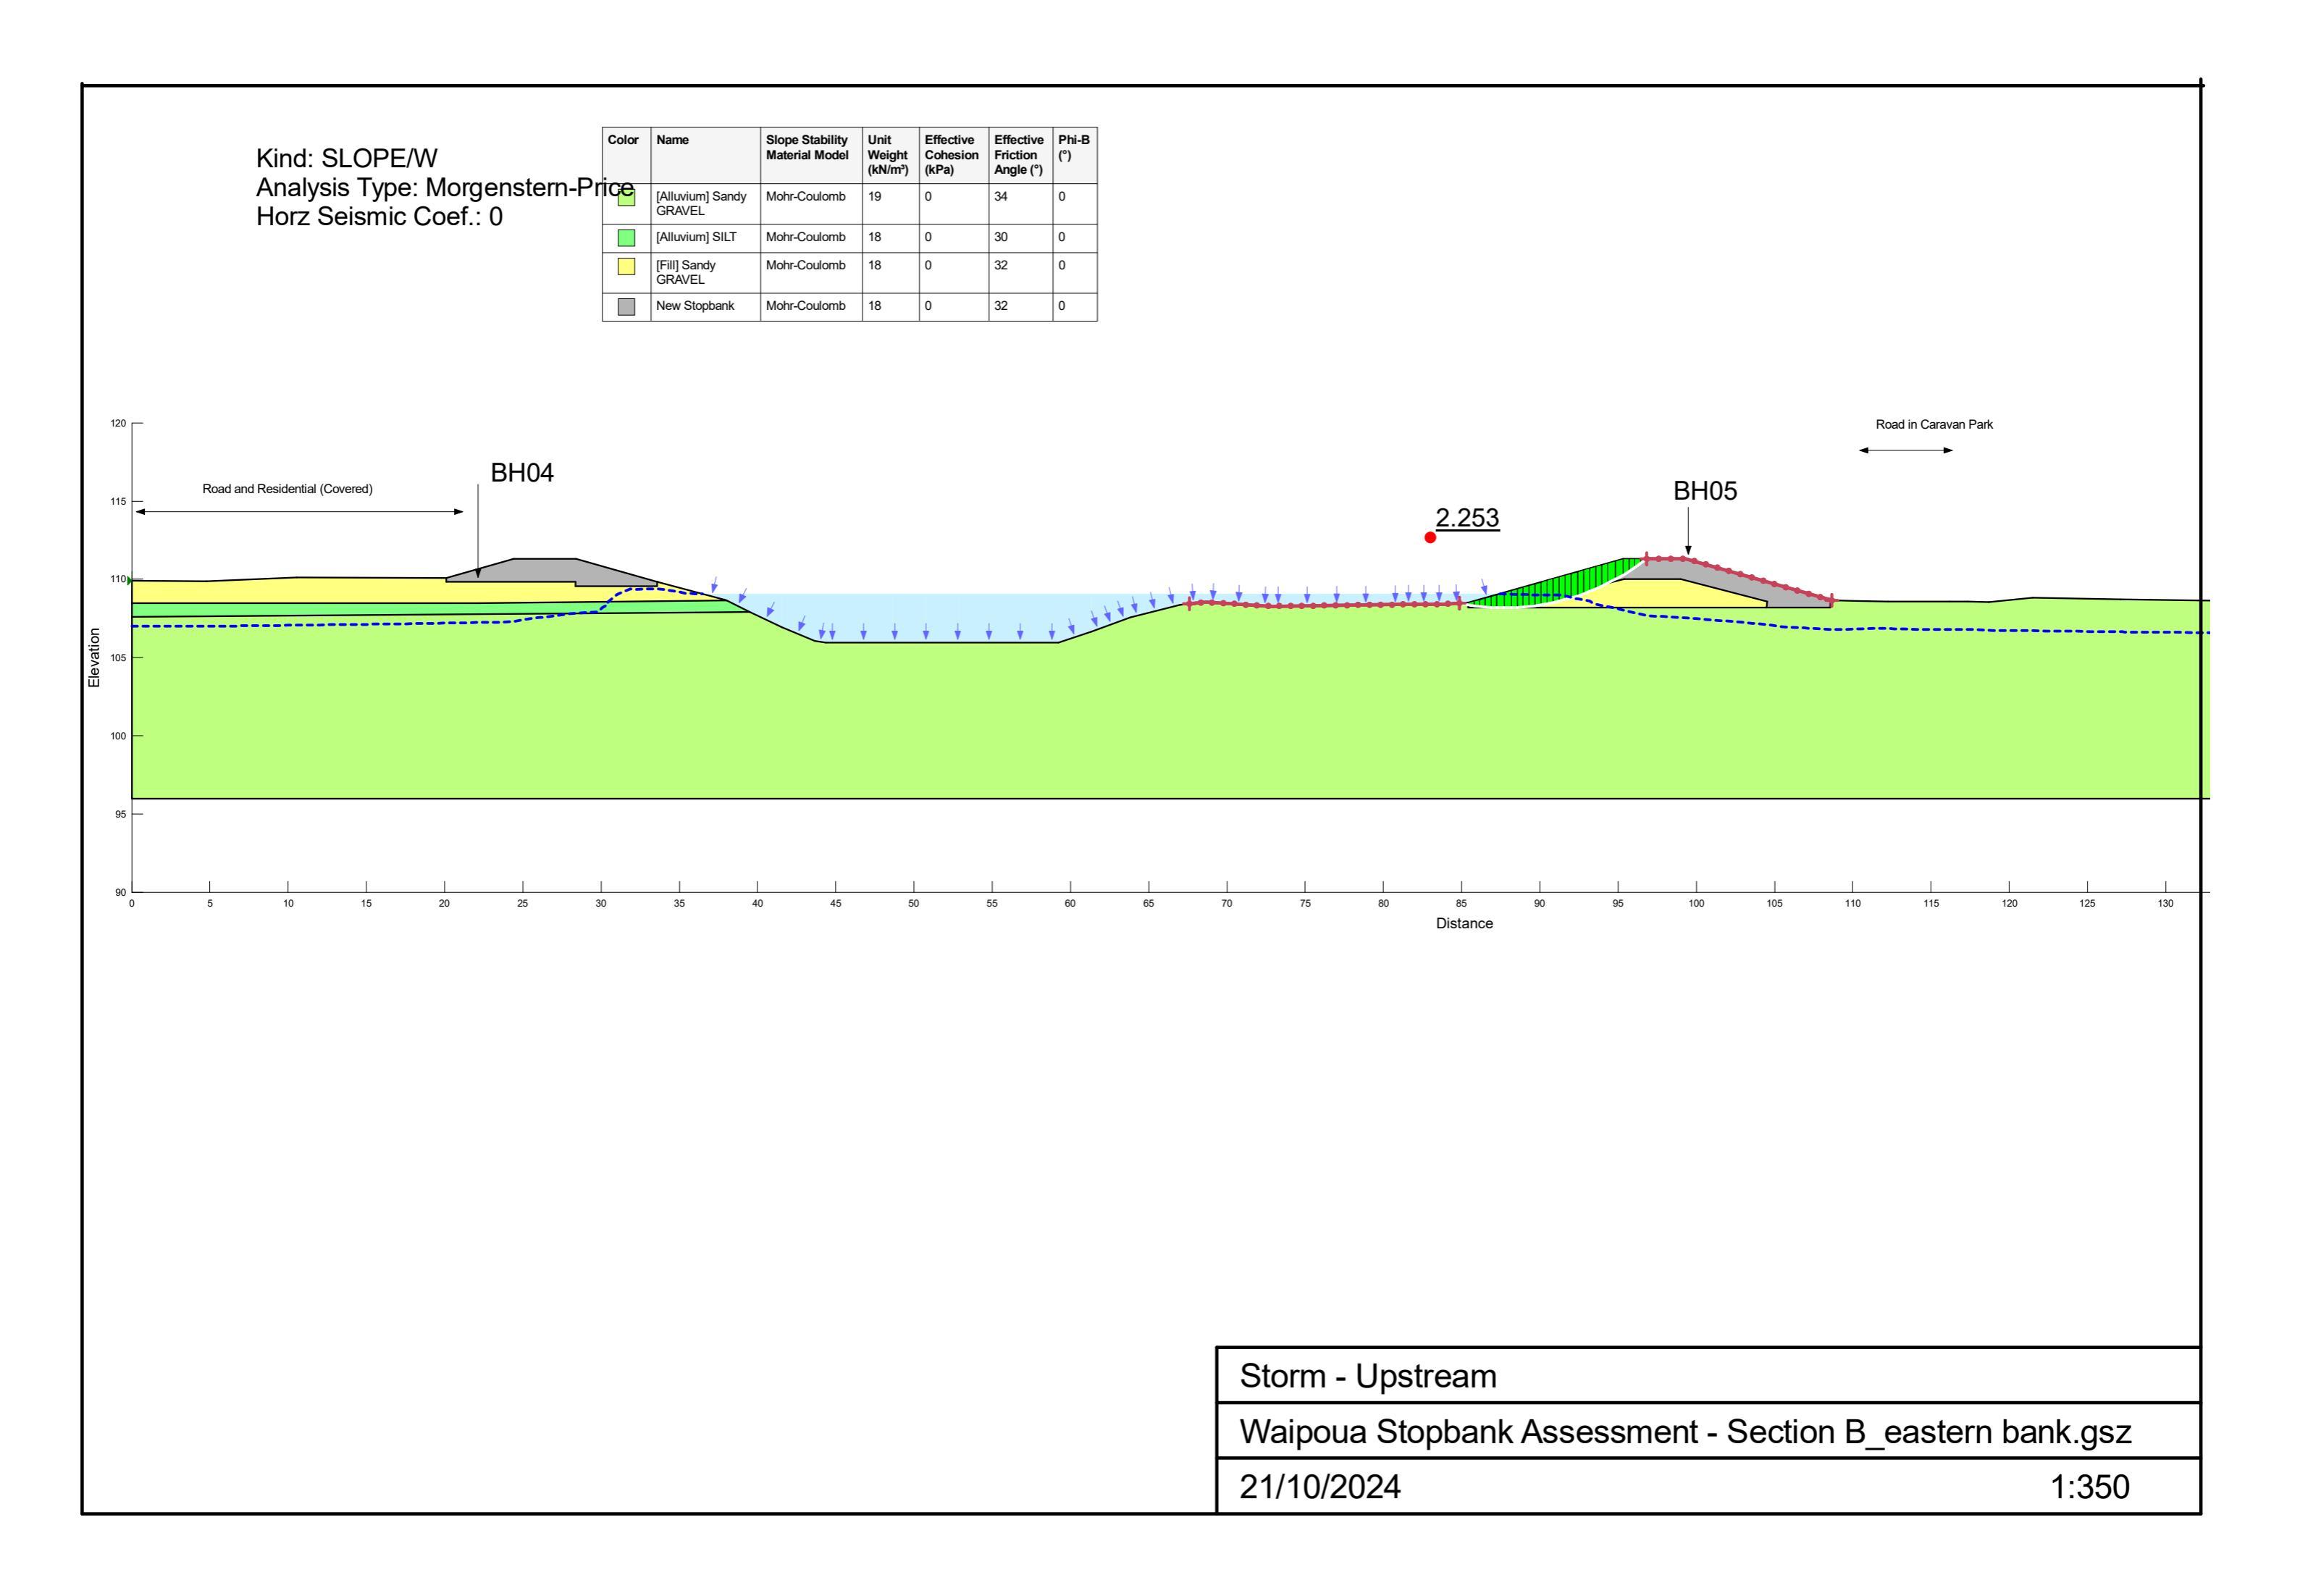
NWL - SEE Seismic Downstream
Waipoua Stopbank Assessment - Sectio
21/10/2024

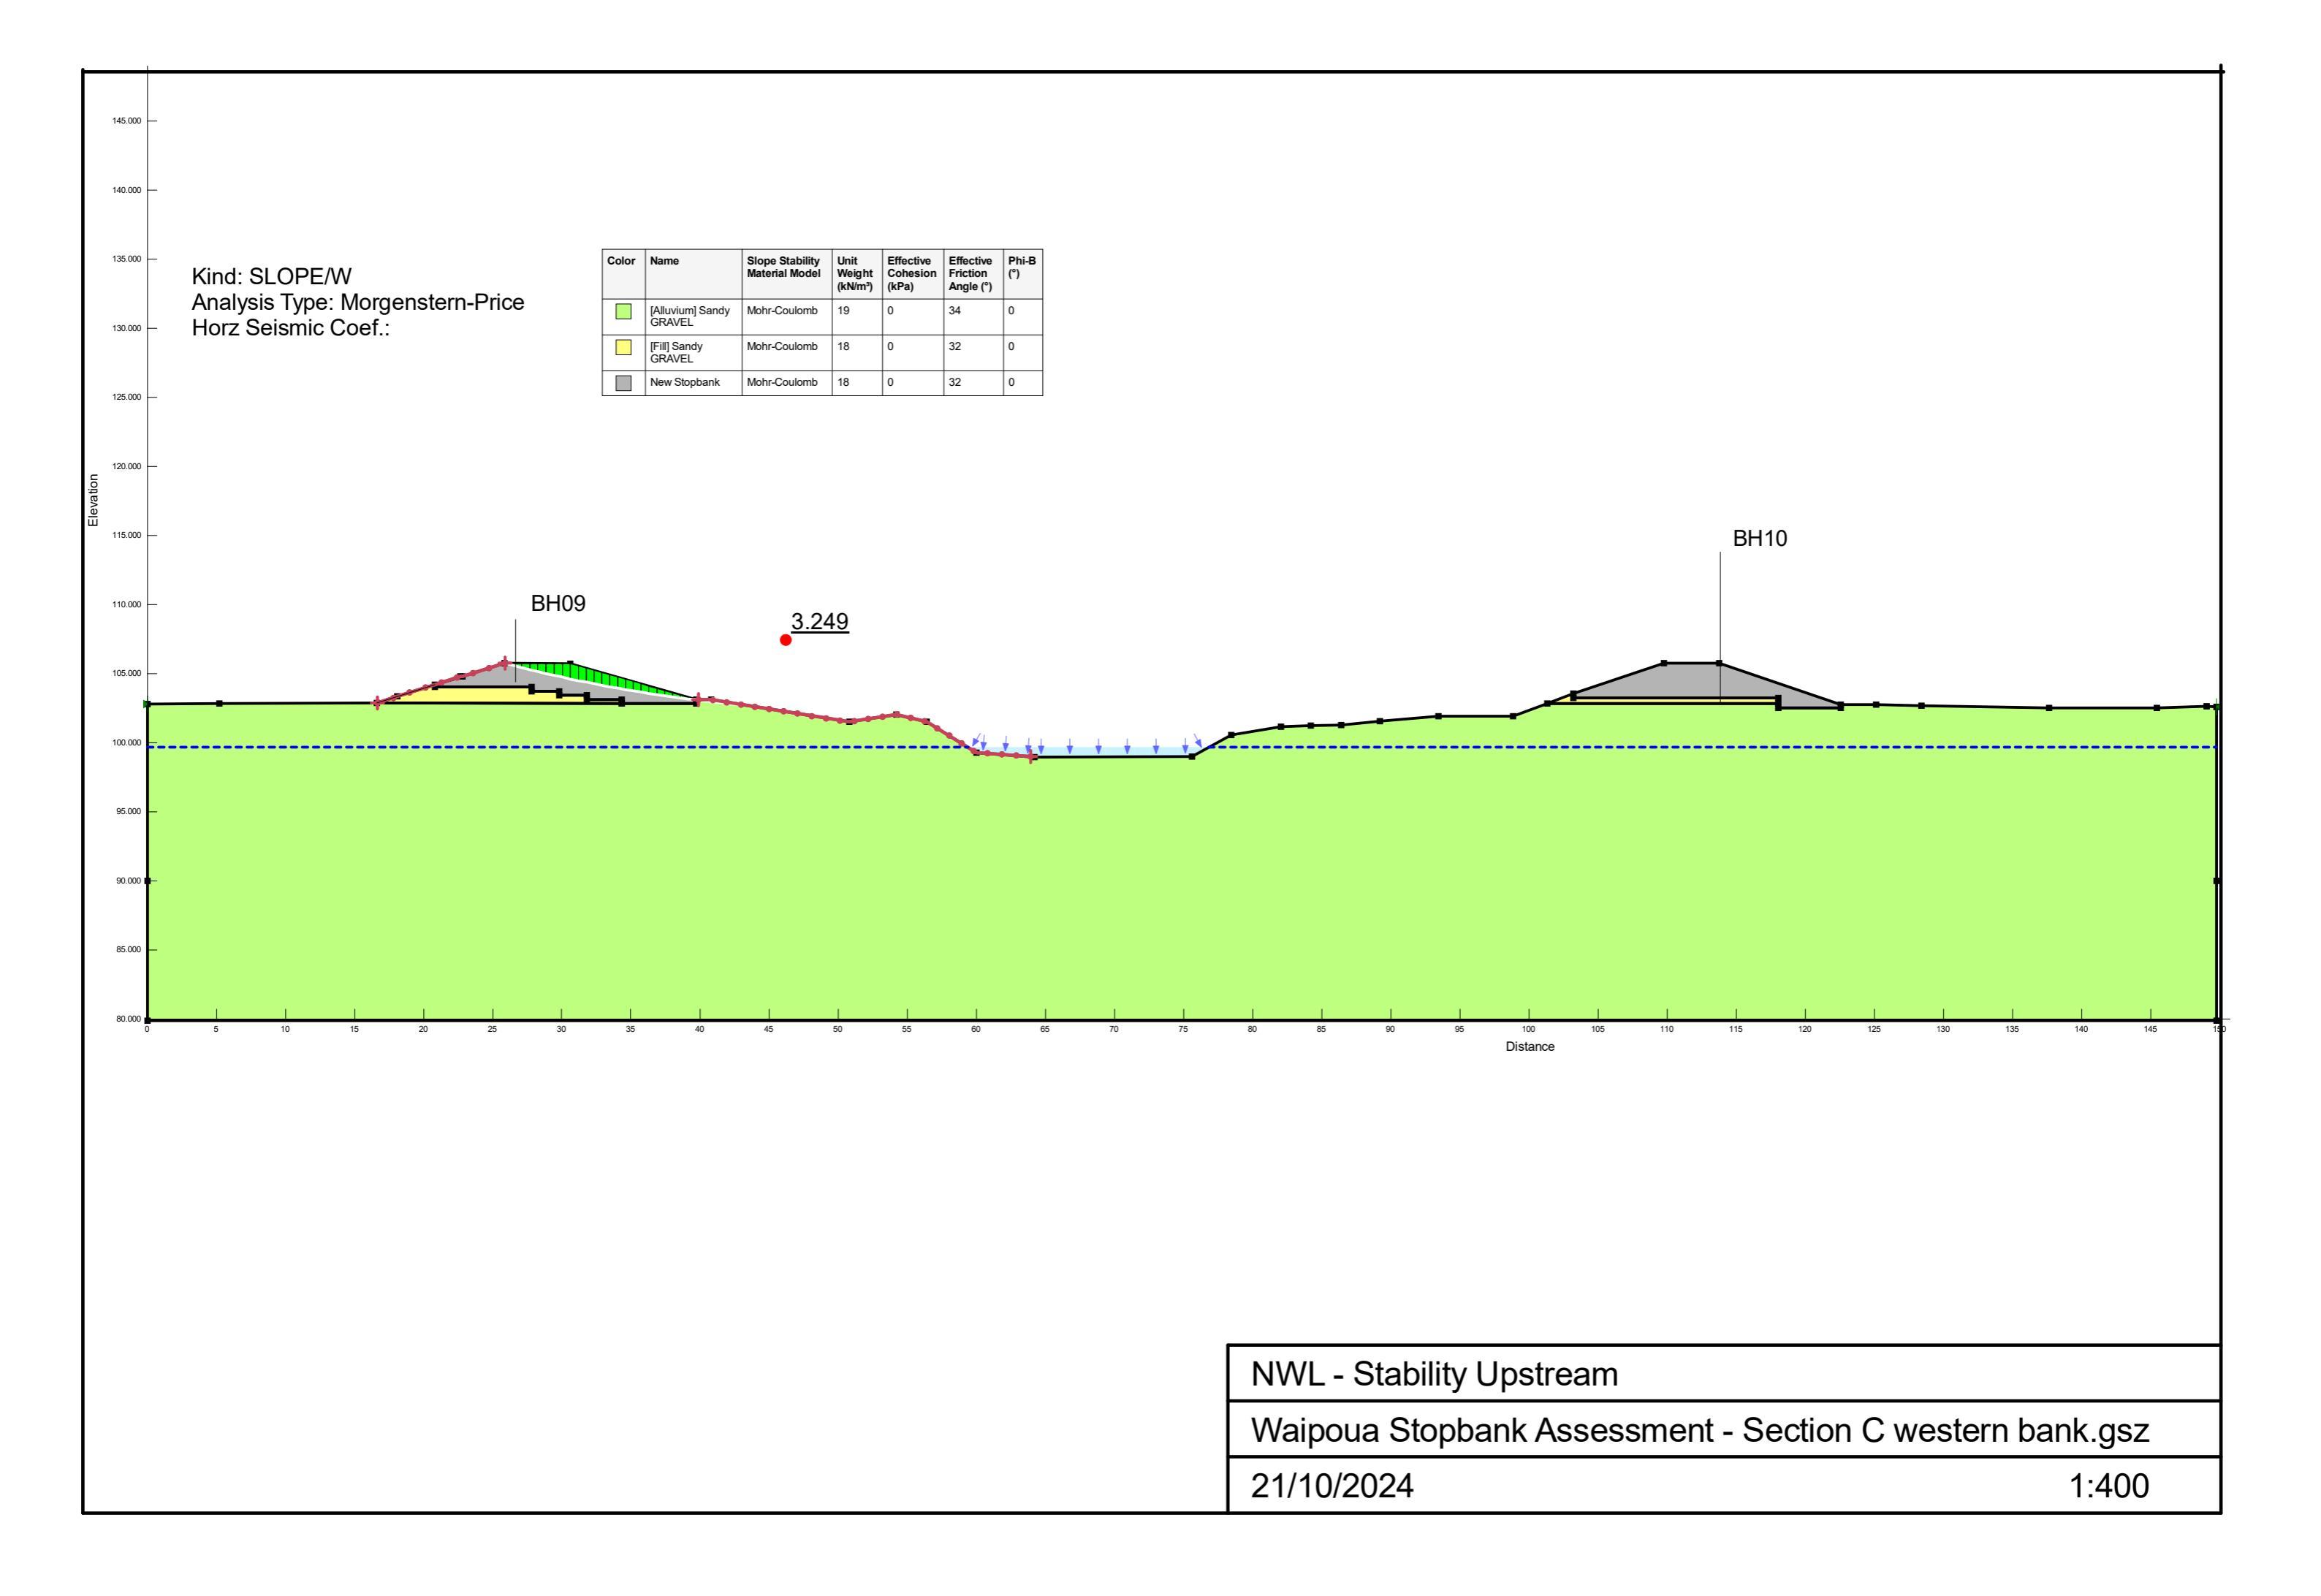
RDD - Upstream
Waipoua Stopbank Assessment - S
21/10/2024
